COLORADO CULTURAL RESOURCE SURVEY

Architectural Inventory Form

- 1. Resource number: **5SM.1833/THAS.105**
- 2. Temporary resource number: **N/A**
- 3. County: **San Miguel**
- 4. City: **Telluride**
- 5. Historic Building Name: **Unknown**
- 6. Current Building Name: **Columbia Avenue LLC House**
- 7. Building Address: **127 E. Columbia Avenue**
- 8. Owner Name and Address: **Jared Vincent
3515 Harbor Rd
Shelburne, VT 54827**

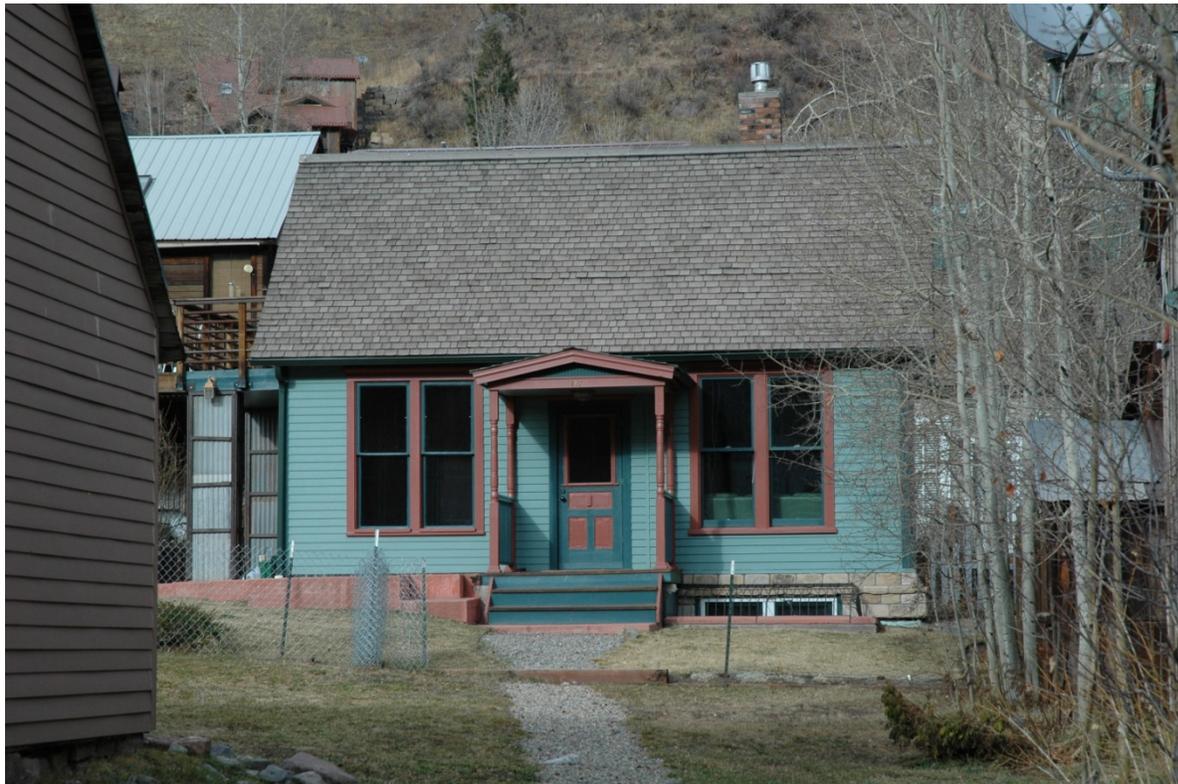
THLD RATING:	Primary Residence - Supporting to District
	Barn –Non-Contributing Without Qualifications
