COLORADO CULTURAL RESOURCE SURVEY

Architectural Inventory Form

- 1. Resource number: **5SM.1796**
- 2. Temporary resource number: **N/A**
- 3. County: **San Miguel**
- 4. City: **Telluride**
- 5. Historic Building Name: **Balliger House**
- 6. Current Building Name: **Cieciuch House**
- 7. Building Address: **317 E. Columbia Avenue**
- 8. Owner Name and Address: **Stephen A. Cieciuch
P. O. Box 932
Telluride, CO 814350932**

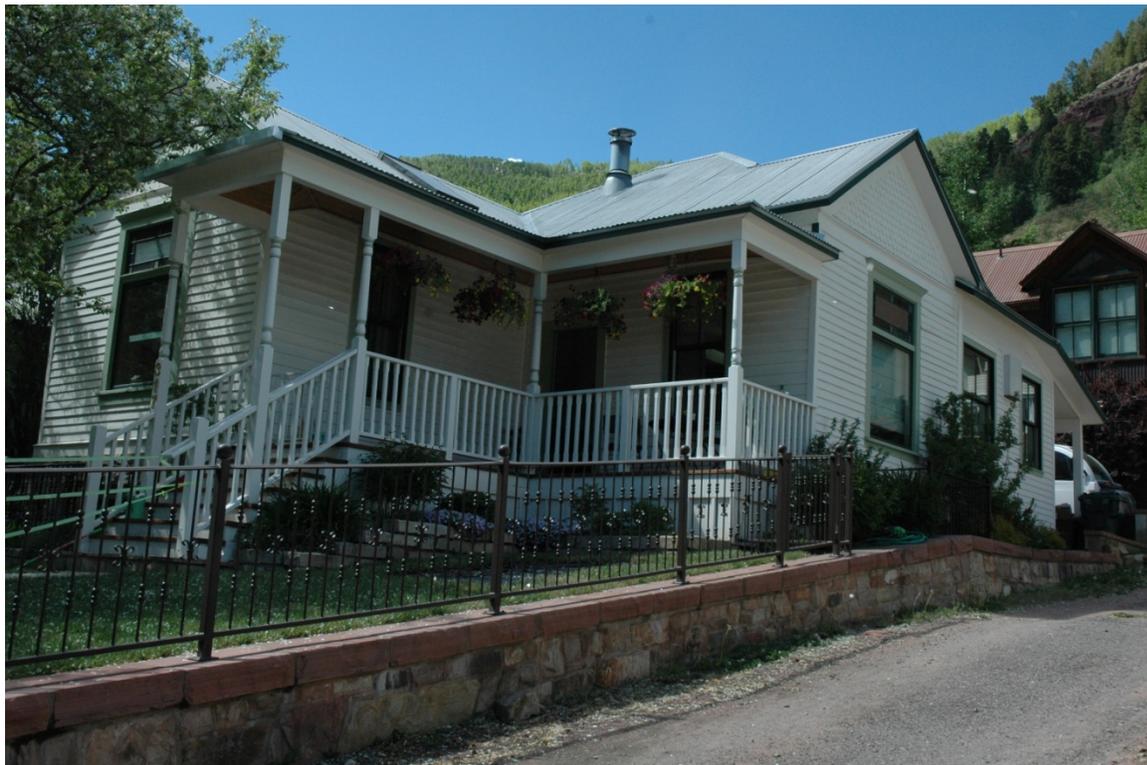
Contributing to District
