COLORADO CULTURAL RESOURCE SURVEY

Architectural Inventory Form

- 1. Resource number: **5SM.1726/THAS27**
- 2. Temporary resource number: **N/A**
- 3. County: **San Miguel**
- 4. City: **Telluride**
- 5. Historic Building Name: **Unknown**
- 6. Current Building Name: **Olson House**
- 7. Building Address: **552 W. Columbia Avenue**
- 8. Owner Name and Address: **Craig L. Olson  
7628-4 Rio Grande Blvd NW  
Albuquerque, NM 87107**

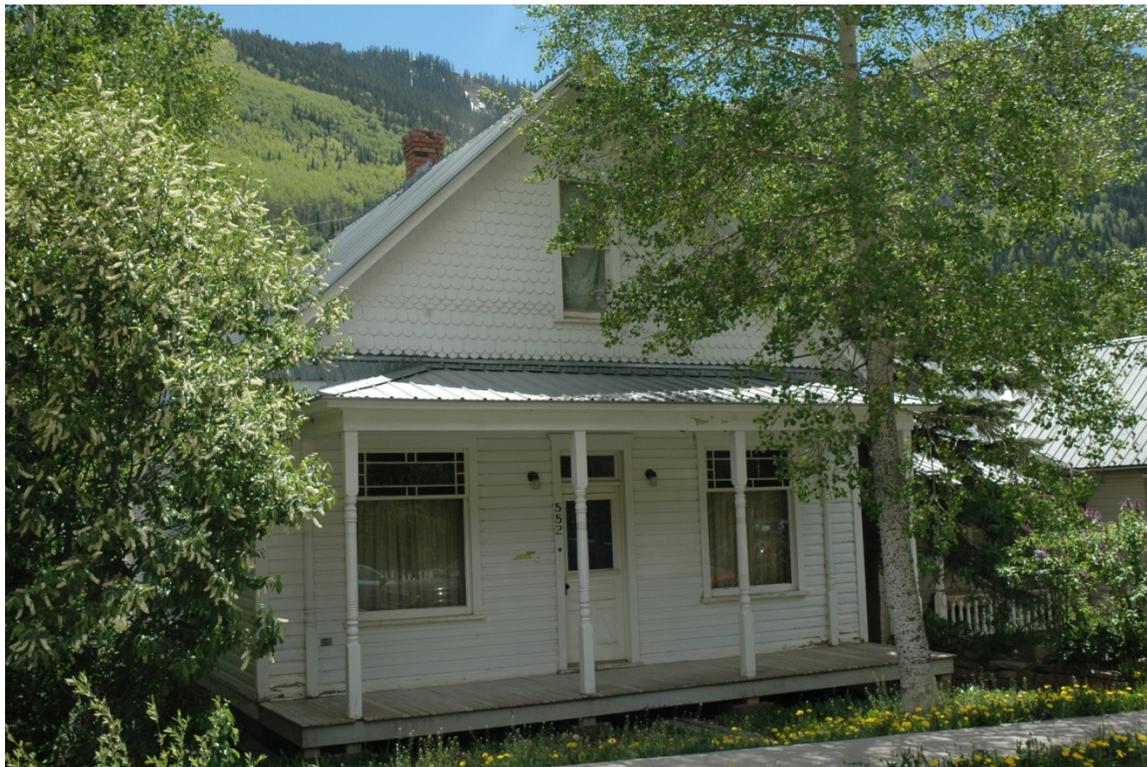
THLD RATING:

Primary - Contributing to District  
Barn – Non-Contributing with Qualifications
