Town of Telluride

MANUAL OF STREETSCAPE STANDARDS

Adopted March 2007

Revised June 2016

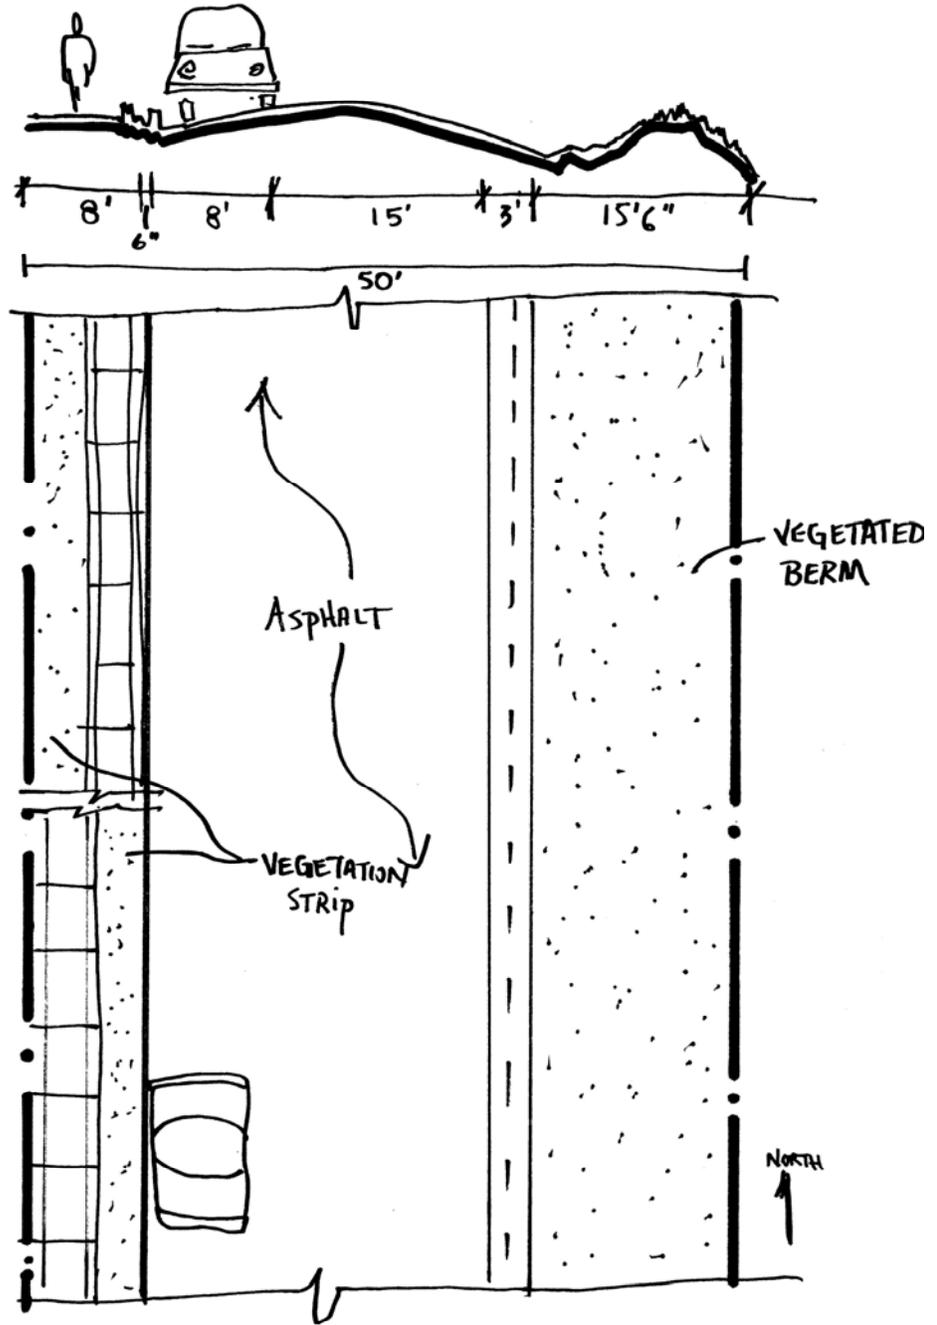
NORTH ALDER STREET - 100 BLOCK
(BETWEEN COLORADO & COLUMBIA)

Existing Street Conditions. This block was improved during Streetscape Phase I, 1998, Construction. Paved with asphalt, it slopes to the south. The concrete curb and gutter along the west side of the block is in good condition, as is the 3' concrete v-pan that borders the edge of asphalt along the east side. An alley intersects the block, but there are no other curb cuts. There is a 5'-wide sidewalk on the west side of the block. South of the alley there is a 3'-wide green strip that separates the sidewalk from the travel way; north of the alley the green strip is on the residential side to accommodate historic encroachments. There is a 15.5'-wide vegetated berm along the entire length of the east side to protect nearby residences from large runoff flows that are directed onto this block. Runoff management is a continued challenge on this block and the north end and at the east and west alley curb cuts. Re-grading and re-contouring the travel way and widening the western 3' v-pan to 5' are two possibilities for improving drainage flow.

Environment/Drainage/Snow Storage. While this block, as it is configured, is consistent with Telluride's snow storage and drainage plans and the existing curb and gutter drainage system effectively handles runoff during a typical runoff event, there is a continued flooding problem during larger runoff events. It should be noted that this block receives up to 70 percent of the runoff in Telluride. Re-grading and re-contouring the travel way and widening the western 3' v-pan to 5' are two possibilities for improving drainage flow. Two large cement sedimentation vaults were installed underneath the northern third of this block in 1998 to remove sediment from runoff flows. The surface and subsurface drainage system requires special maintenance to ensure the fugitive sediment that settles out here does not adversely impact air and water quality. To this end, the drop inlets and sedimentation vaults are completely cleaned with a vacuum truck every six months. Snow is typically stored along the west side in winter.

1. Re-engineer street grades (e.g., add a more significant crown) to improve drainage from travel way.
2. Replace the 3'-wide drain pan along the west side with a 5'-wide pan.

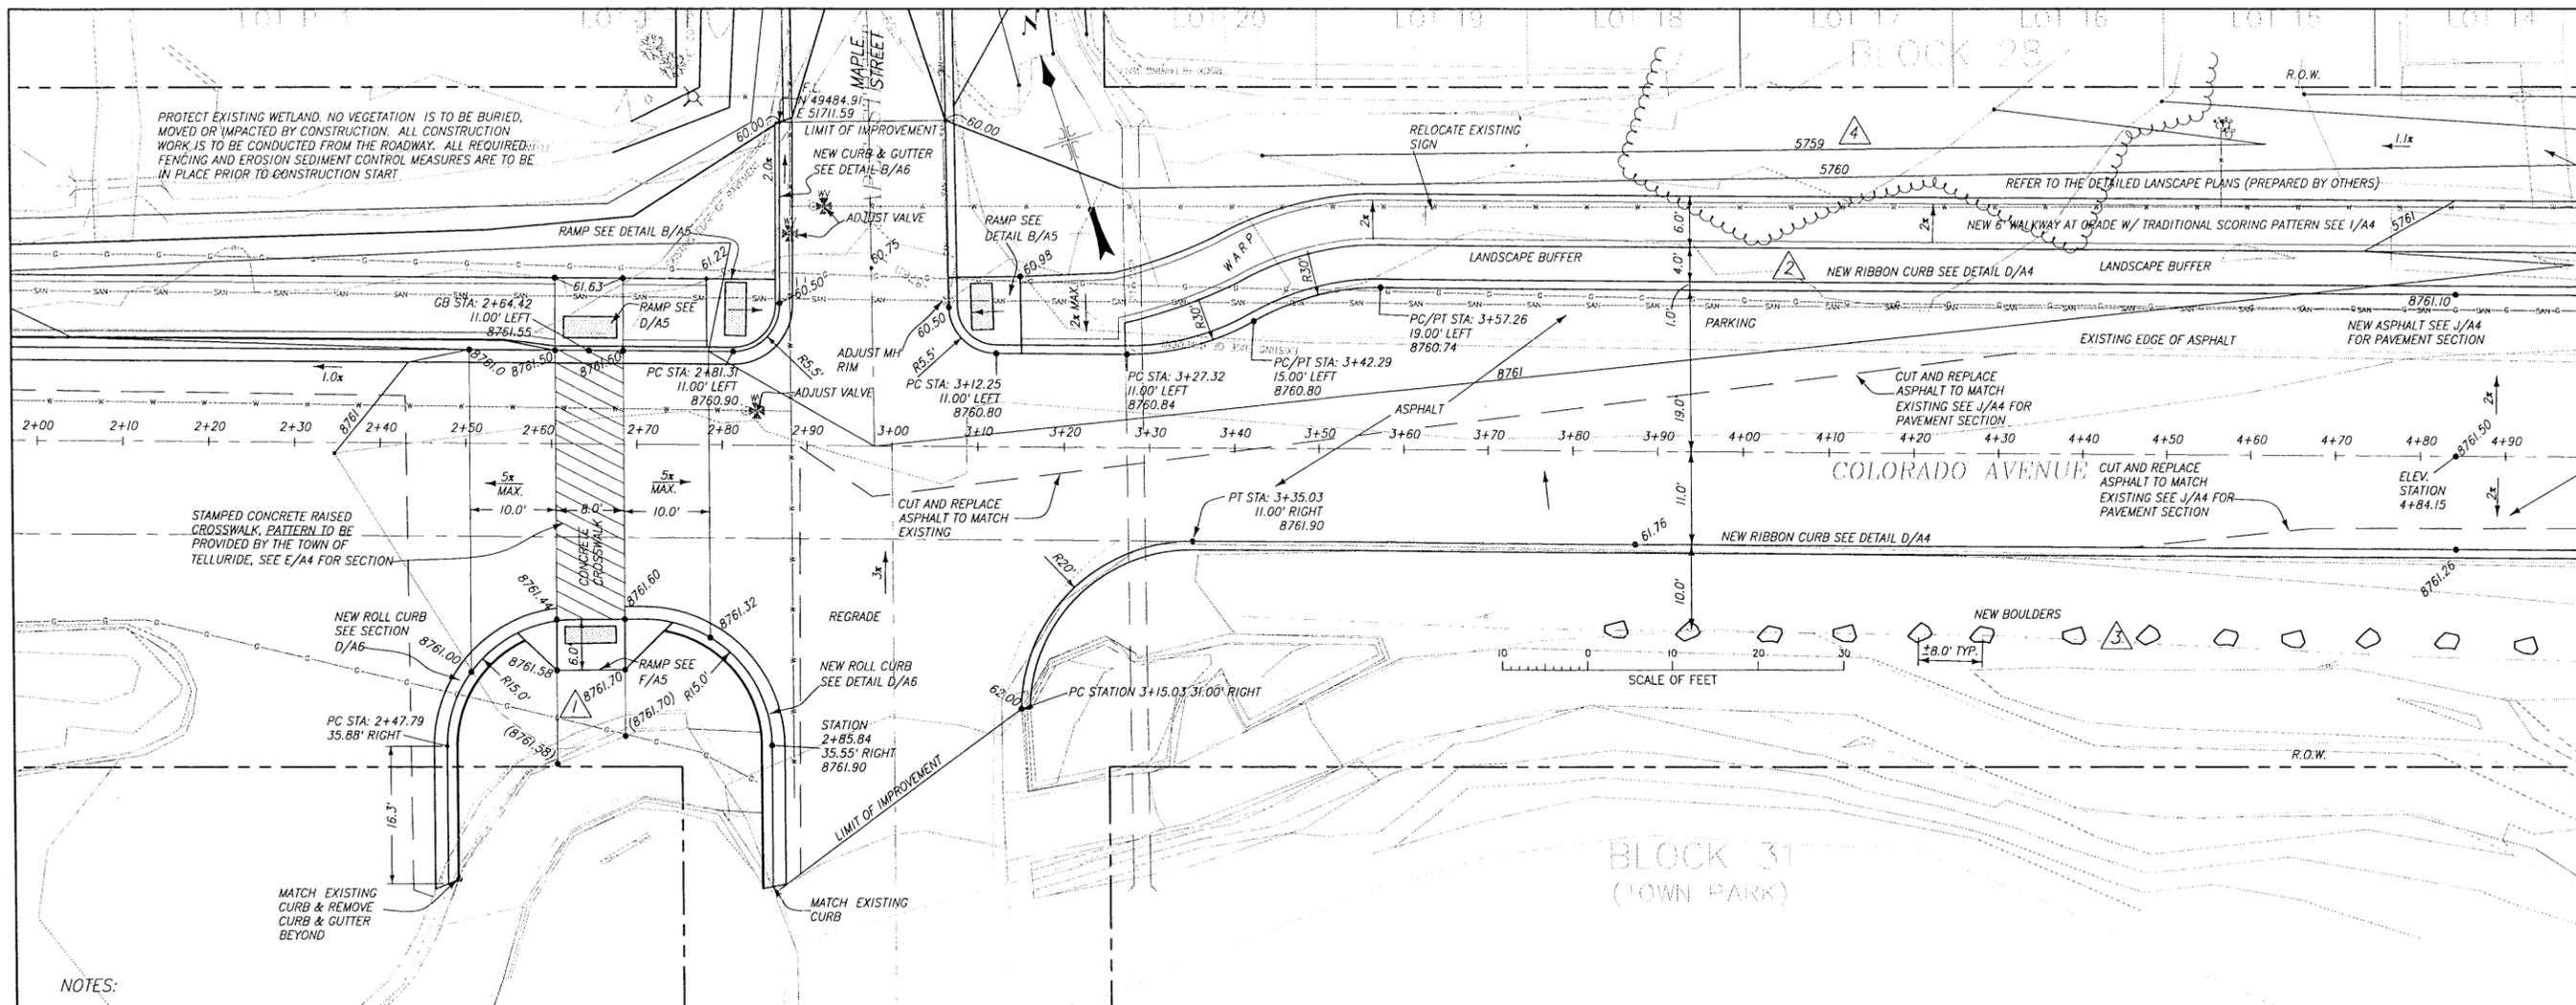
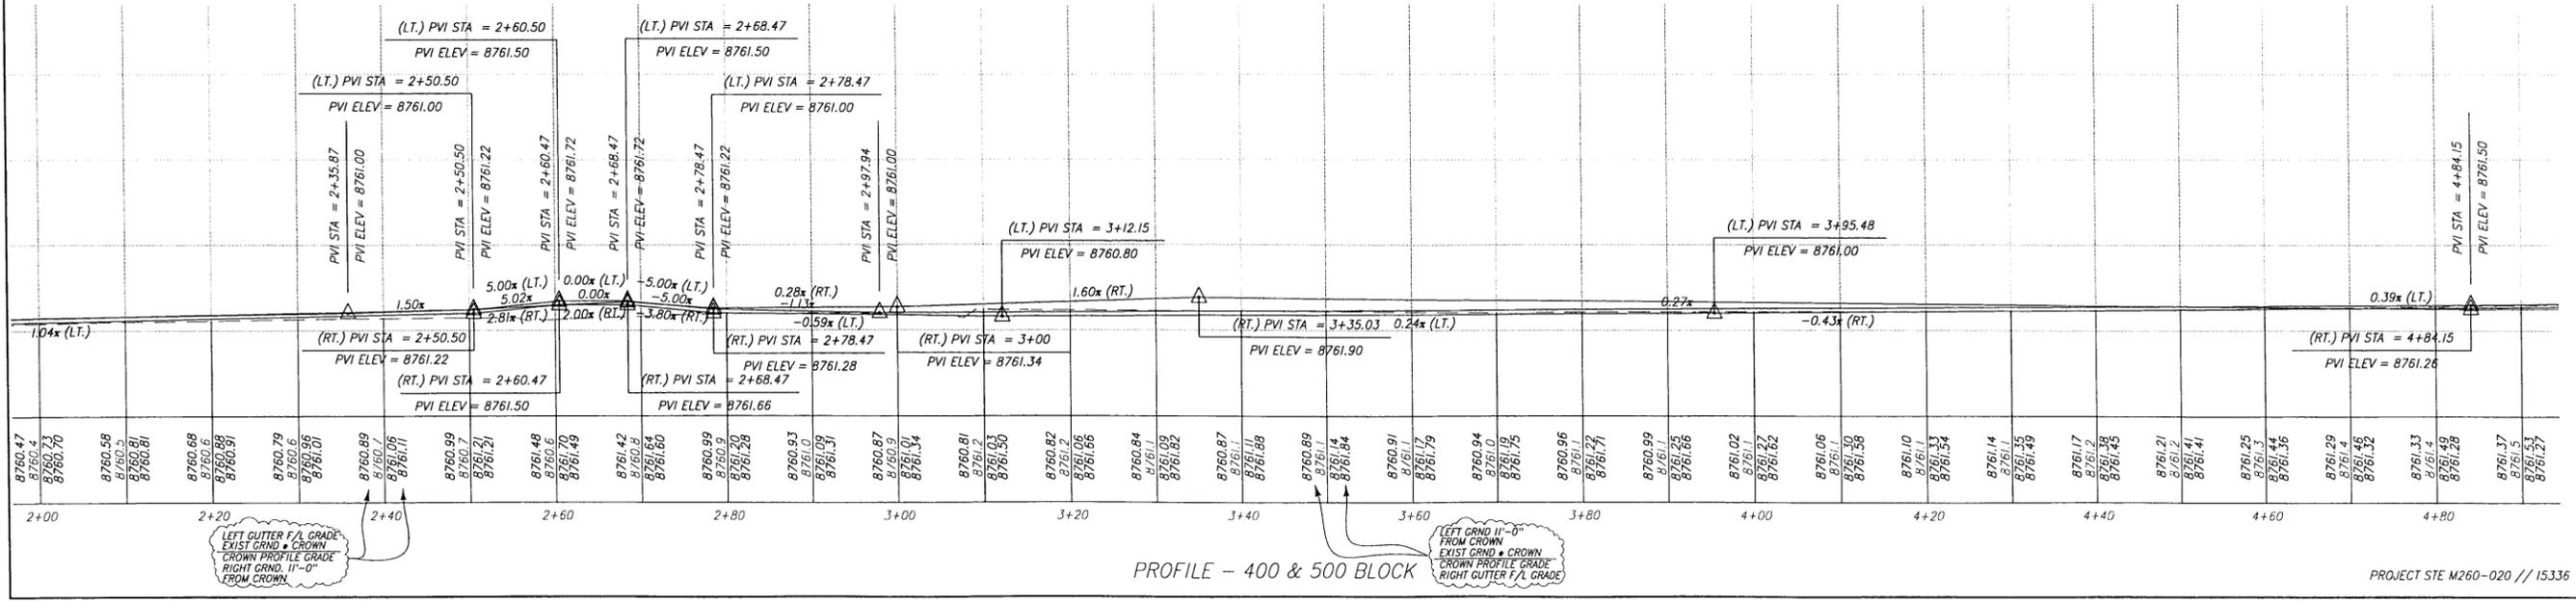
TELLURIDE STREETSCAPES - EAST TELLURIDE
EAST COLORADO AVENUE PLAN AND PROFILE
STA. 2+00 TO STA. 4+90 (400 & 500 BLOCKS)

- NOTES:
- 1 MATCH MASTER PLAN OF PARK IMPROVEMENTS ALONG THE SOUTH SIDE OF COLORADO.
 - 2 LANDSCAPE BUFFER BETWEEN WALKWAY AND RIBBON CURB TO VARY, MINIMUM 3.5 FT. AND MAXIMUM 5.5 FT.
 - 3 PLACE 24"-36" DIAMETER BOULDERS SOUTH OF SPECIAL EVENTS PARKING. FINISH PARKING AREA WITH 1-1/2" ANGULAR WASHED GRAVEL.
 - 4 UNLESS OTHERWISE NOTED, ALL EXISTING LANDSCAPING TO REMAIN.
 - 5 SEE STREETSCAPE R.O.W. GUIDELINES FOR LANDSCAPE SPECIFICATIONS.

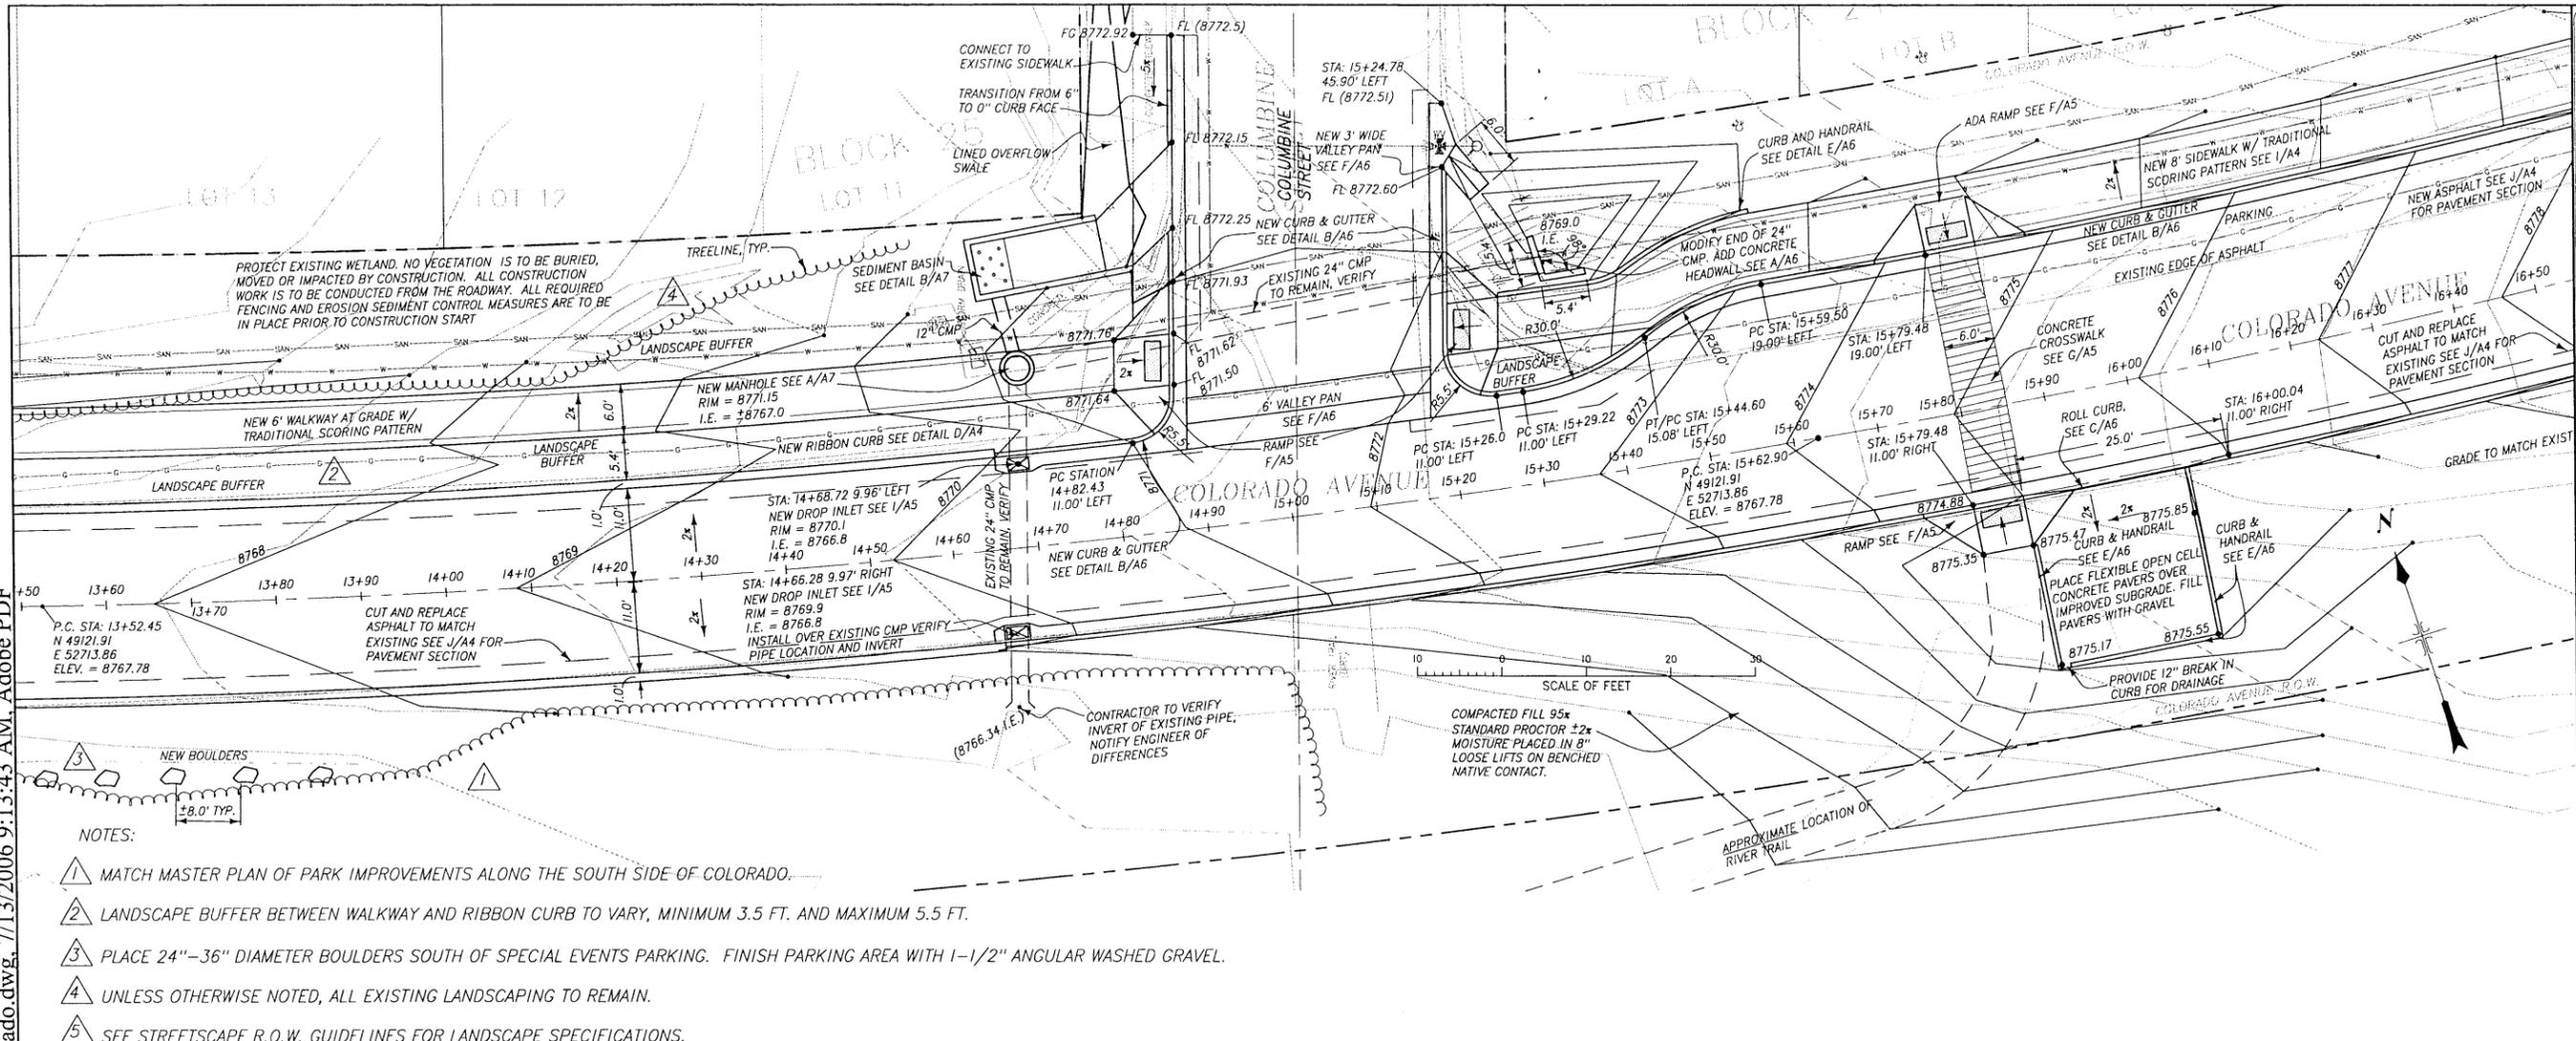
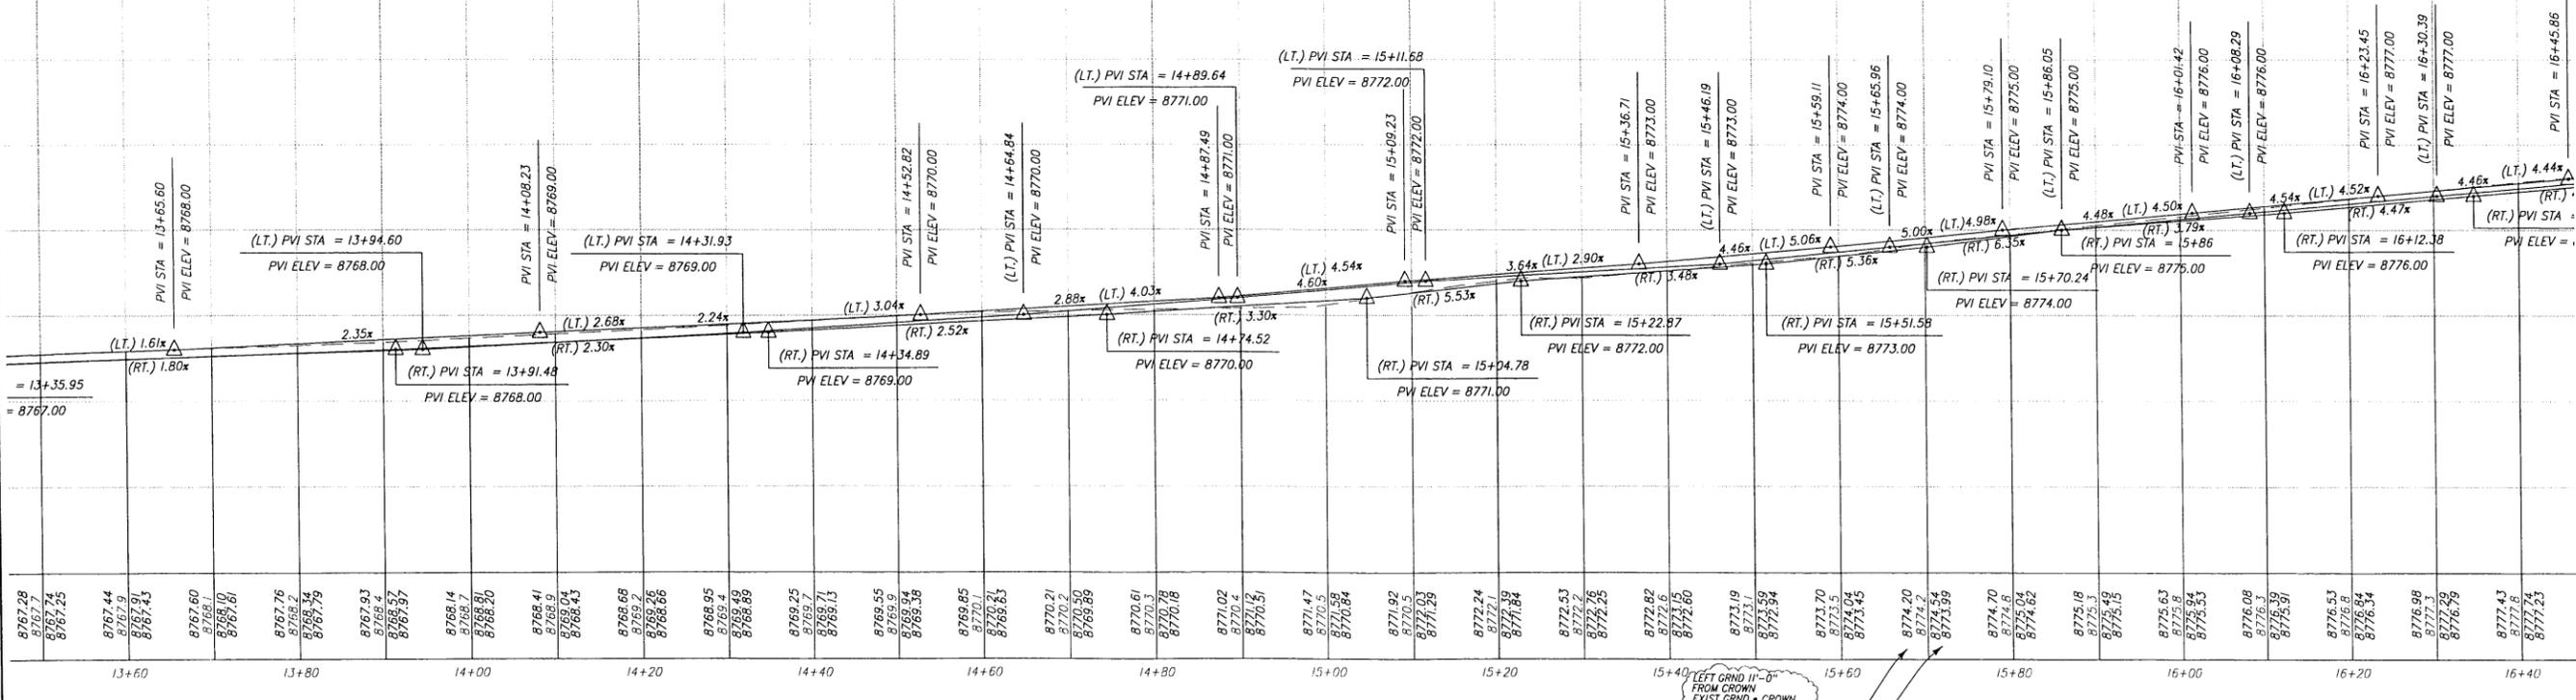
TELLURIDE STREETSCAPES - EAST TELLURIDE
EAST COLORADO AVENUE PLAN AND PROFILE
STA. 13+50 TO STA. 16+50 (800 & 900 BLOCKS)

- NOTES:
- 1 MATCH MASTER PLAN OF PARK IMPROVEMENTS ALONG THE SOUTH SIDE OF COLORADO.
 - 2 LANDSCAPE BUFFER BETWEEN WALKWAY AND RIBBON CURB TO VARY, MINIMUM 3.5 FT. AND MAXIMUM 5.5 FT.
 - 3 PLACE 24"-36" DIAMETER BOULDERS SOUTH OF SPECIAL EVENTS PARKING. FINISH PARKING AREA WITH 1-1/2" ANGULAR WASHED GRAVEL.
 - 4 UNLESS OTHERWISE NOTED, ALL EXISTING LANDSCAPING TO REMAIN.
 - 5 SEE STREETSCAPE R.O.W. GUIDELINES FOR LANDSCAPE SPECIFICATIONS.

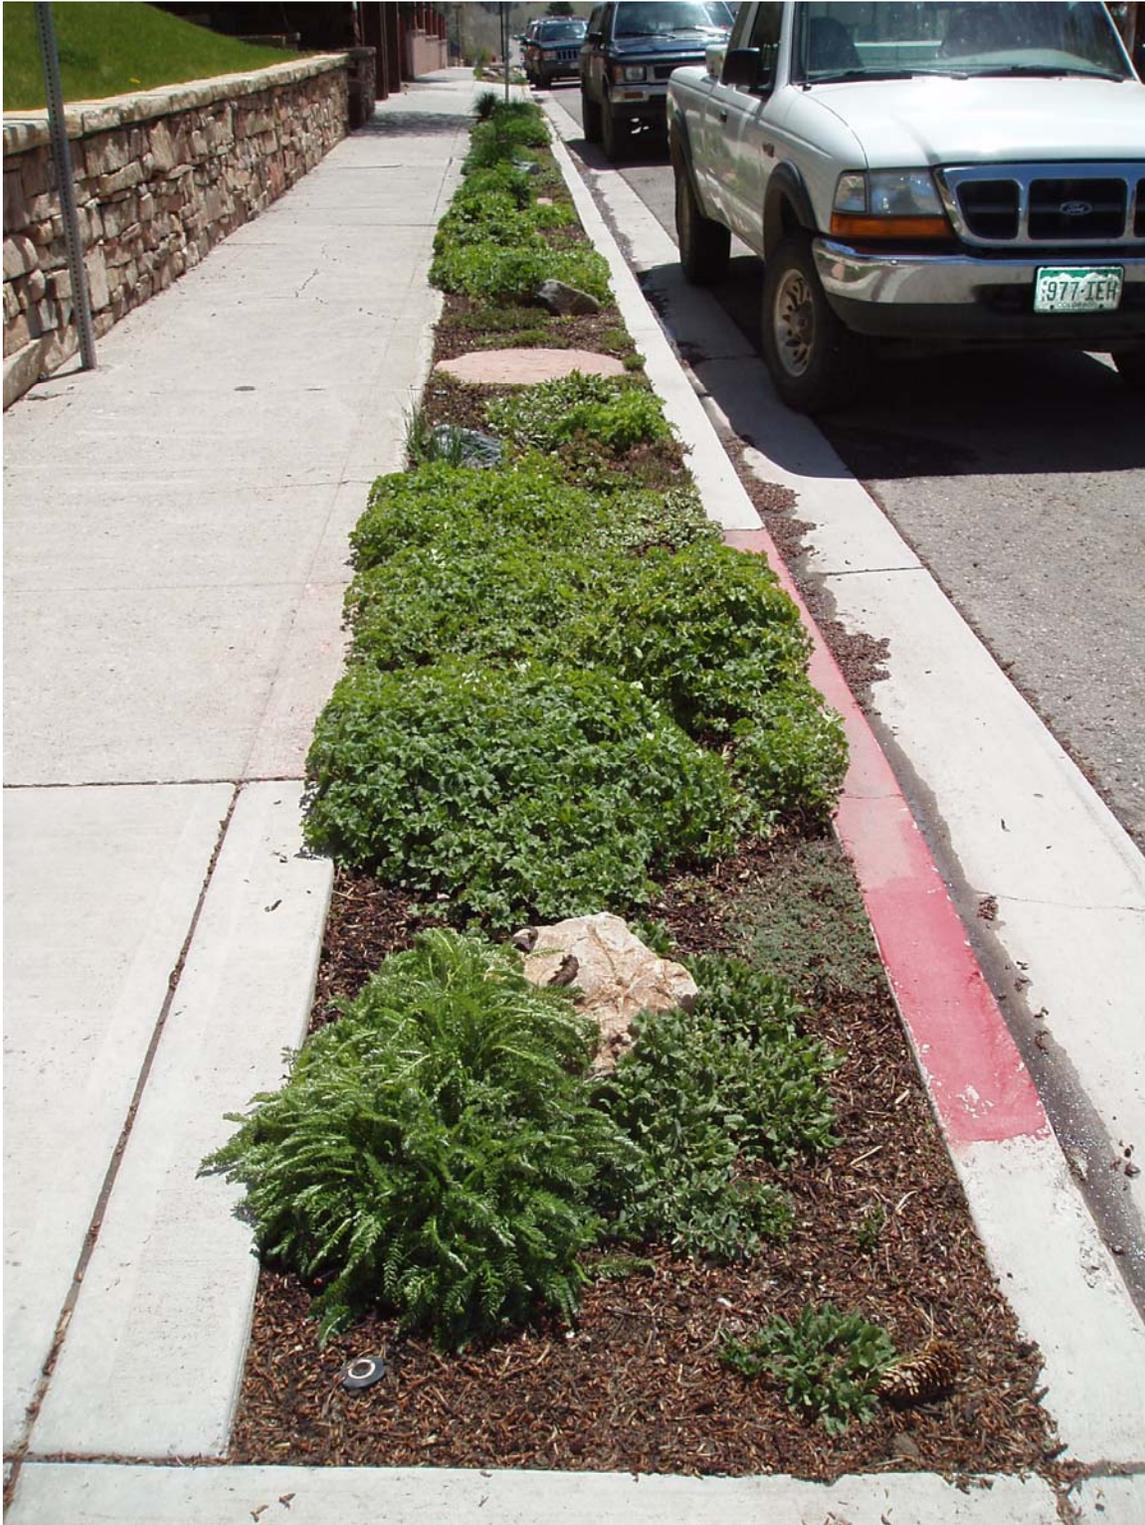
Profile A (example: east side of North Oak Street) – These are narrow, 24 - 36" wide, planting, strips between the sidewalk and the street. The flat stones serve as a step between the sidewalk and parking.

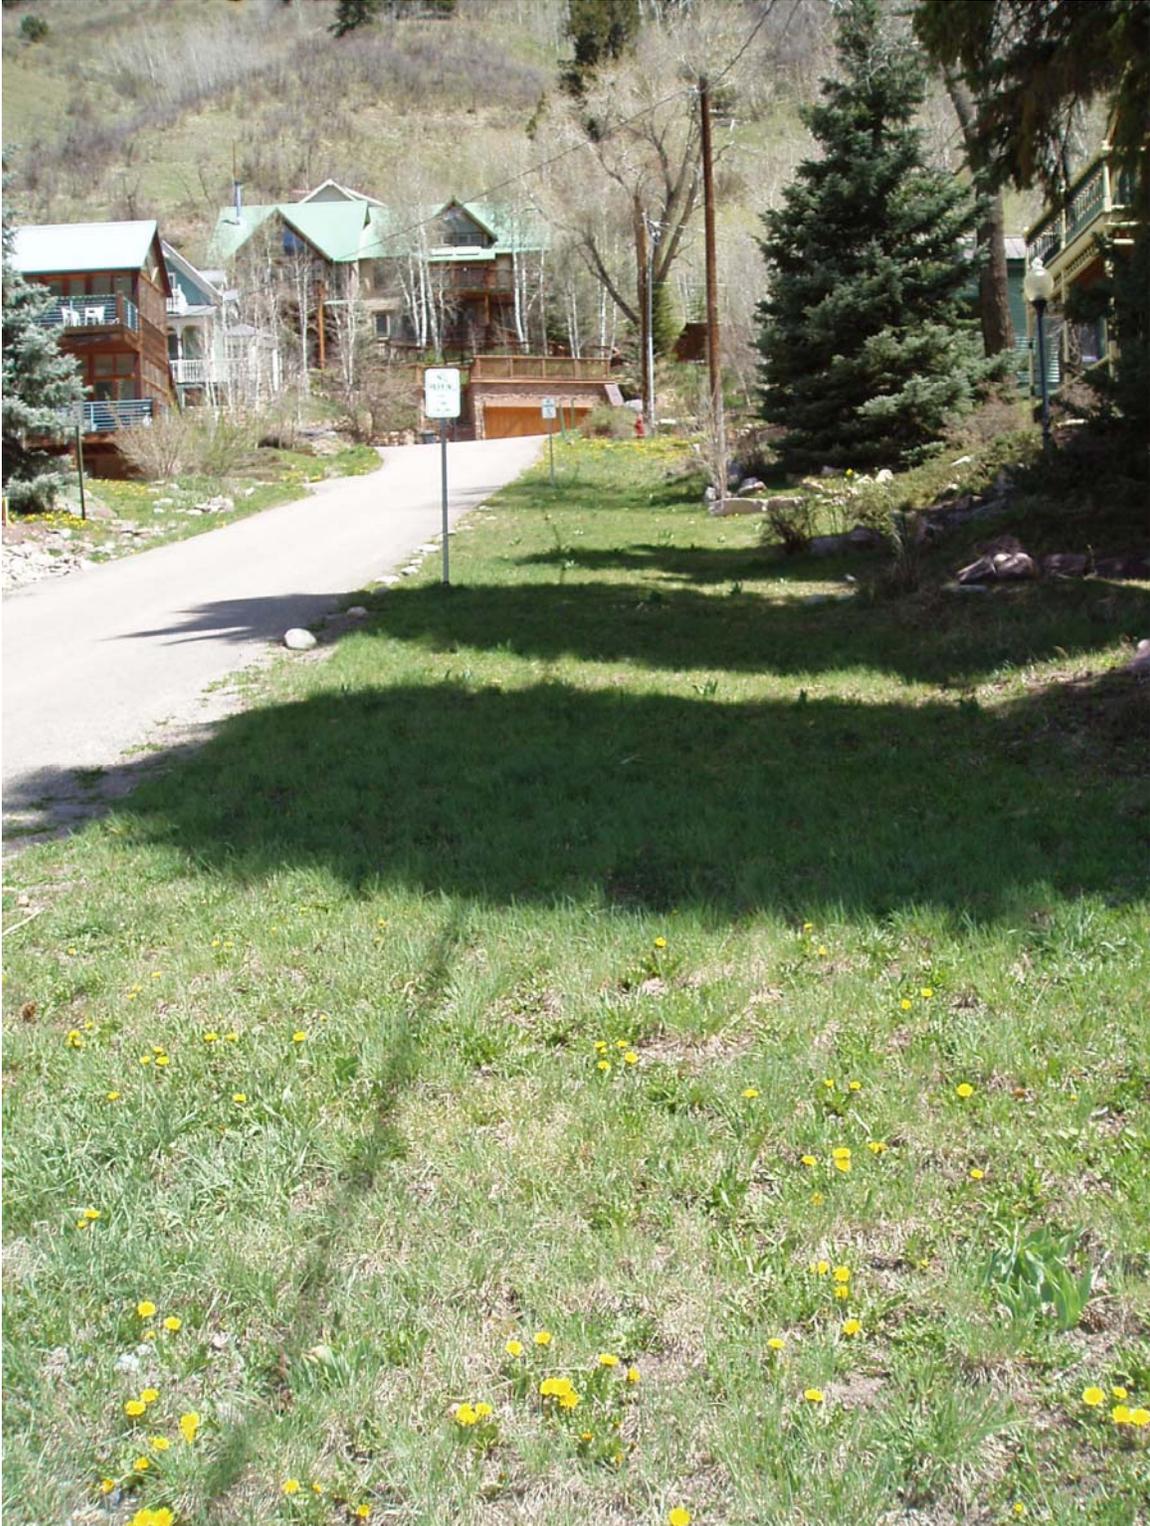
Profile B (example: 300 block of N Spruce Street) -- With the travel way being narrowed to 18 feet and the sidewalks removed, a 22 foot wide greenspace became available directly adjacent to the properties on the E side of Spruce Street. With a total of 4,400 square feet, this area resembles a pocket park more than a planting strip. It constitutes a small victory over the dominance of the car!

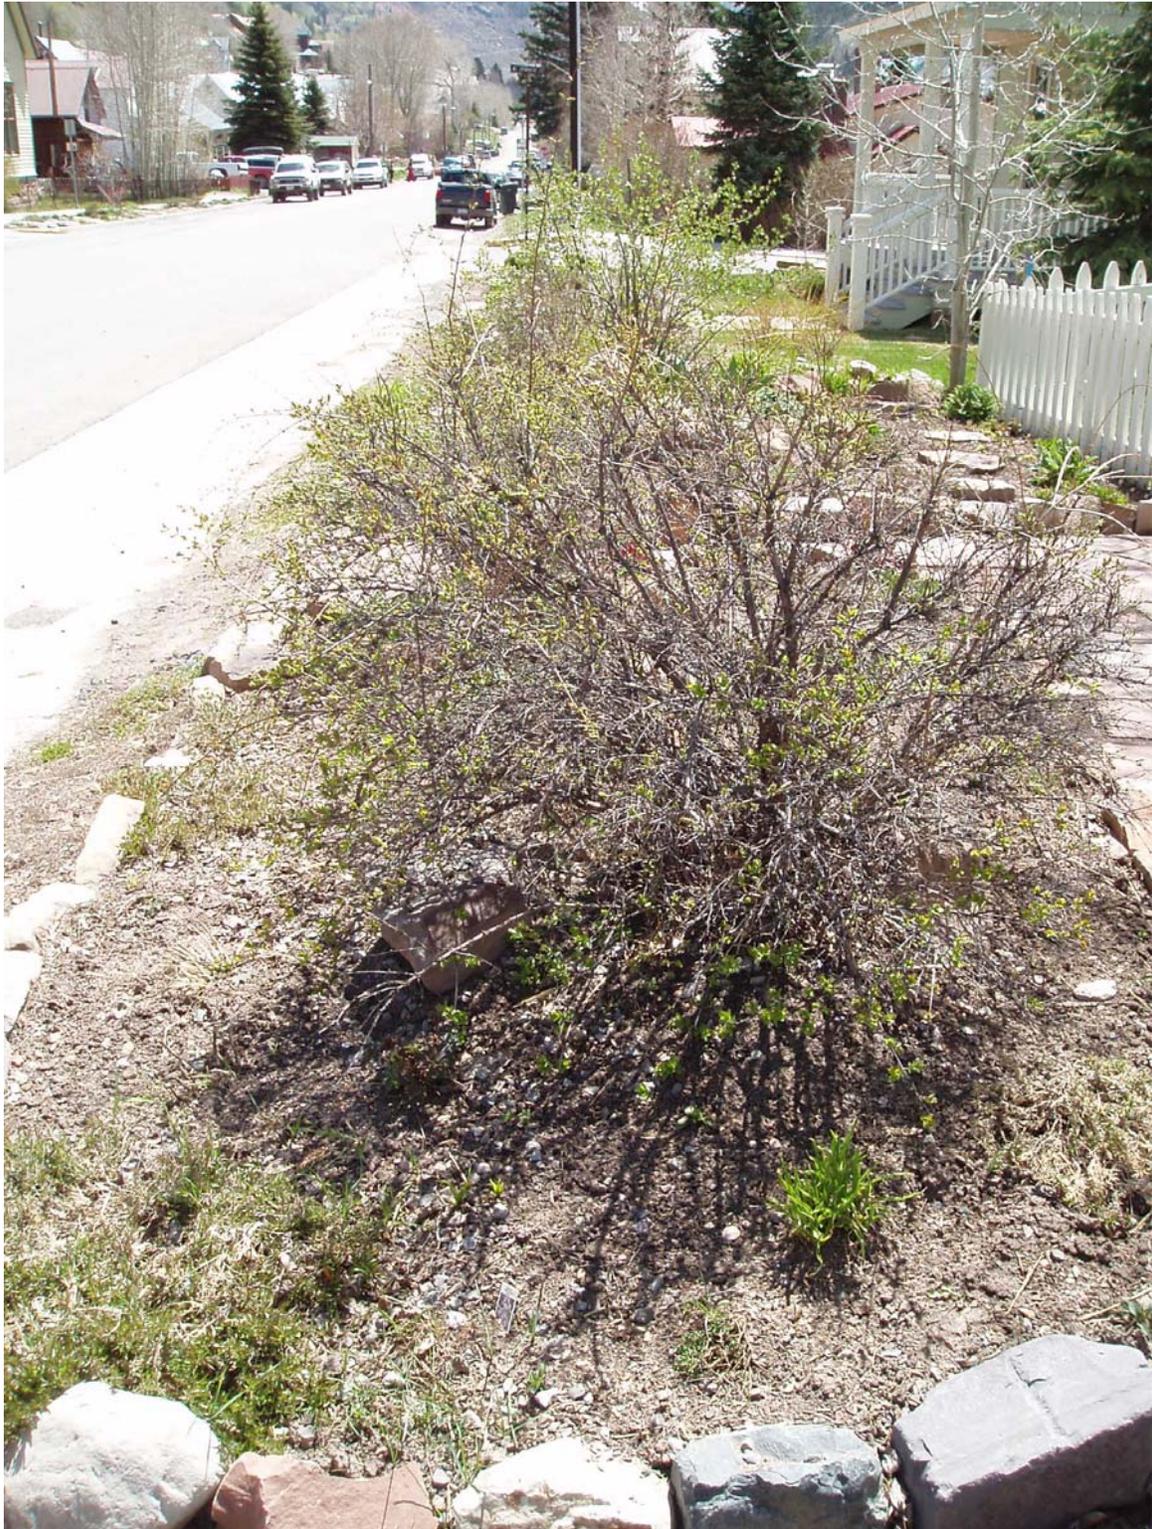
Profile C (example: south side of E Columbia)—wide berm for snow storage and flood/runoff management/wetland.

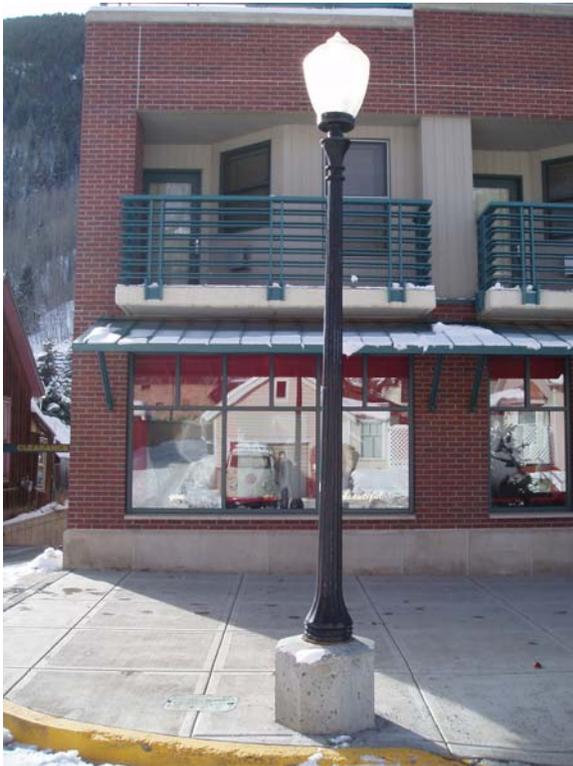
Figure 2. Telluride's Standard Commercial Streetlight

After considerable research to identify a completely different light fixture for the commercial district, the Streetscape Task Force determined that Town residents preferred to keep the existing fixture (Figure 2). Focus then shifted to globe inserts that

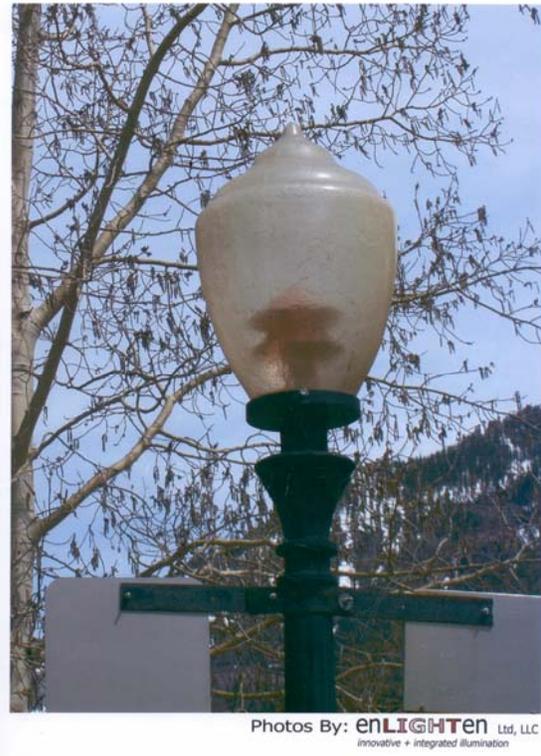
Figure 3. Globe insert to the Standard Streetlight to decrease light spill and direct more light onto

would succeed in directing more light down onto the sidewalk and much less into the night sky and neighboring buildings. Figure 3 illustrates the final solution.

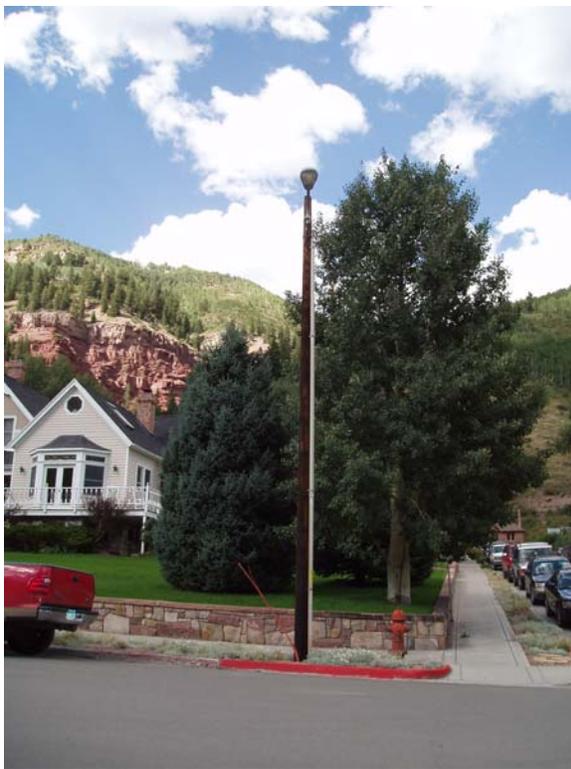
Figure 4. SMPA-supplies pole mounted residential light

The pole-mounted residential light fixture that was historically provided by the San Miguel Power Association (Figure 4) is aesthetically unpleasing and tends to spill light into buildings that are on adjacent properties. It also creates a notable “glow” in the night sky. Figure 5 illustrates the preferred fixture selected after extensive research into available lighting options. Goals included energy efficiency, aesthetic appeal, and efficient lighting of the intersection.

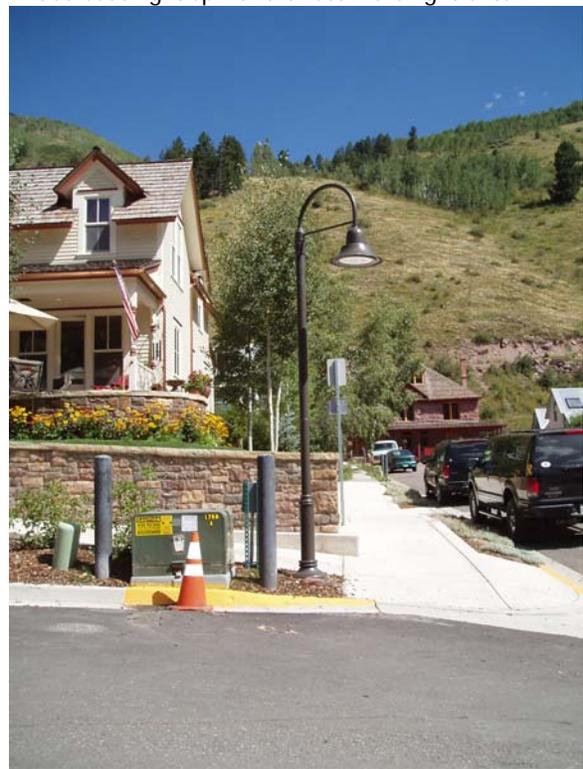
the sidewalk.
Figure 5. Selected residential light fixture

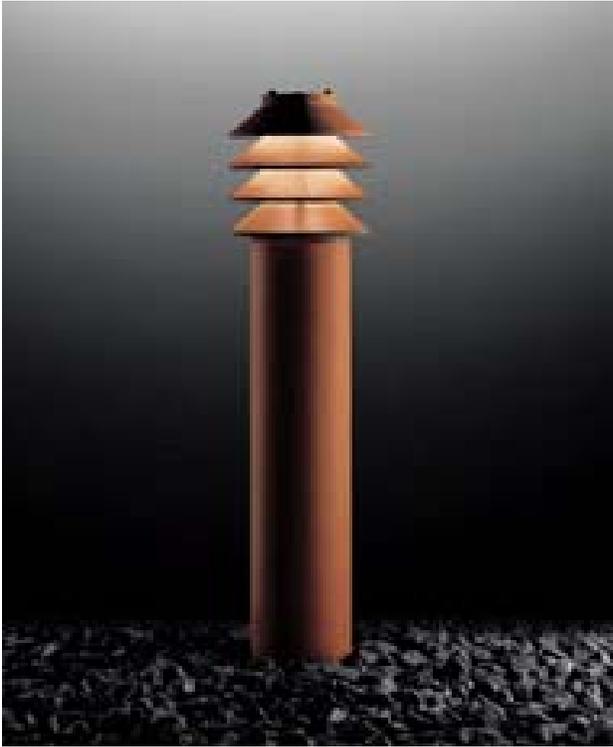
Figure 6. Bollard style selected for East Colorado Avenue intersections from Maple Street to Columbine Street

Figure 6 illustrates the bollard that was selected for placement at each intersection along East Colorado Avenue from Maple Street to Columbine Street. This bollard is intended to replace the anomalous standard commercial streetlights in the East Colorado residential area.
