COLORADO CULTURAL RESOURCE SURVEY

Architectural Inventory Form

I. IDENTIFICATION

- 1. Resource number: **5SM.1710 / THAS.55**
- 2. Temporary resource number: **N/A**
- 3. County: **San Miguel**
- 4. City: **Telluride**
- 5. Historic Building Name: **Wheeler House**
- 6. Current Building Name: **Cowart House**
- 7. Building Address: **239 N. Aspen Street**
- 8. Owner Name and Address: **Trent and Janice Cowart  
3206 Caliente Court, No. 6458  
Arlington, TX 76017**

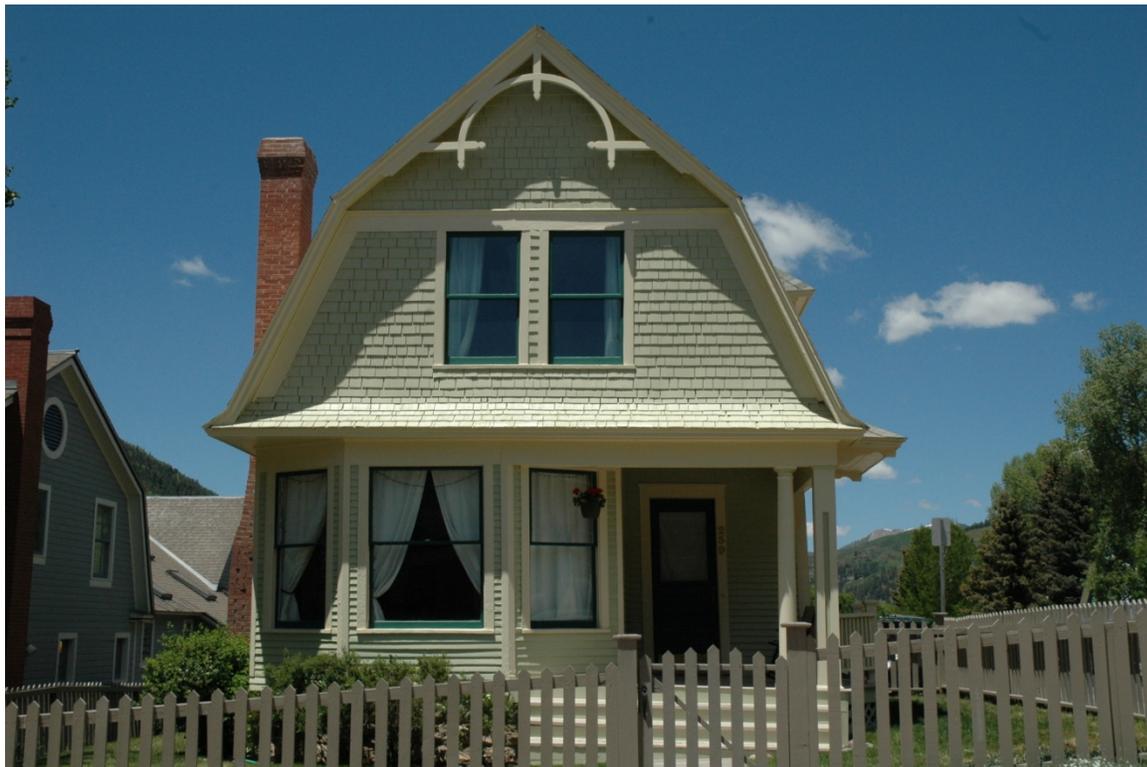
<b>THLD RATING:</b>	<b>1710 Residence - Contributing 55 – Barn/Shed - Contributing</b>
---------------------	--

21. General architectural description:  
**This 1½-story Dutch Colonial Revival style dwelling is supported by a sandstone foundation, and its exterior walls are clad with painted green horizontal wood siding with 1" by 4" corner boards. Painted green square-cut wood shingles appear in the upper gambrel ends. The gambrel roof is steeply-pitched, with a large intersecting gambrel on the south-facing roof slope. A large hipped-roof dormer, with two 1/1 double-hung sash windows, is located on the north-facing roof slope. The roof is finished with green asphalt composition shingles, and the eaves are flared with painted cream white wood trim. A distinctive gable ornament adorns the façade's upper gambrel end, while a tall red brick fireplace chimney, with a corbelled cap, is located near the front end of the south elevation. A canted bay, with three 1/1 double-hung sash windows, forms the southern 2/3s of the façade, facing toward Aspen Street on the east elevation. Other windows are primarily 1/1 double-hung sash with painted dark green wood frames and painted cream white wood surrounds. A painted green wood-paneled door, with one upper sash light, enters the north end of the façade from a 4-step porch which is recessed under the home's northeast corner. The porch features a tongue-in-groove wood floor, paired painted white Tuscan columns, a painted white square incised column, and a bead board ceiling. The north end of the porch bays out, is enclosed by an open wood railing, and is covered by a bracketed hipped porch roof extension. A painted green wood-paneled door, with one upper sash light, enters the house from within a glassed-in rear porch on the west elevation.**

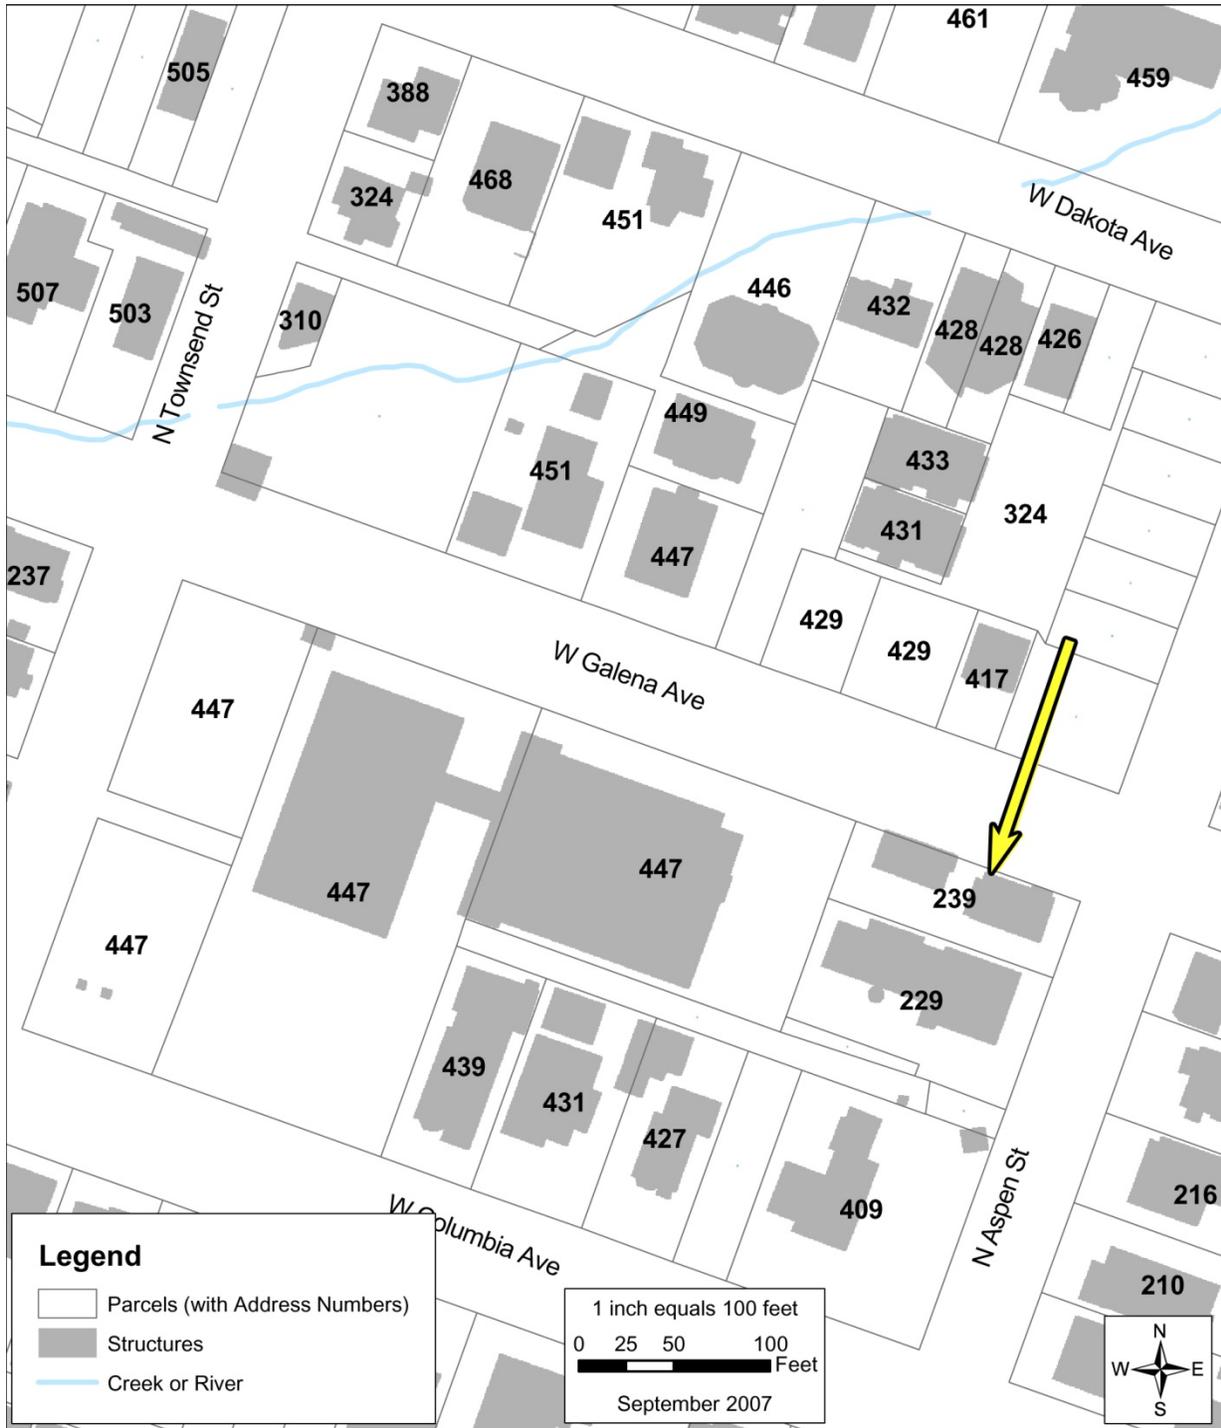
## Sketch Map

**This well-maintained property is located at the southwest corner of Aspen Street and Galena Avenue. A small planted grass front yard and narrow side yards are enclosed by a picket fence. The lawn is nicely landscaped with native plants and shrubs.**

**A barn/garage (THAS #55) is located near the rear of the property. It is a wood frame cross-gabled structure, with a wood floor and board and batten exterior walls. The walls are covered with white paint which is badly faded. The cross gable roof is covered with metal roofing material laid over 1x wood decking and 2x wood rafters. Two painted white rollaway garage doors open toward Galena on the north elevation.**
