COLORADO CULTURAL RESOURCE SURVEY

Architectural Inventory Form

- 1. Resource number: **5SM.1620**
- 2. Temporary resource number: **N/A**
- 3. County: **San Miguel**
- 4. City: **Telluride**
- 5. Historic Building Name: **Telluride Transfer Company Building**
- 6. Current Building Name: **Telluride Transfer Company Building**
- 7. Building Address: **200 W. Pacific Avenue**
- 8. Owner Name and Address: **Zoline Telluride Properties III LLC
c/o Gumbiner Savett et. al. Inc.
516 and one half Hill Street
Santa Monica, CA 90405**

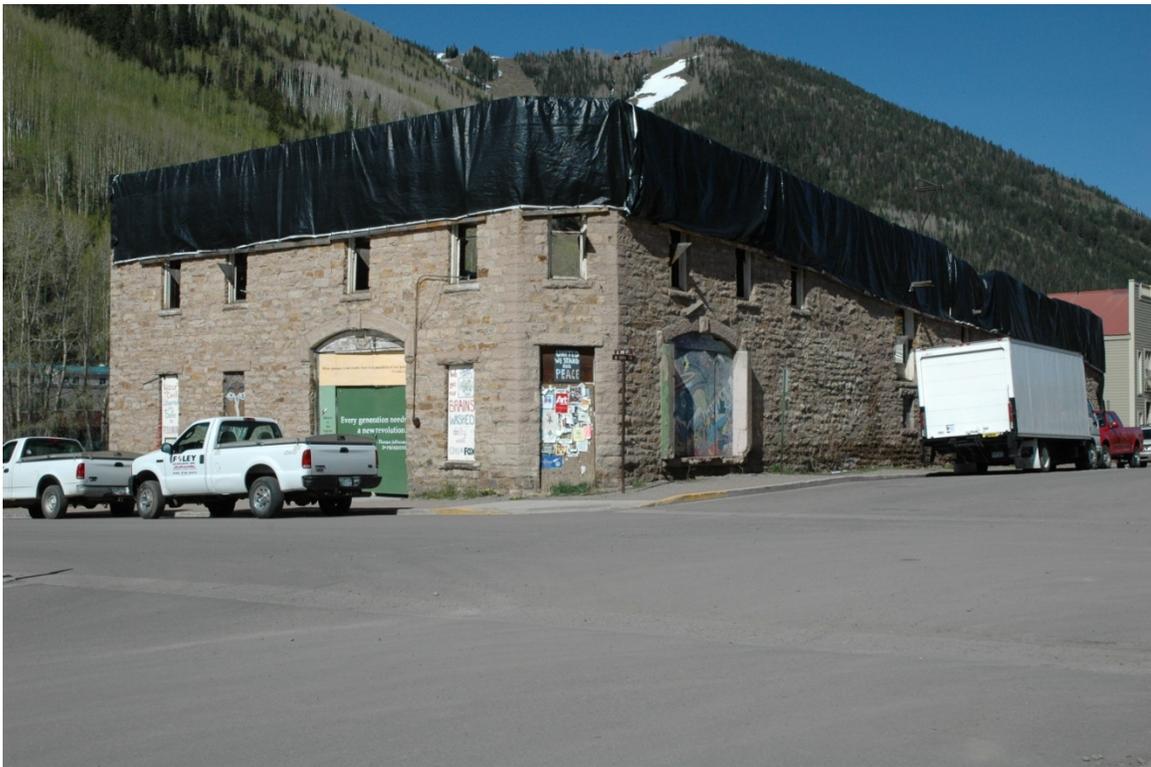
18. Roof configuration: **N/A**
19. Primary external roof material: **N/A**
20. Special features: **Window/Segmental Arch**
21. General architectural description:
Built in 1906, the Telluride Transfer Company Warehouse is an imposing, two-story, sandstone structure located at the southwest corner of Pacific Avenue and Fir Street. The coursed sandstone walls extend well below grade. The roof was removed several years ago. A blunted (NE) corner entry faces the corner of Pacific Avenue and S. Fir Street. This entry contains a tall plywood-filled door, with a sandstone lintel, and a 1/1 double-hung sash second story window. The long north elevation faces toward Pacific Avenue. A large former wagon door opening is located near the east end of this elevation, is spanned by a segmental sandstone arch. The north elevation is also penetrated by six first story window openings, and six second story window openings, all with sandstone lugsills and lintels. The north elevation's second story is also penetrated by a larger hayloft type opening. The east elevation faces toward S. Fir Street. A large former wagon door opening, spanned by a segmental sandstone arch enters the center of this elevation, and is now inset with a set of non-historic, paired, painted green plywood or particle board doors. The east elevation is also penetrated by three first story window openings, and four second story window openings, all with sandstone lugsills and lintels. The long south elevation also contains a large wagon door opening, with a segmental sandstone arch, near its east end. The south elevation is also penetrated by nine first story window openings, and five second story window openings, all with sandstone lugsills and lintels. Another, larger, hayloft opening, with its diagonal wood planking still intact, penetrates the south elevation's second story. The west elevation faces the alley, and is penetrated by a

plywood-filled door opening and one plywood-filled window opening. It appears that the building's windows were primarily 1/1 double-hung sash, however, most windows are now filled with plywood, with most panes and muntins missing. Unsightly heavy black plastic has been draped around the top of the building's walls.

The restoration and adaptive reuse of this building should be a high priority for the Town of Telluride.
