COLORADO CULTURAL RESOURCE SURVEY

Architectural Inventory Form

- 1. Resource number: **5SM.1625**
- 2. Temporary resource number: **N/A**
- 3. County: **San Miguel**
- 4. City: **Telluride**
- 5. Historic Building Name: **Unknown**
- 6. Current Building Name: **The Beauty Parlor/ Mariposa Medical Spa Building**
- 7. Building Address: **227 W. Pacific Avenue**
- 8. Owner Name and Address: **Solomon and Solomon LLC
P.O. Box 1748, Telluride, CO 81435**

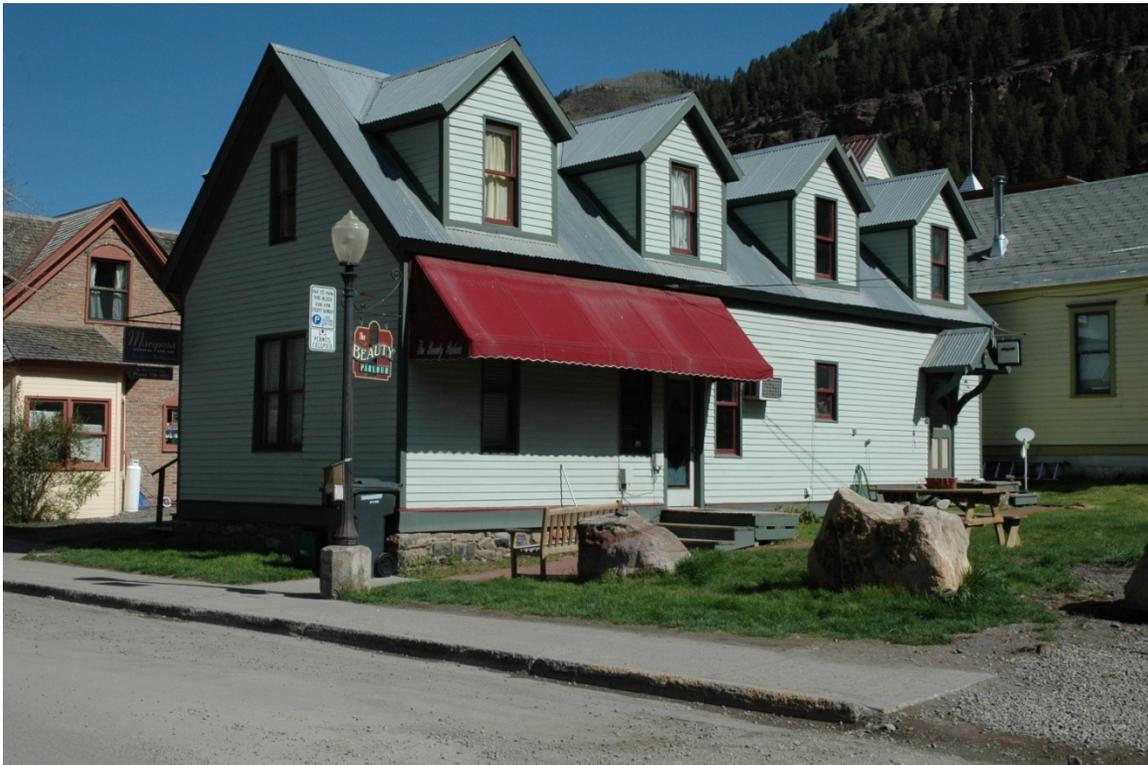
THLD RATING:

Noncontributing With Qualifications to District

21. General architectural description:
Traditionally a dwelling, this 1.5-story, rectangular-shaped, wood frame, dwelling now houses a beauty parlor and a "medical spa." The building is supported by a low, unpainted, coursed sandstone foundation, and its exterior walls are clad with painted pale green horizontal wood siding, with painted dark green 1" by 4" corner boards. The steeply-pitched side gable roof is covered with corrugated metal roofing material, and the eaves are boxed with painted dark green wood trim. Four gabled dormers, each with a 1/1 double-hung sash window, are located on the east-facing roof slope; three similar dormers are located on the opposite west-facing roof slope. The entry into the beauty shop is located near the south end of the east elevation. Here, a painted white, with burgundy trim, glass-in-wood-frame door enters the beauty parlor from a small wood porch covered by a canvas awning. A painted white wood-paneled door, with one upper sash light, enters the north end of the east elevation from a 2-step wood porch covered by a gable hood with knee brace supports. The east elevation wall is also penetrated by four 1/1 double-hung sash windows, with painted burgundy wood frames and painted dark green wood surrounds. A painted dark green, with burgundy and white trim, wood door enters the Mariposa Medical Spa from a small 4-step porch on the west elevation. This porch is made out of wood and recycled "Trex" type material, and is covered by a gable hood with S-shaped knee braces. The west elevation wall is also penetrated by four 1/1 double-hung sash windows, with painted burgundy wood frames and painted dark green wood surrounds. The

south elevation, which faces Pacific Avenue, is penetrated by a set of paired 1/1 double-hung sash windows, and a single 1/1 double-hung sash window in the upper gable end.

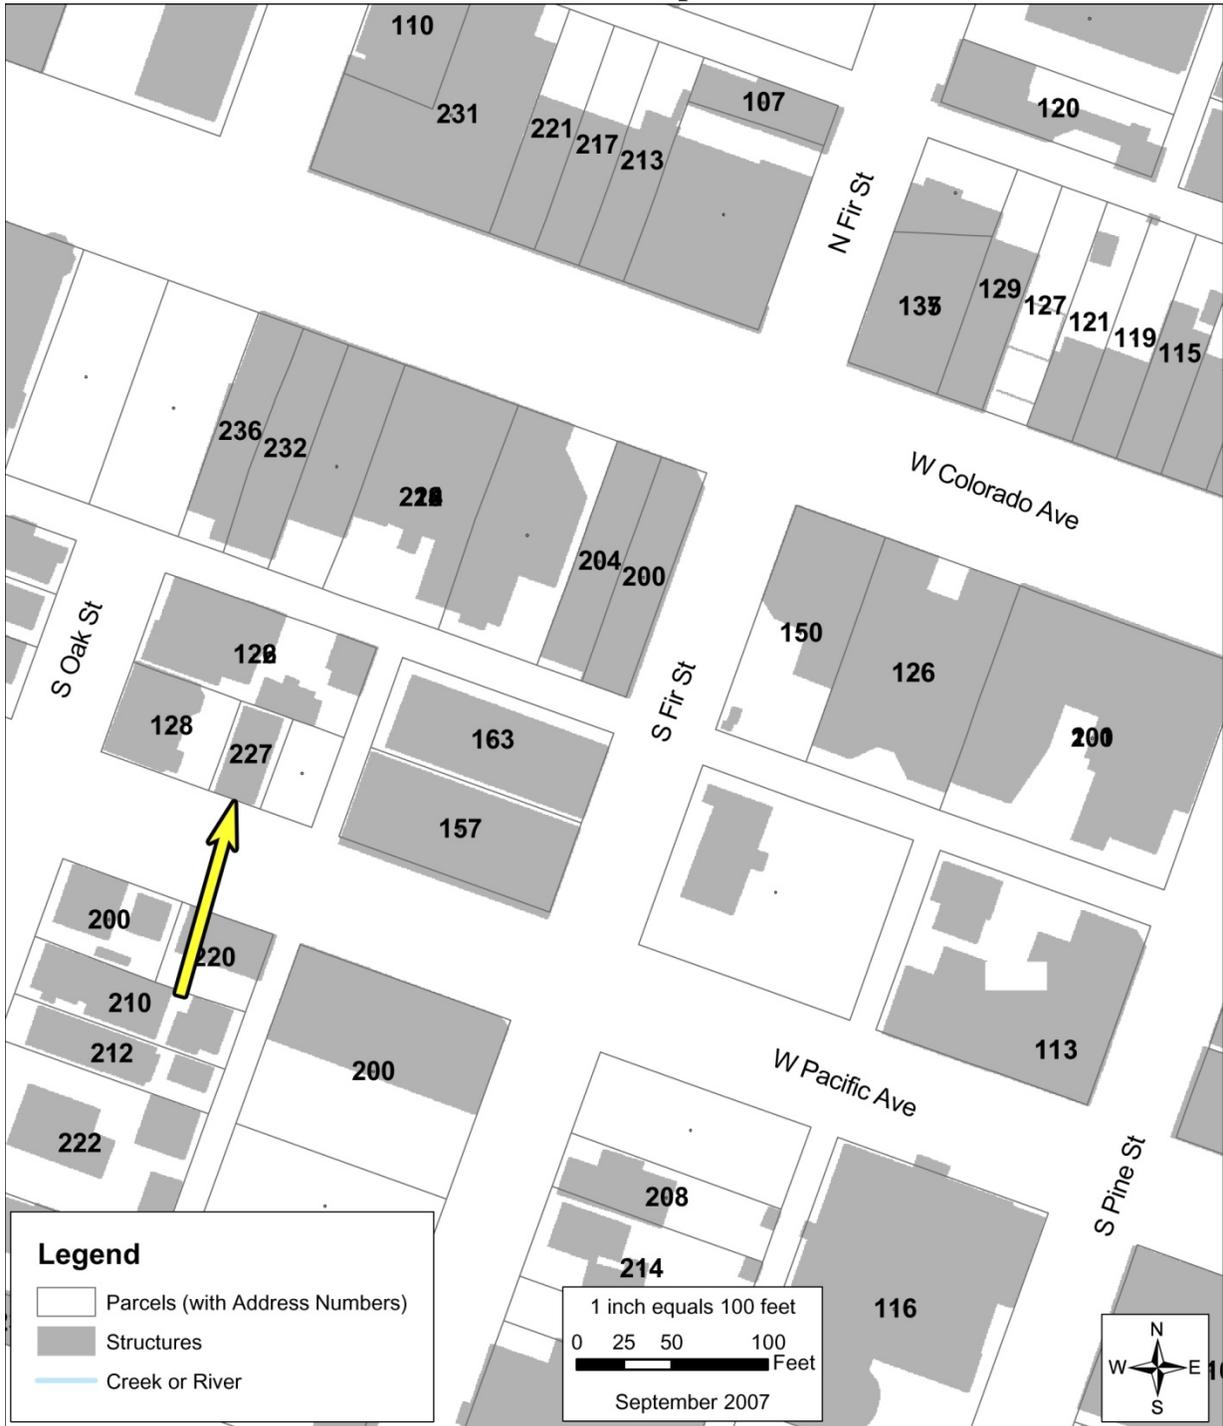
Sketch Map

This property is located on the north side of Pacific Avenue in the block between Fir and Oak Streets.
