COLORADO CULTURAL RESOURCE SURVEY

Architectural Inventory Form

- 1. Resource number: **5SM.1642** Parcel number(s):
- 2. Temporary resource number: **N/A**
- 3. County: **San Miguel**
- 4. City: **Telluride**
- 5. Historic Building Name: **Unknown**
- 6. Current Building Name: **Hampton Court Townhouse Condos**
- 7. Building Address: **316/320 W. Pacific Avenue**
- 8. Owner Name and Address:

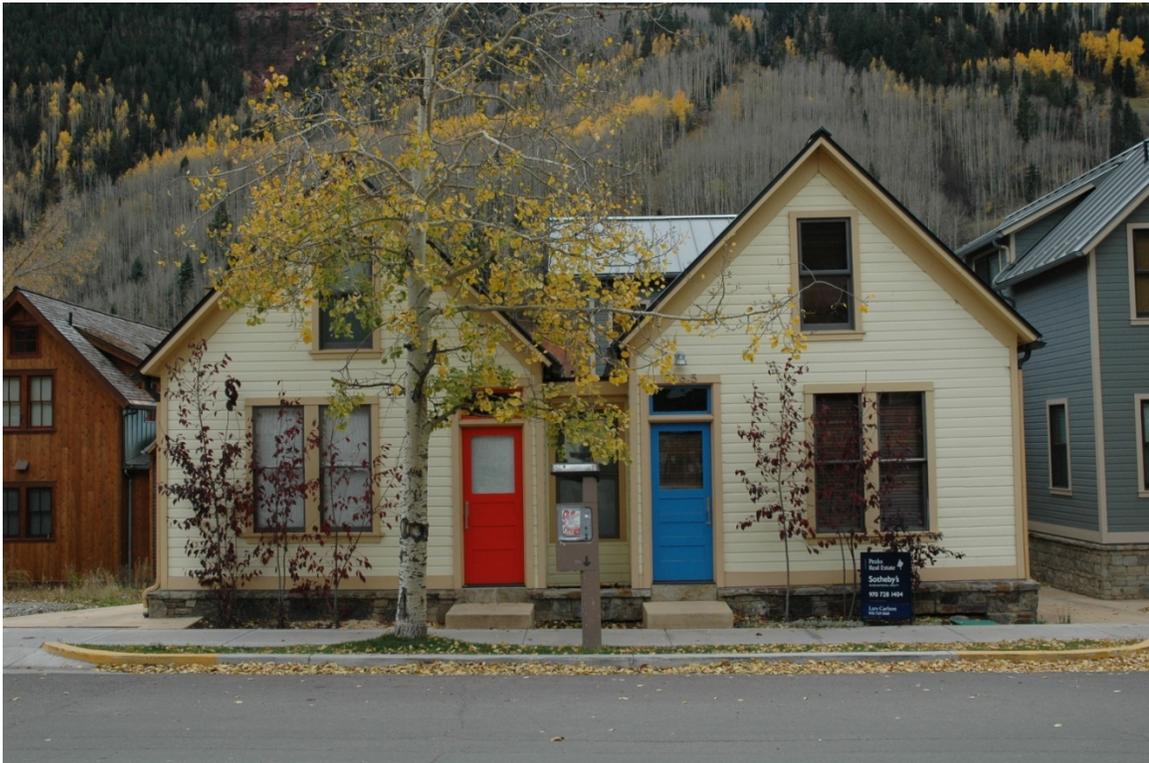
The historic building to the east (316 W. Pacific Avenue) is supported by a low concrete foundation which has been faced with stone. It has painted yellow horizontal weatherboard walls, with painted beige 1" by 4" corner boards. It is covered by a steeply-pitched front gable roof, with metal roofing material and with painted beige boxed eaves. A painted red wood-paneled door, with one upper sash light and with a transom light, enters the west end of the façade from a concrete stoop. The façade wall is also penetrated by a set of paired 1/1 double-hung sash windows, and by a single 1/1 double-hung sash window in the upper gable end. The east (side) elevation is penetrated by one set of paired and one single 1/1 double-hung sash windows. All of this building's windows have painted beige wood surrounds. A non-historic rear entry door enters the shed-roofed extension on the south (rear) elevation.

The historic building to the west (316 1/2 W. Pacific Avenue) is essentially a mirror image of the building to the east. This building is also supported by a low concrete foundation which has been faced with stone. It has painted yellow horizontal weatherboard walls, with painted beige 1" by 4" corner boards. It is covered by a steeply-pitched front gable roof, with metal roofing material and with painted beige boxed eaves. Small non-historic skylights are located near the south end of the east and west facing roof slopes. A painted blue wood-paneled door, with one upper sash light and with a transom light, enters the east end of the façade from a concrete stoop. The façade wall is also penetrated by a set of paired 1/1 double-hung sash windows, and by a single 1/1 double-hung sash window in the upper gable end. The west (side) elevation is penetrated by a set of paired sash windows. All of this building's windows also have painted beige wood surrounds. The shed-roofed extension to this building's south (rear) elevation is now covered by the large L-shaped addition.

The L-shaped, two-story, addition is composed of two rectangular-shaped blocks joined by a connecting element. Each block is supported by a concrete foundation, has painted blue horizontal weatherboard walls, and a steeply-pitched gable roof with metal roofing material and painted white boxed eaves. A stained brown wood-paneled door, with one upper sash light and with a transom light, enters the west end of the north elevation from a 5-step concrete porch covered by a shed roof.
