COLORADO CULTURAL RESOURCE SURVEY

Architectural Inventory Form

- 1. Resource number: **5SM.1648**
- 2. Temporary resource number: **N/A**
- 3. County: **San Miguel**
- 4. City: **Telluride**
- 5. Historic Building Name: **Finn Town Flats**
- 6. Current Building Name: **Finn Town Flats**
- 7. Building Address: **416 W. Pacific Avenue**
- 8. Owner Name and Address: **James G. Pope
141 Twelve Oaks Lane
Ponte Verde Beach, FL 32082**

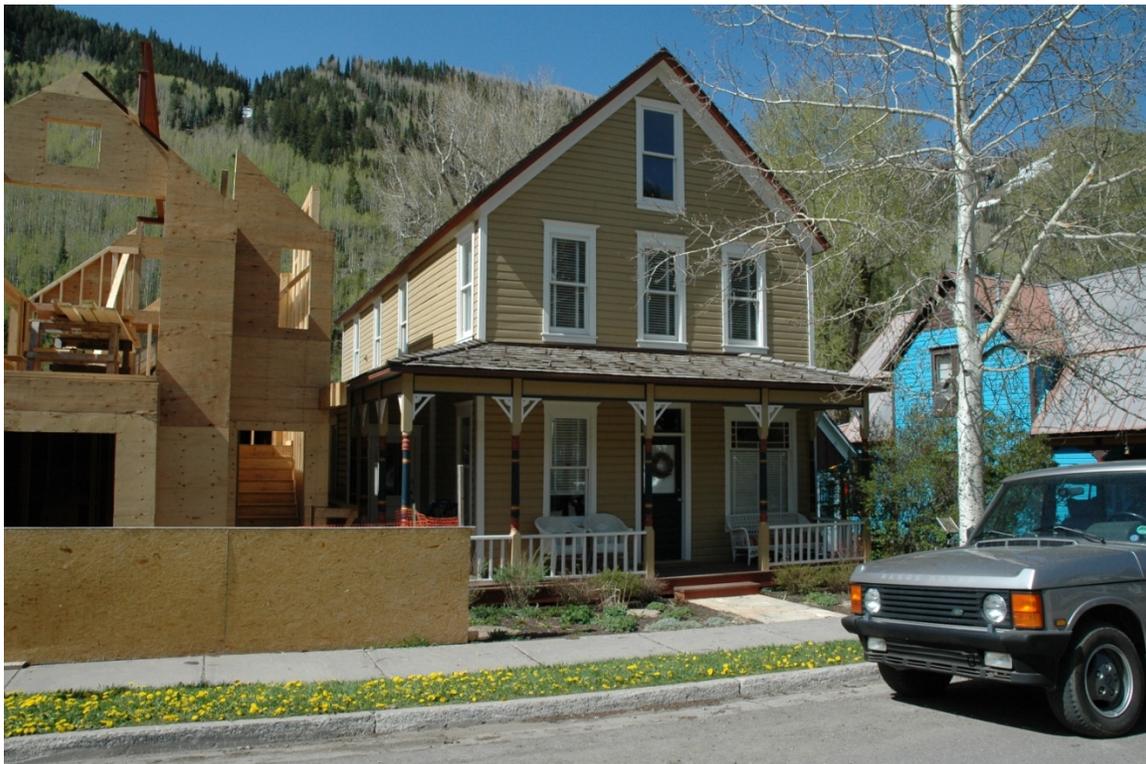
21. General architectural description:
This is a 2.5-story, rectangular-shaped, wood frame building which measures 46' N-S (deep) by 20.5' E-W (across). Not included in these dimensions is a small, 11' by 5' hip-roofed addition to the east (side) elevation. The building is supported by a non-historic foundation of round concrete piers, and its exterior walls are clad with painted gold horizontal weatherboard walls with painted white 1" by 4" corner boards. The front gable roof is steeply-pitched, and is covered with wood shingles. The eaves are boxed with painted red and white wood trim. A wood frame front porch extends across all of the façade (north elevation), and wraps around to cover the north end of the east elevation. The porch features a wood plank floor, an open white wood railing, turned columns with decorative brackets, and a low-pitched hipped roof. Two wood-paneled doors enter the building from the front porch. One of these doors is centered on the north elevation and is painted blue, with an upper sash light and a transom light; the other is located at the north end of the east elevation, and is painted white, and also has an upper sash light, but does not have a transom light. A single-hung sash window, with stained glass Queen Anne upper sash lights, overlooks the west end of the front porch. Windows elsewhere are primarily 1/1 double-hung sash with painted white wood frames and surrounds. A below-grade basement-level entry on the south (rear) elevation is covered by a shed roof.

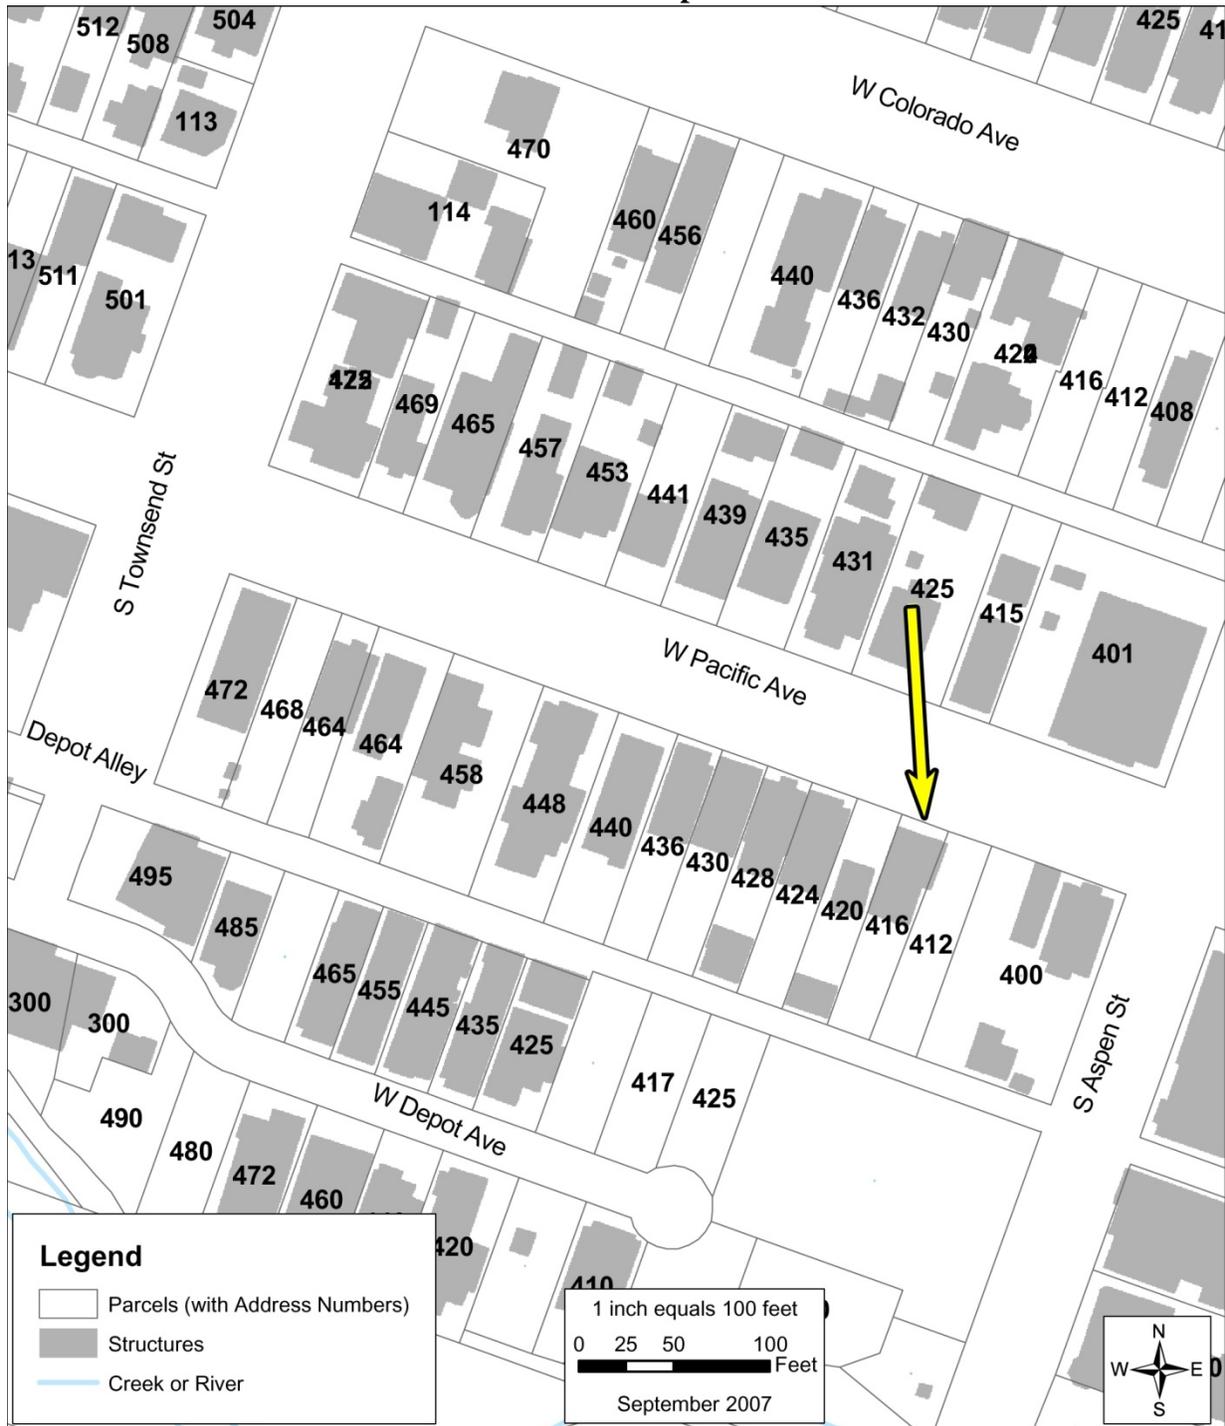
Sketch Map

This building is located on the south side of Pacific Avenue in the block between Aspen and Townsend Streets. It is set back just a few feet from the front sidewalk which parallels Pacific Avenue. There are no secondary buildings on the property.
