COLORADO CULTURAL RESOURCE SURVEY

Architectural Inventory Form

- 1. Resource number: **5SM.1649/THAS.182**
- 2. Temporary resource number: **N/A**
- 3. County: **San Miguel**
- 4. City: **Telluride**
- 5. Historic Building Name: **Unknown**
- 6. Current Building Name: **Hopkins House**
- 7. Building Address: **420 W. Pacific Avenue**
- 8. Owner Name and Address: **Lawrence White Hopkins
P. O. Box 888
Telluride, CO 814350888**

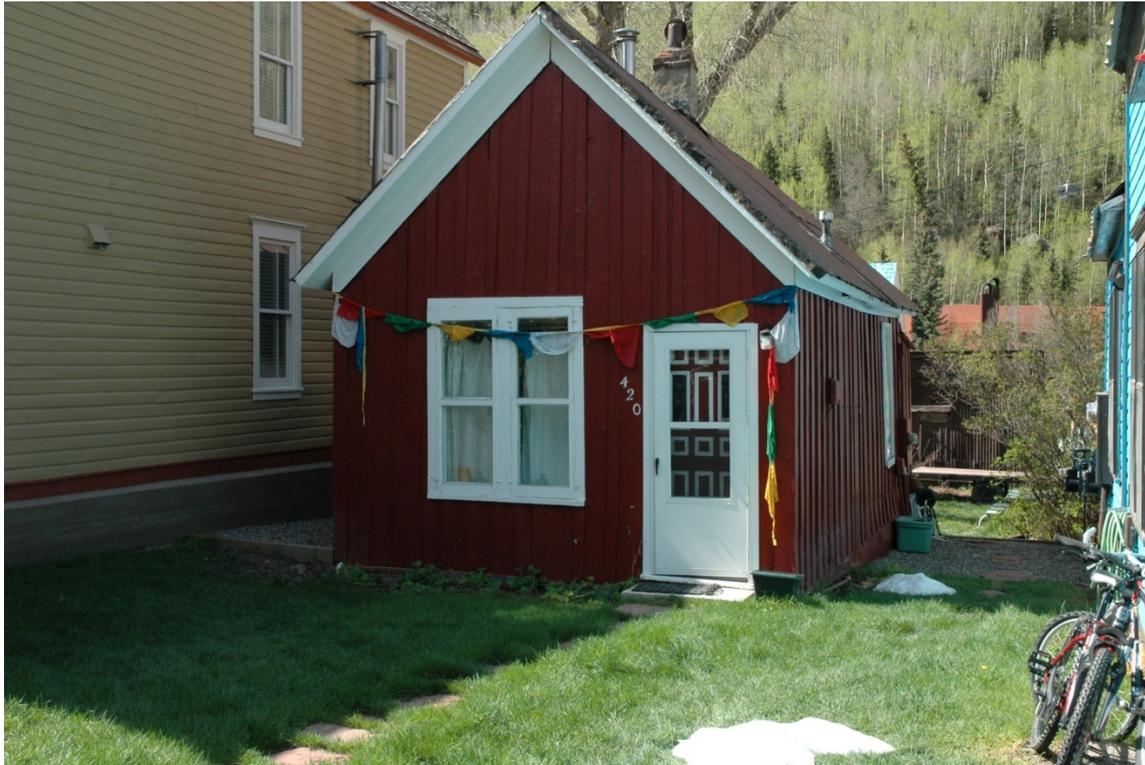
18. Roof configuration: **Gabled Roof/Front Gabled Roof**
19. Primary external roof material: **Metal Roof**
20. Special features: **Chimney**
21. General architectural description:
This is a small, rectangular-shaped, one-story, wood-frame dwelling which measures 24' 4" N-S (deep) by 14' 6" E-W (across), with an addition to the south elevation which measures approximately 14' 5" by 3' 6". Its exterior walls are made of painted red board-and-batten, and its steeply-pitched front gable roof is covered with rusted corrugated metal. The eaves are boxed with painted white wood trim. A red brick chimney is located on the roof ridge. The small house's asymmetrical façade faces toward Pacific Avenue on the north elevation. A non-historic painted red, with white trim, metal front door, covered by a non-historic white metal storm door, enters the west end of the façade from a concrete stoop. The dwelling's windows are primarily single and paired 1/1 double-hung sash with painted white wood frames and surrounds; however, a non-historic (1970s) fixed-pane window is located in the south elevation's upper gable end. A painted white wood-paneled door enters a small non-historic shed-roofed extension from a 4-step wood stoop on the south elevation.

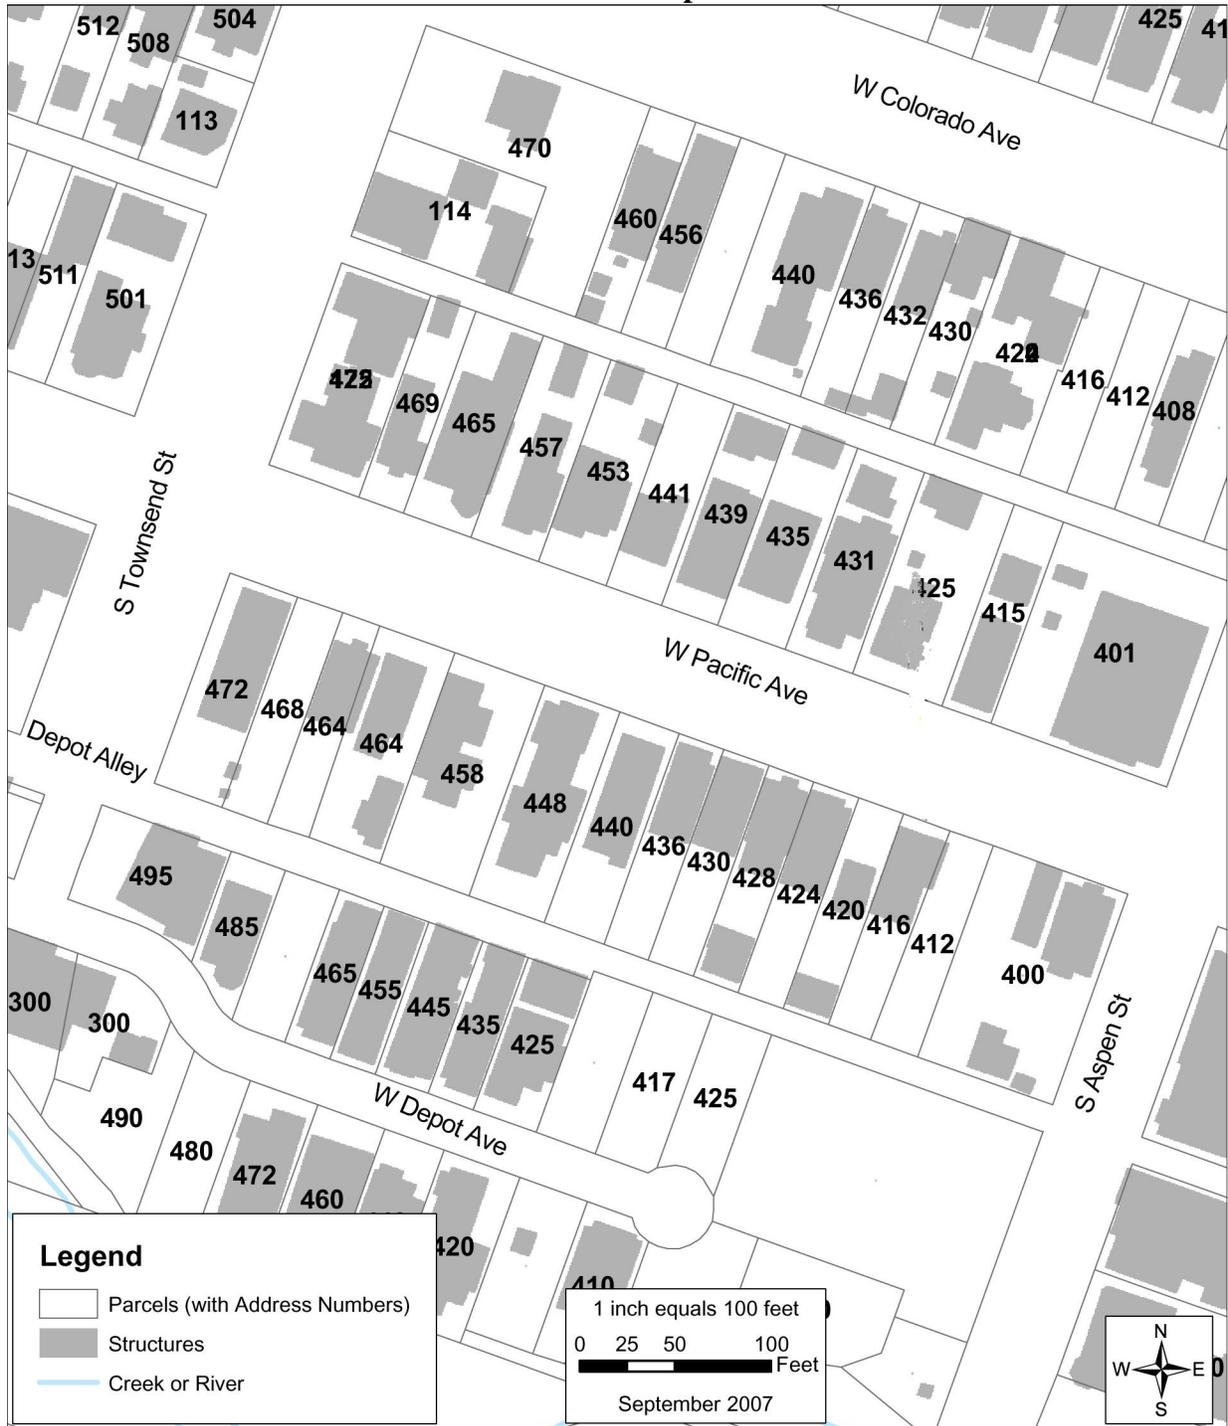
Sketch Map

This property is located on the south side of Pacific Avenue in the block between Aspen and Townsend Streets. The small house is set back farther from the street compared with other nearby dwellings.

A shed, which measures 16.5' N-S by 22.5' E-W, is located adjacent to the alley at the rear, south, end of the property. This building features rusted corrugated metal exterior wall cladding, over horizontal wood planks. The shed roof is covered with corrugated metal roofing material (reportedly non historic "pro panel" roofing.) laid over 1x wood decking. A set of non-historic paired plywood doors, side-hinged with metal strap hinges, open toward the alley on the south elevation. Two corrugated metal clad doors, also side-hinged with metal strap hinges, are located on the non-original north elevation.
