COLORADO CULTURAL RESOURCE SURVEY

Architectural Inventory Form

- 1. Resource number: **5SM.1650**
- 2. Temporary resource number: **N/A**
- 3. County: **San Miguel**
- 4. City: **Telluride**
- 5. Historic Building Name: **Unknown**
- 6. Current Building Name: **Brown House**
- 7. Building Address: **424 W. Pacific Avenue**
- 8. Owner Name and Address: **Paul Brown
8155 Kroger Farm Road
Cincinnati, OH 45243**

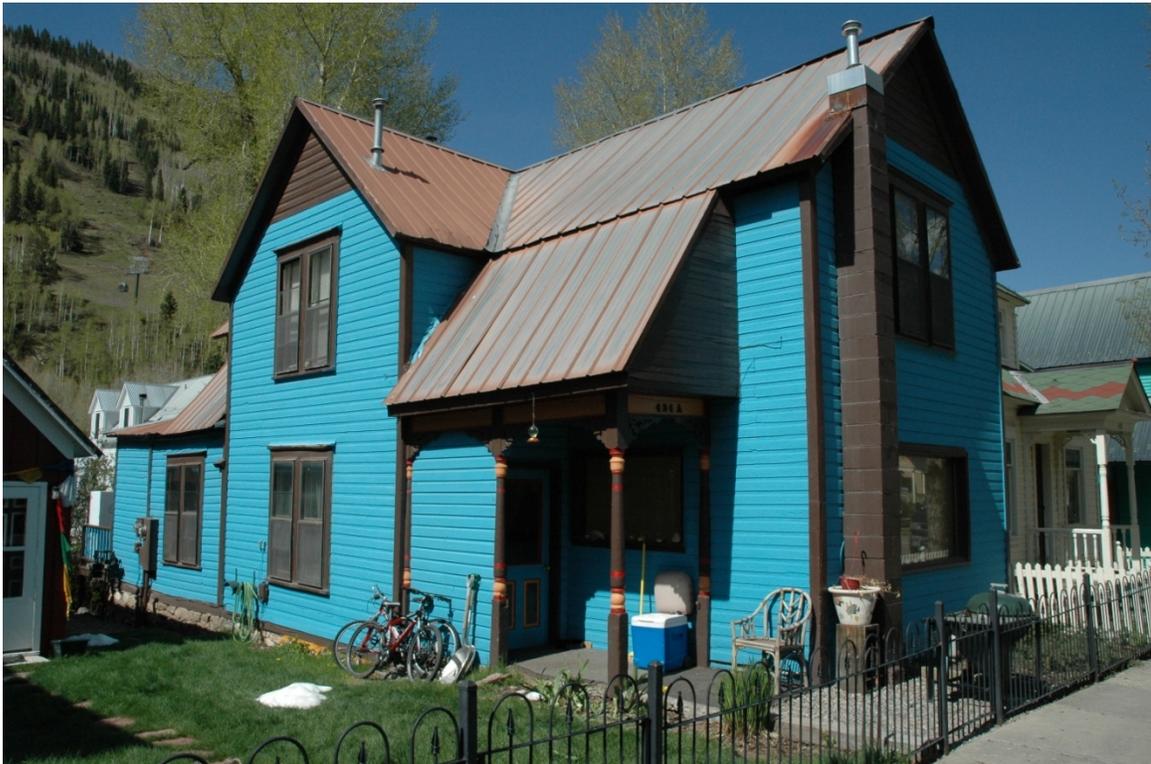
THLD RATING:	Supporting to District
---------------------	-------------------------------

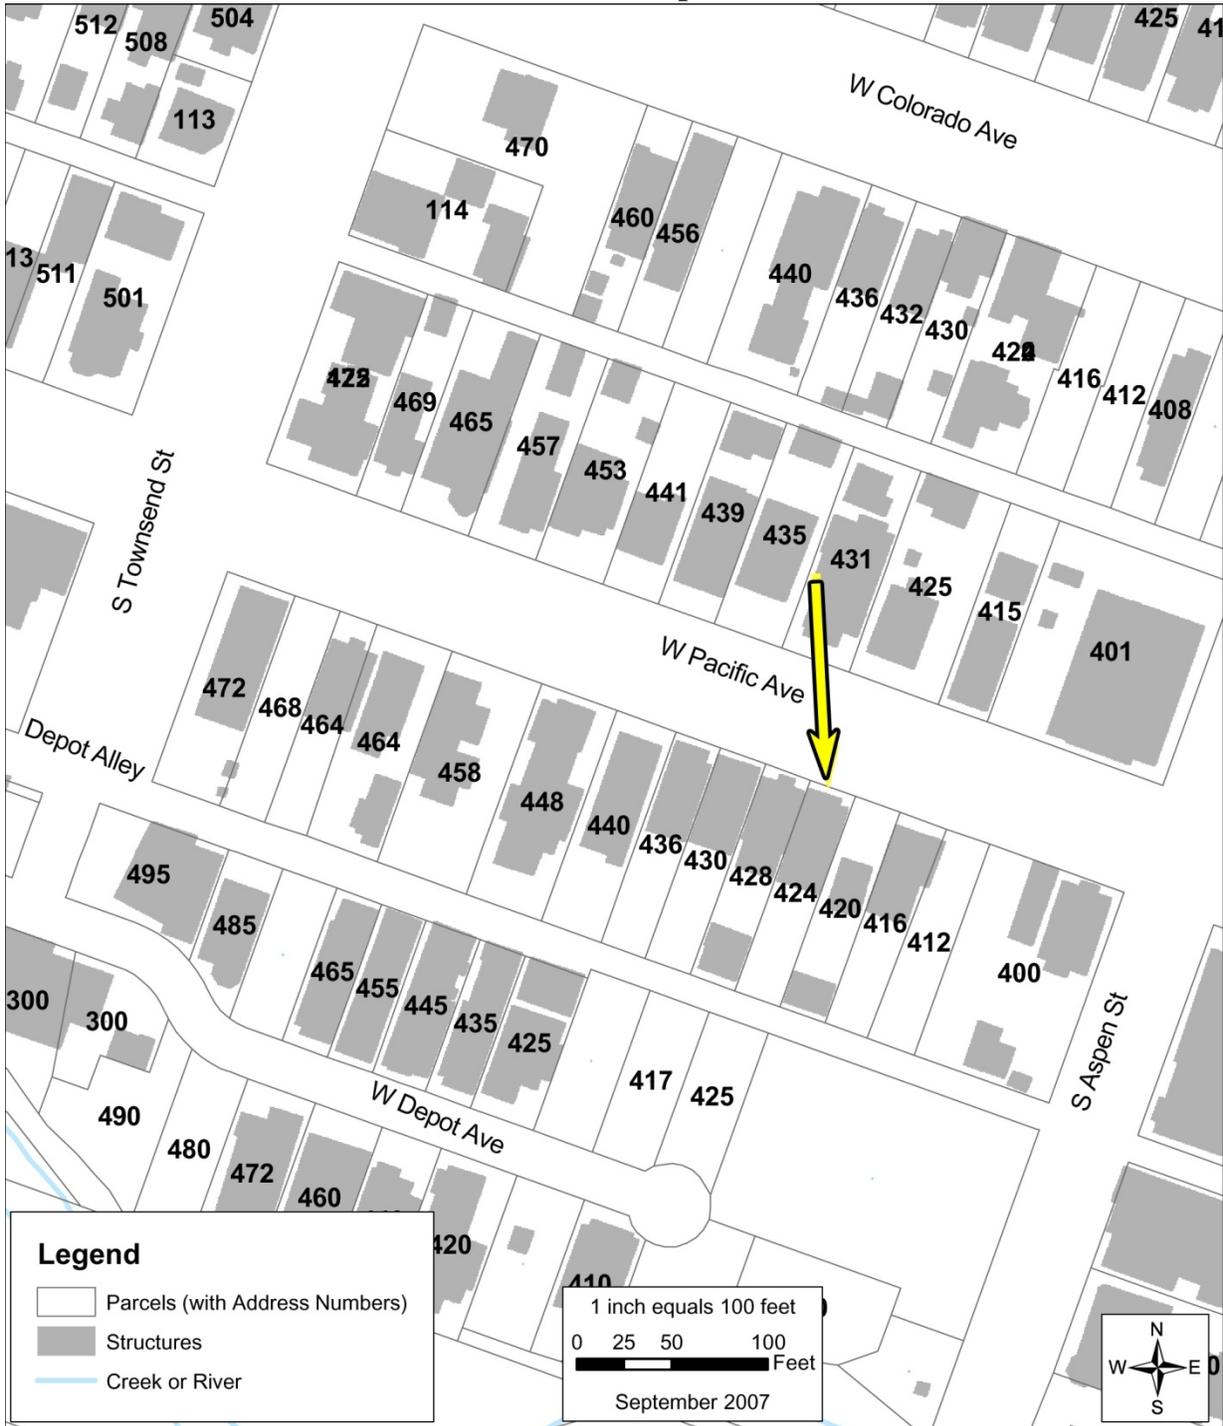
Sketch Map

This property is located on the south side of West Pacific Avenue in the block between Aspen and Townsend Streets. A wrought iron fence parallels the front sidewalk.
