COLORADO CULTURAL RESOURCE SURVEY

Architectural Inventory Form

- 1. Resource number: **5SM.1677**
- 2. Temporary resource number: **N/A**
- 3. County: **San Miguel**
- 4. City: **Telluride**
- 5. Historic Building Name: **Unknown**
- 6. Current Building Name: **Gunty House**
- 7. Building Address: **425 W. Pacific Avenue**

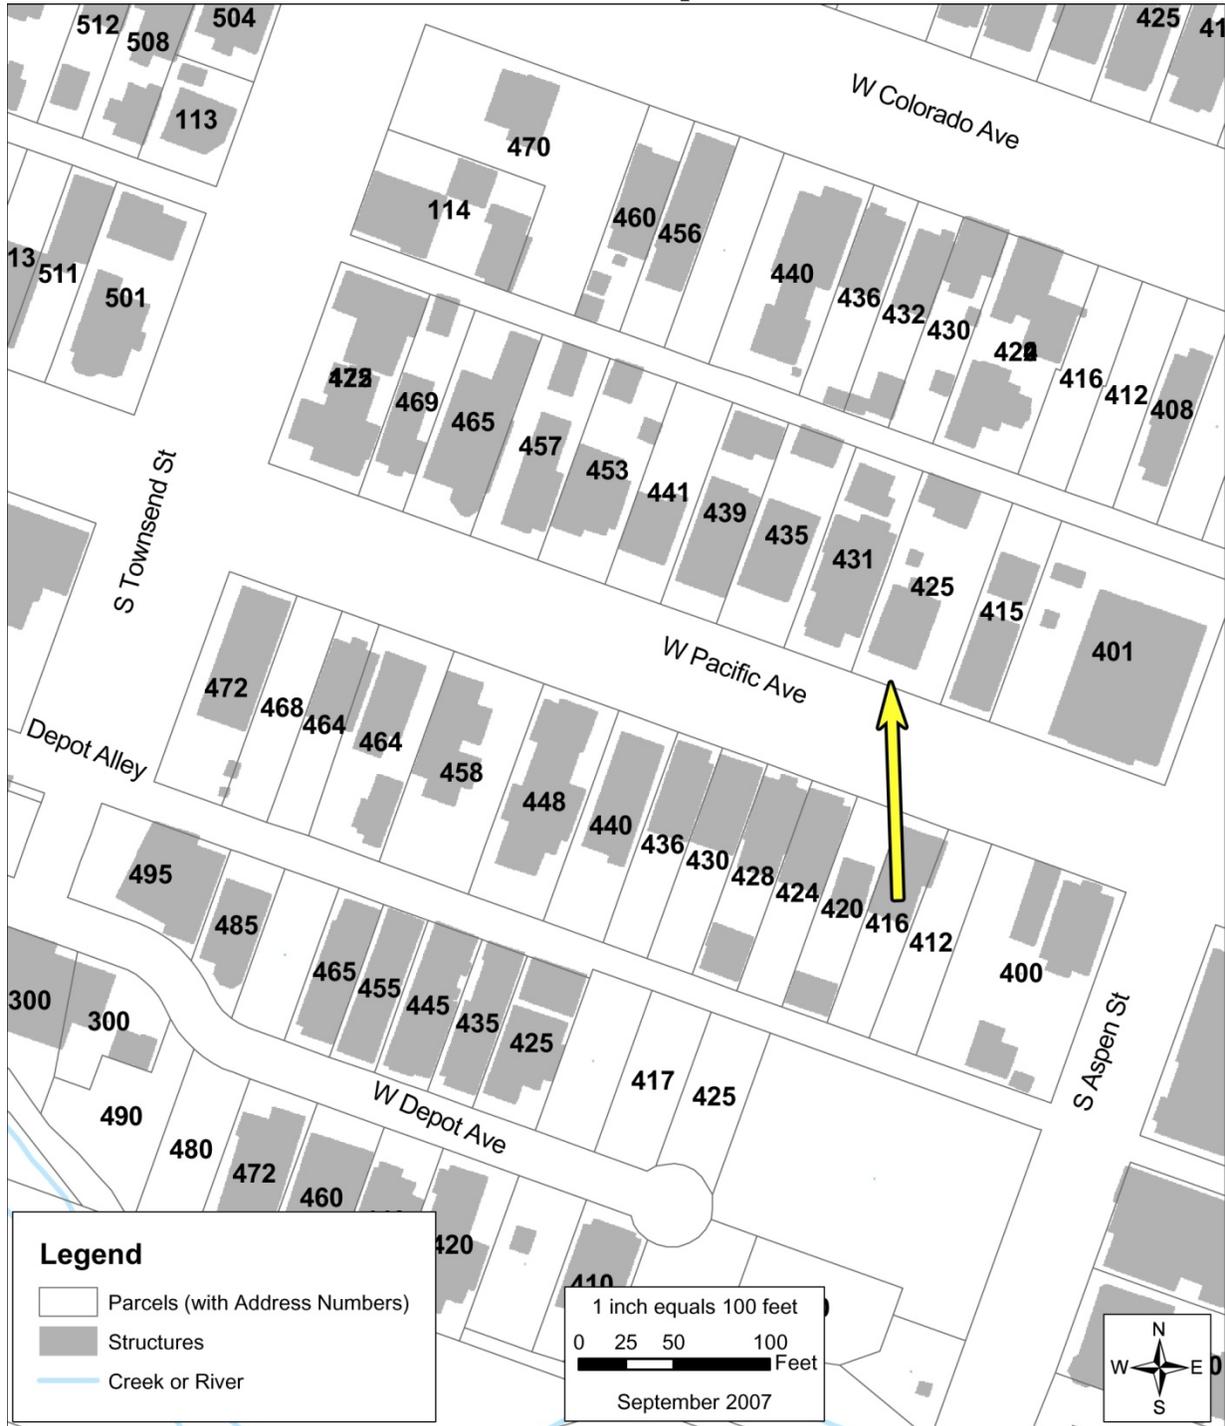
Sketch Map

23. Landscape or special setting features: **This property is located on the north side of Pacific Avenue in the block between Aspen and Townsend Streets.**
