COLORADO CULTURAL RESOURCE SURVEY

Architectural Inventory Form

- 1. Resource number: **5SM.1651**
- 2. Temporary resource number: **N/A**
- 3. County: **San Miguel**
- 4. City: **Telluride**
- 5. Historic Building Name: **Unknown**
- 6. Current Building Name: **430 W. Pacific LLC House**
- 7. Building Address: **428 W. Pacific Avenue**
- 8. Owner Name and Address: **430 W. Pacific LLC
c/o Whitcom Partners
375 Park Avenue, Suite 3800
New York, NY 10152**

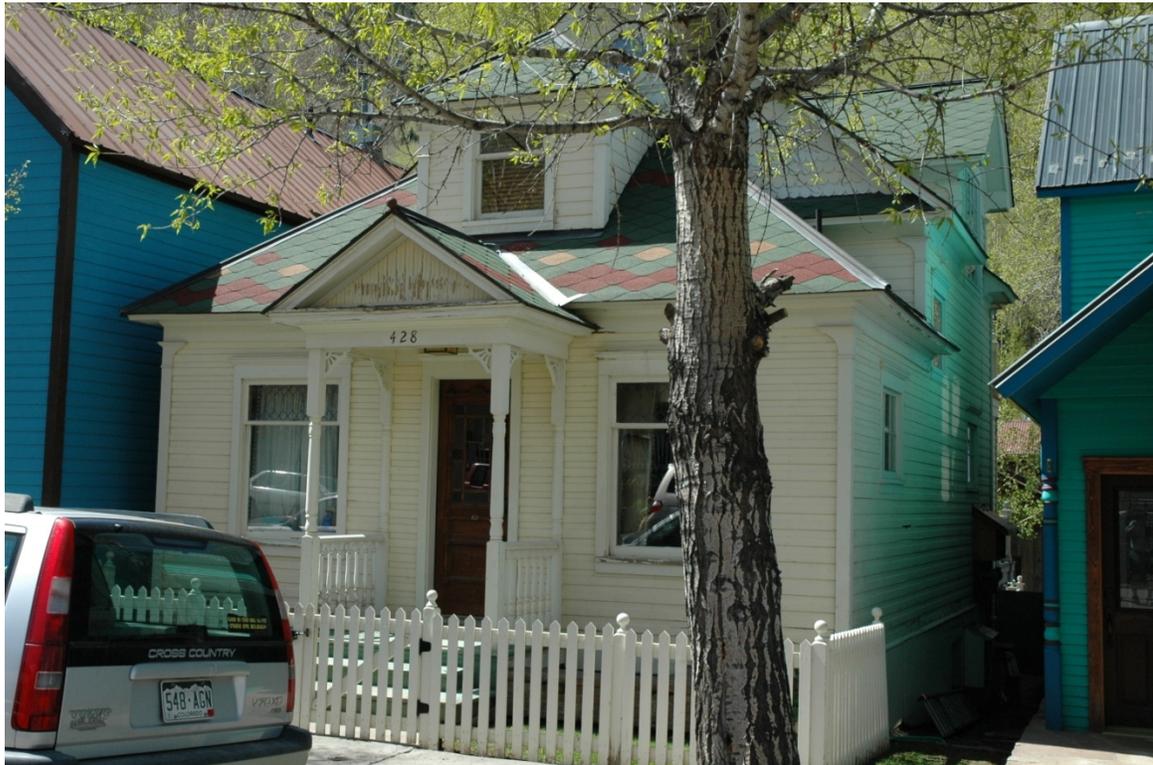
21. General architectural description:
This is a 1½-story wood frame Classic Cottage style dwelling, with a large gabled addition to the south (rear) elevation. The original hipped-roof portion of the extant dwelling measures approximately 32' N-S (deep) by 22' E-W (across); the entire dwelling, with the addition measures approximately 55' N-S by 22' E-W. The original dwelling is supported by a low concrete foundation which has been faced with red brick on the façade (north elevation), and with painted yellow vertical wood planks on the east and west (side) elevations. The house's exterior walls are clad with painted yellow horizontal weatherboard siding with painted white 1" by 4" corner boards. The roof is covered with red and green diamond-pattern asphalt composition shingles, and the eaves are boxed with painted white wood trim. A hip-roofed dormer, with a 1/1 single-hung sash window is centered on the north-facing roof slope overlooking the façade. The house features a symmetrical façade which faces toward Pacific Avenue on the north elevation. A stained brown wood-paneled front door, with stained glass upper sash lights, enters the center of the façade from a 3-step wood porch. This porch features a wood floor, a painted white open wood railing with turned balusters, painted white turned columns with decorative brackets, and a gable roof with a cannonball finial. The porch is flanked on either side by a 1/1 single-hung sash window, with leaded glass in the upper sashes. A painted white glass-in-wood-frame door enters the south (rear) elevation of

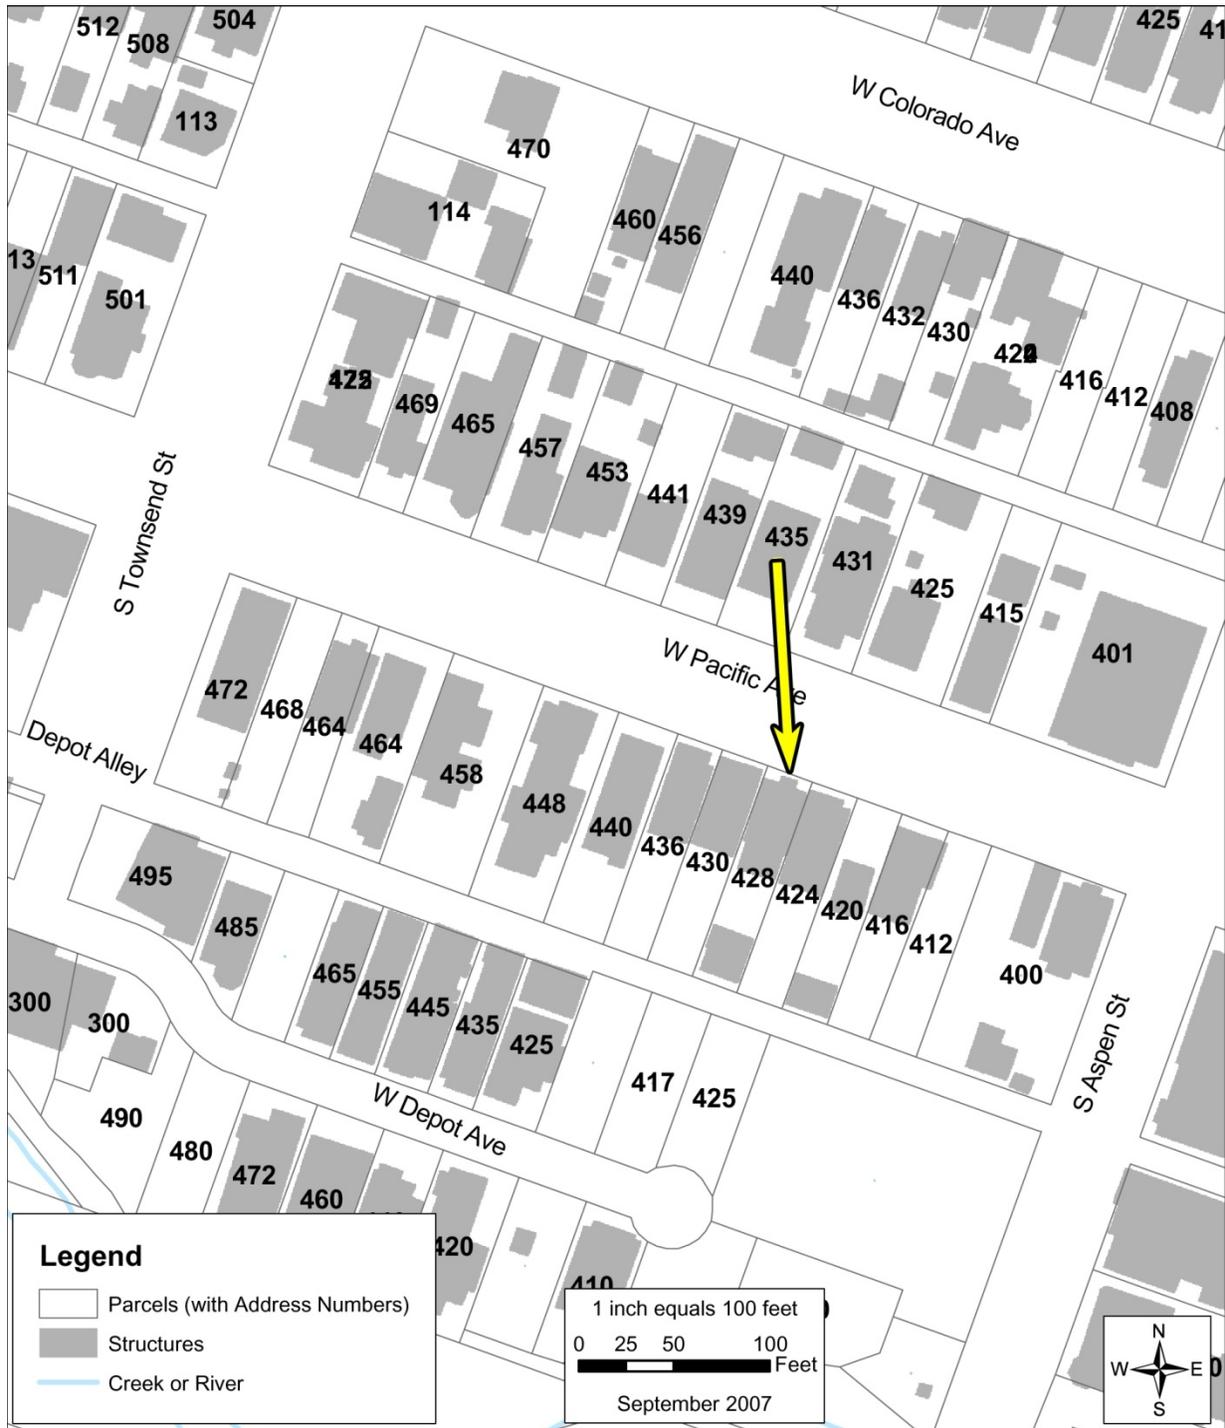
Sketch Map

This property is located on the south side of West Pacific Avenue in the block between Aspen and Townsend Streets. The front yard is enclosed by a low painted white picket fence.

Garage/ Secondary Residence (428½ W. Pacific Ave.)
A non-historic garage/secondary residence (with the address of 428½ W. Pacific Avenue) is located behind the main residence, near the alley. This building measures approximately 19' N-S by 22' E-W. It features a concrete slab foundation, and has stained brown vertical wood plank walls. The building is covered by a shed roof, with a large intersecting gable on the west elevation which is penetrated by a set of paired double-hung sash windows. The roof is covered with corrugated metal. Two vertical wood plank garage doors, with X-bracing, face the alley on the south elevation. Windows are primarily 2/2 double-hung sash.
