COLORADO CULTURAL RESOURCE SURVEY

Architectural Inventory Form

- 1. Resource number: **5SM.1653**
- 2. Temporary resource number: **N/A**
- 3. County: **San Miguel**
- 4. City: **Telluride**
- 5. Historic Building Name: **Finn Hall**
- 6. Current Building Name: **Finn Hall**
- 7. Building Address: **440 W. Pacific Avenue**
- 8. Owner Name and Address: **Susan Coit
3153 9th Street
Boulder, CO 80304**

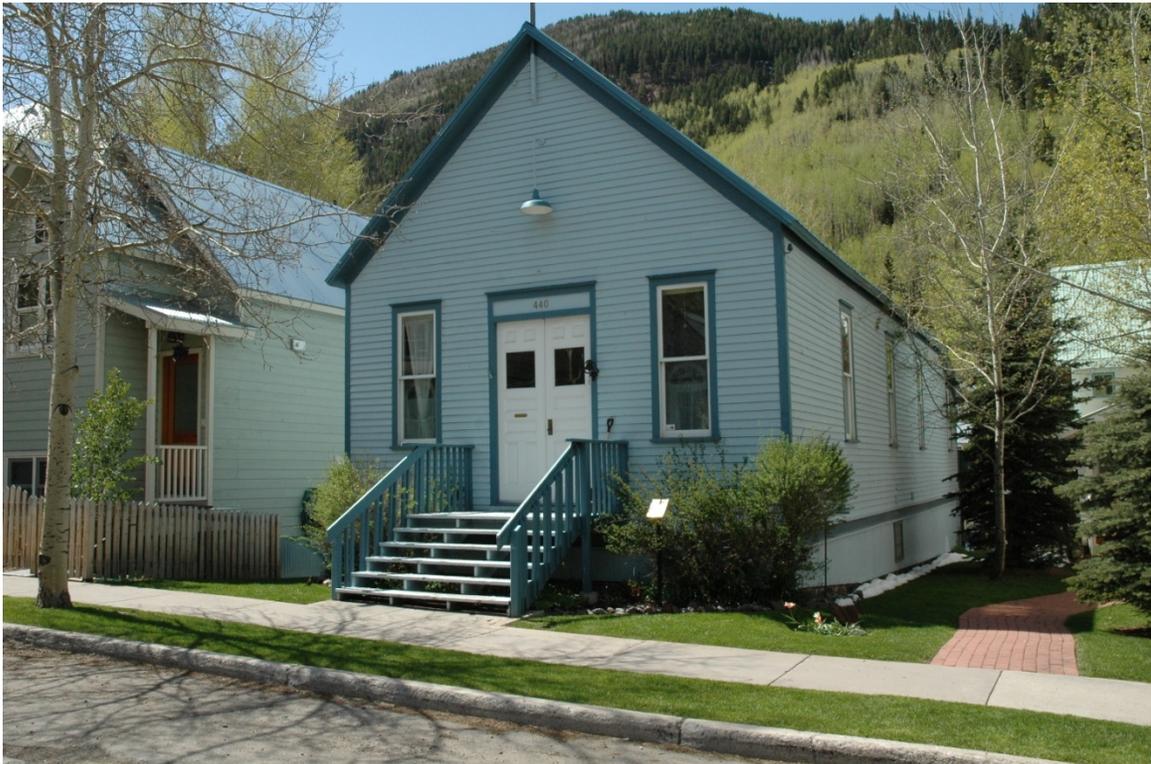
18. Roof configuration: **Gabled Roof/Front Gabled Roof**
19. Primary external roof material: **Metal Roof**
20. Special features: **Porch**
21. General architectural description:
Finn Hall is a rectangular-shaped, front-gabled, wood frame building with a modest shed-roofed addition to its south (rear) elevation. The building is supported by a low, unpainted, concrete foundation, covered by a painted pale blue bead board skirting. The exterior walls are clad with painted pale blue horizontal wood siding, with painted dark blue 1" by 4" corner boards. The front gable roof is covered with corrugated metal, and the eaves are boxed with painted dark blue wood trim. The building features a symmetrical façade which faces toward Pacific Avenue on the north elevation. A set of paired, painted white, wood-paneled doors, each with an upper sash light, and topped by a single transom light, enter the center of the façade from an open 6-step wood porch. Single 1/1 double-hung sash windows, with painted white wood frames and painted blue wood surrounds, penetrate the façade wall to either side of the porch. Windows elsewhere are also predominantly 1/1 double-hung sash with painted white wood frames and painted blue wood surrounds. The shed-roofed rear addition on the south elevation features a walkout basement level, which in part serves as a garage. A painted pale blue vertical wood plank garage door opens from the basement level onto a gravel driveway which extends to the alley. A painted white wood-paneled door, with an upper sash light, enters the main level from an elevated wood deck above the walkout basement level.

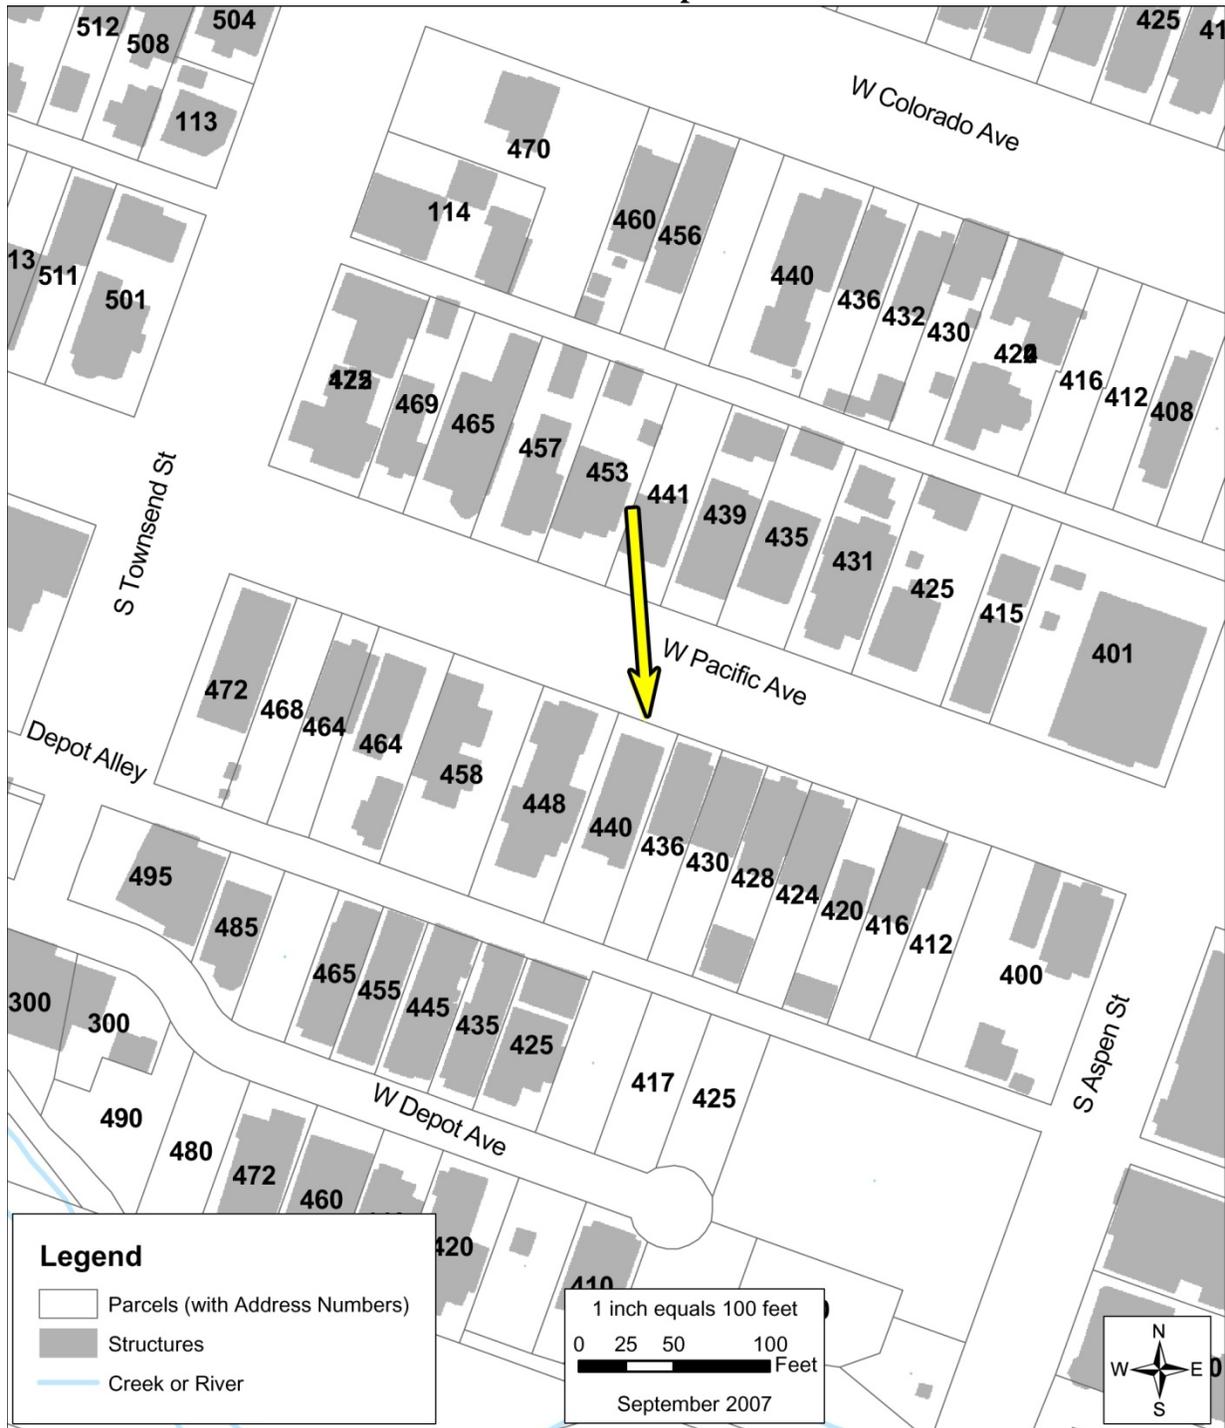
Sketch Map

23. Landscape or special setting features: **This property is located on the south side of West Pacific Avenue in the block between Aspen and Townsend Streets.**
24. Associated buildings, features or objects: **N/A**
