**COLORADO CULTURAL RESOURCE SURVEY**
**Architectural Inventory Form**

1. Resource number: **5SM.1673/THAS.206**
2. Temporary resource number: **N/A**
3. County: **San Miguel**
4. City: **Telluride**
5. Historic Building Name: **Unknown**
6. Current Building Name: **Park House**
7. Building Address: **457 W. Pacific Avenue**

| 48. Report title: | <b>Town of Telluride Re-Survey of Historic Structures</b> | | <b>Planning and Building<br/>Department</b> |

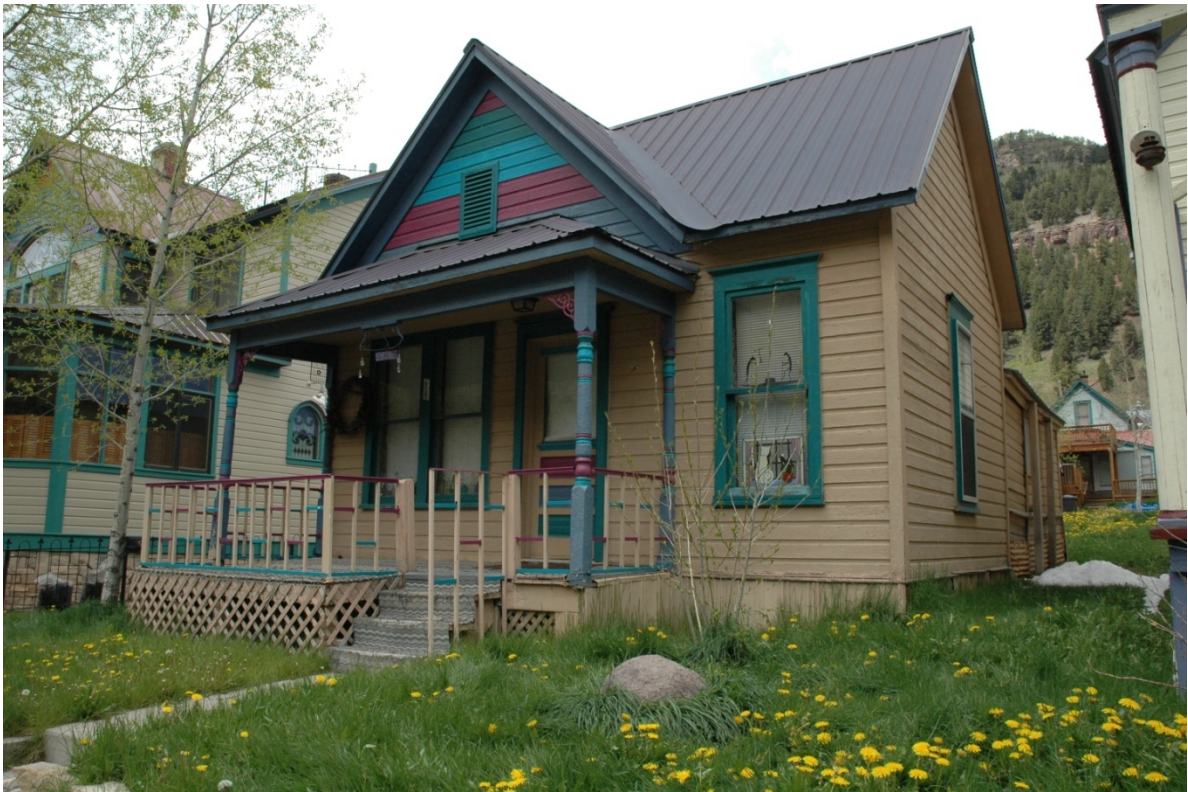
**THLD RATING:**
**Primary - Contributing to District**  
**Shed - Contributing to District**

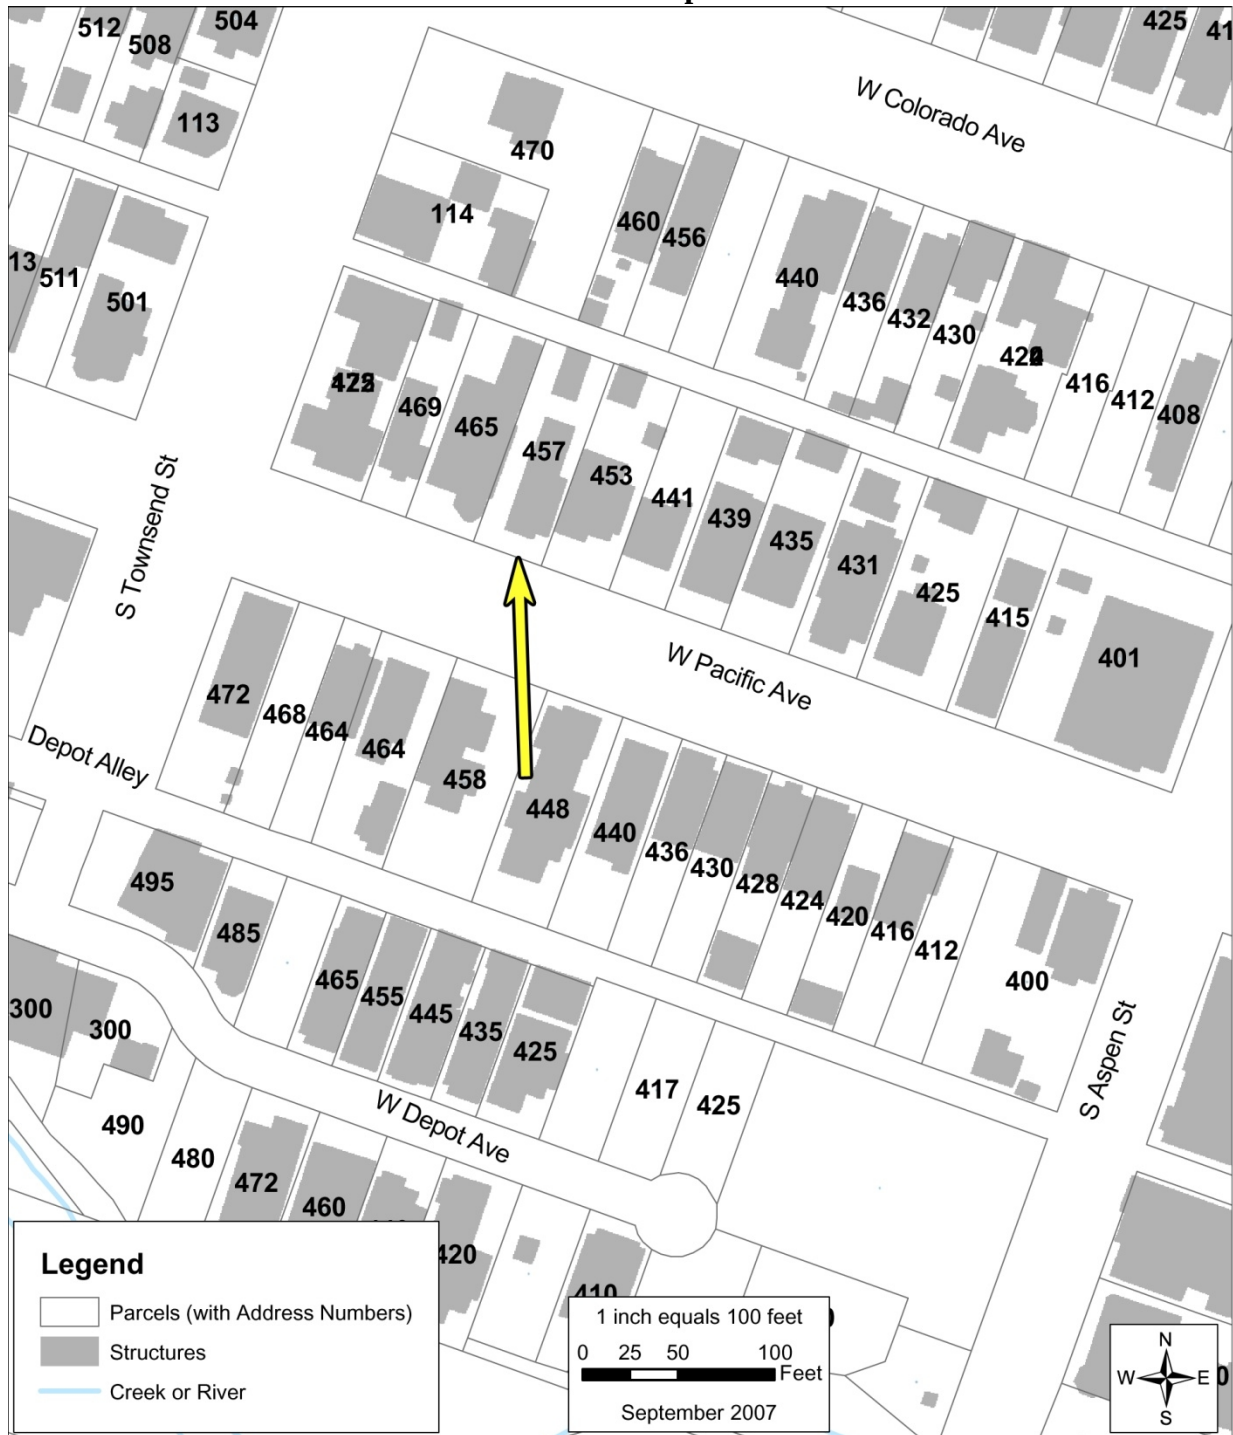
## Sketch Map

**This property is located on the north side of West Pacific Avenue in the block between Aspen and Townsend Streets. A stone retaining wall parallels the front sidewalk.**

**A wood frame shed (THAS #206) is located adjacent to the alley at the rear of the property. This building measures approximately 24' N-S by 10' E-W, and is supported by a wood timbers on grade foundation. Its exterior walls are clad with rusted corrugated metal, over horizontal wood planks, while the shed roof is covered with deteriorated rusted corrugated metal over 1x wood decking. A single square window opening penetrates the west elevation. A large single-light window penetrates the east elevation. A corrugated metal clad entry door enters the shed near the south end of the east elevation.**
