COLORADO CULTURAL RESOURCE SURVEY

Architectural Inventory Form

- 1. Resource number: **5SM.1668**
- 2. Temporary resource number: **N/A**
- 3. County: **San Miguel**
- 4. City: **Telluride**
- 5. Historic Building Name: **Unknown**
- 6. Current Building Name: **Marlens Black 1997 Trust House**
- 7. Building Address: **525 W. Pacific Avenue**
- 8. Owner Name and Address: **Marlens Black 1997 Trust
15260 Ventura Blvd Suite 1040
Sherman Oaks, CA 91403**

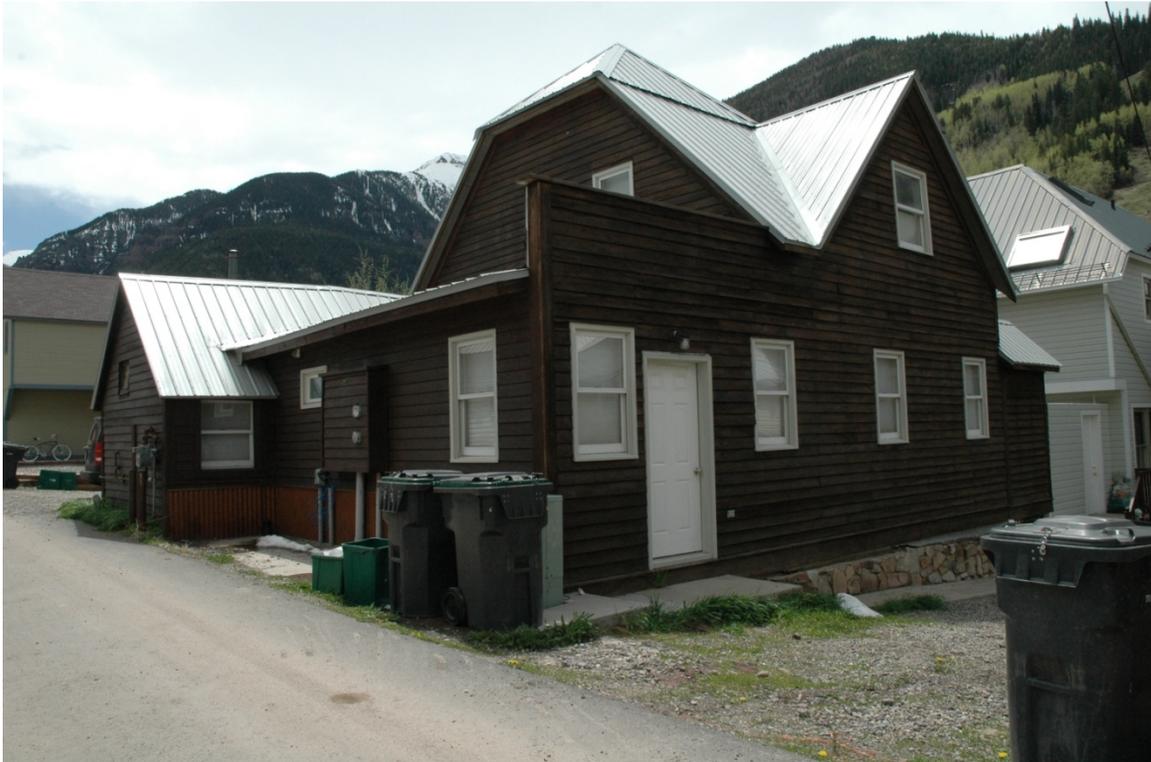
THLD RATING:	Rear Residence - Noncontributing Without Qualifications Front Residence – Non-Designated – New Construction
---------------------	--

18. Roof configuration: **Hipped Roof/Gable-on-hip Roof**
19. Primary external roof material: **Metal Roof**
20. Special features: **Porch**
21. General architectural description:
This historic 1.5-story wood frame dwelling is located on the back half of this lot. It is now located behind a modern dwelling which has been erected on the front half of the lot. This building is supported by a low stone and concrete foundation, and its exterior walls are clad with stained brown horizontal wood siding, with painted white variegated wood shingles in the upper gable end on the south elevation. The house is covered by a steeply-pitched hip--on-gable roof, with corrugated metal roofing material, and with stained brown boxed eaves. Two non-historic bubble skylights, and two flat skylights, are located on the east-facing roof slope. A set of paired, non-historic, 10-light glass-in-wood-frame doors enter the center of the south elevation from anon-historic wood deck. A painted white wood-paneled door enters a small gabled extension at the north end of the west elevation. A canted hip-roofed bay is located at the east end of the south elevation. Windows elsewhere are predominantly 1/1 double-hung sash with painted white wood frames and painted grey wood surrounds.

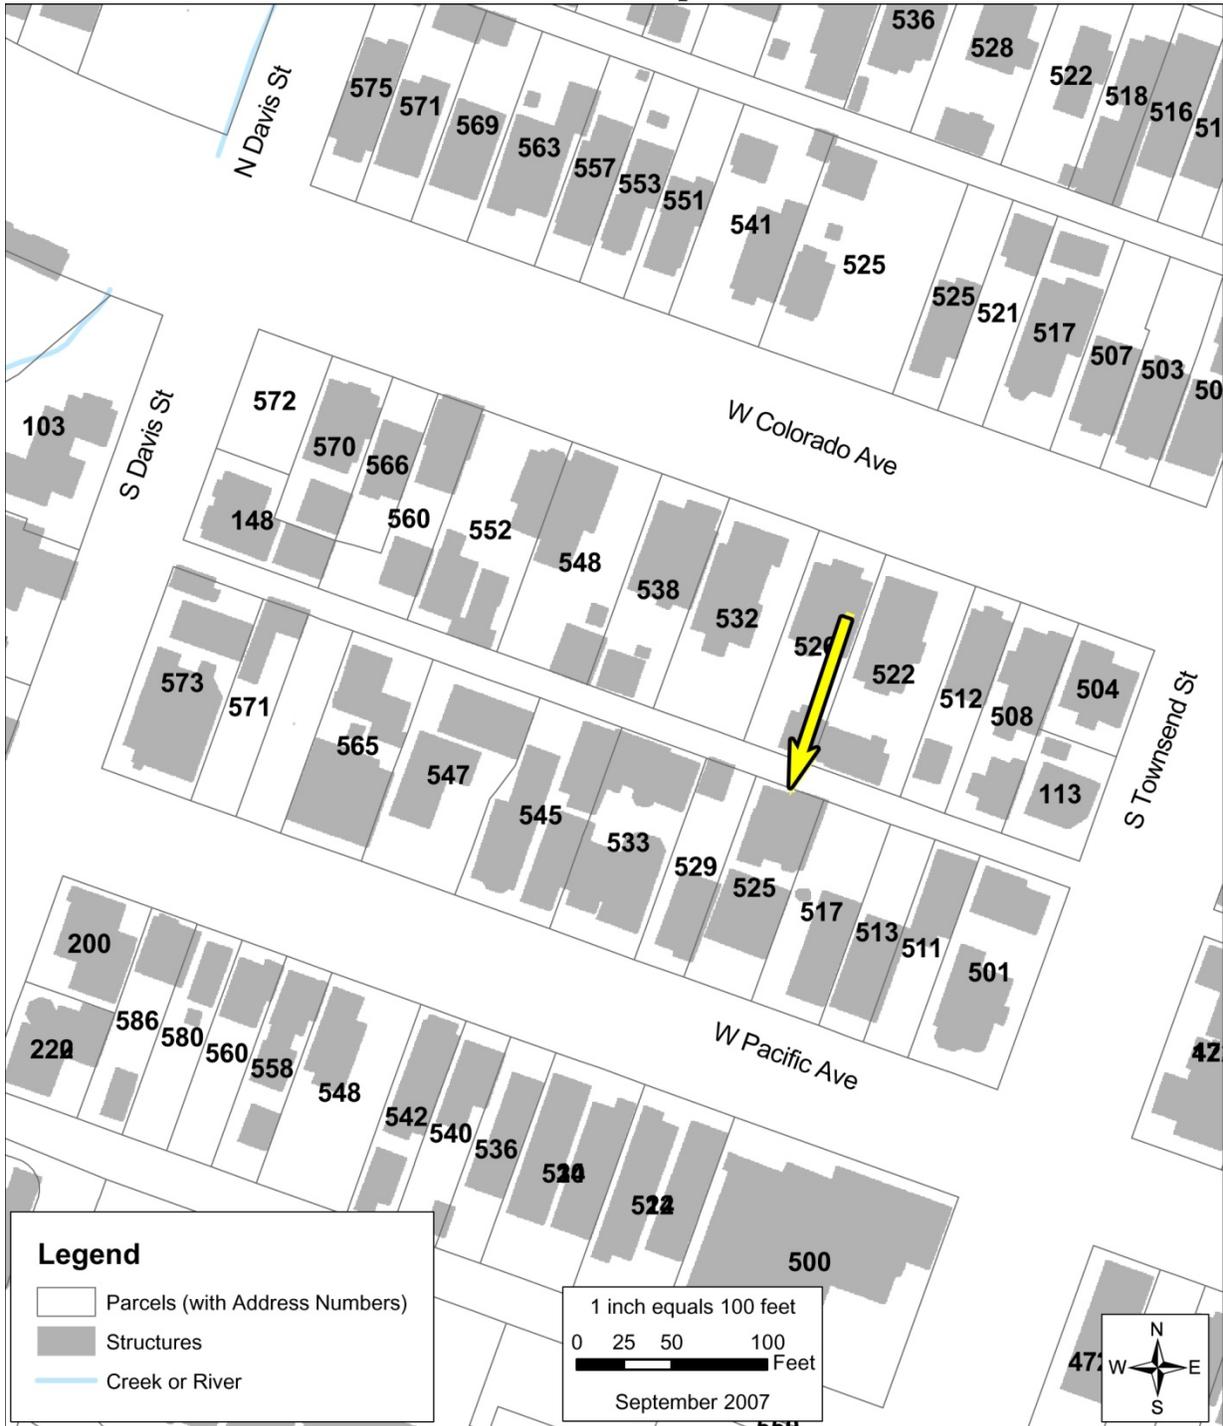
Sketch Map

This property is located on the north side of West Pacific Avenue in the block between Townsend and Davis Street. The historic dwelling is located near the rear of the property; a non-historic, Neo-Victorian style, dwelling has been built on the front half of the property
