COLORADO CULTURAL RESOURCE SURVEY

Architectural Inventory Form

1. Resource number:	5SM.1666	Parcel number(s):	456536318027
2. Temporary resource number:	N/A		456536318026
3. County:	San Miguel		456536318025
4. City:	Telluride		
5. Historic Building Name:	Unknown		
6. Current Building Name:	Capaldo House		
7. Building Address:	547 W. Pacific Avenue		
8. Owner Name and Address:	Christine M. Capaldo P.O. Box 3778 Telluride, CO 81435 The Lady Doctor Real Estate Company LLC P.O. Box 2253 Telluride, CO 81435 John D. Linzinmeir P.O. Box 442 Telluride, CO 81435

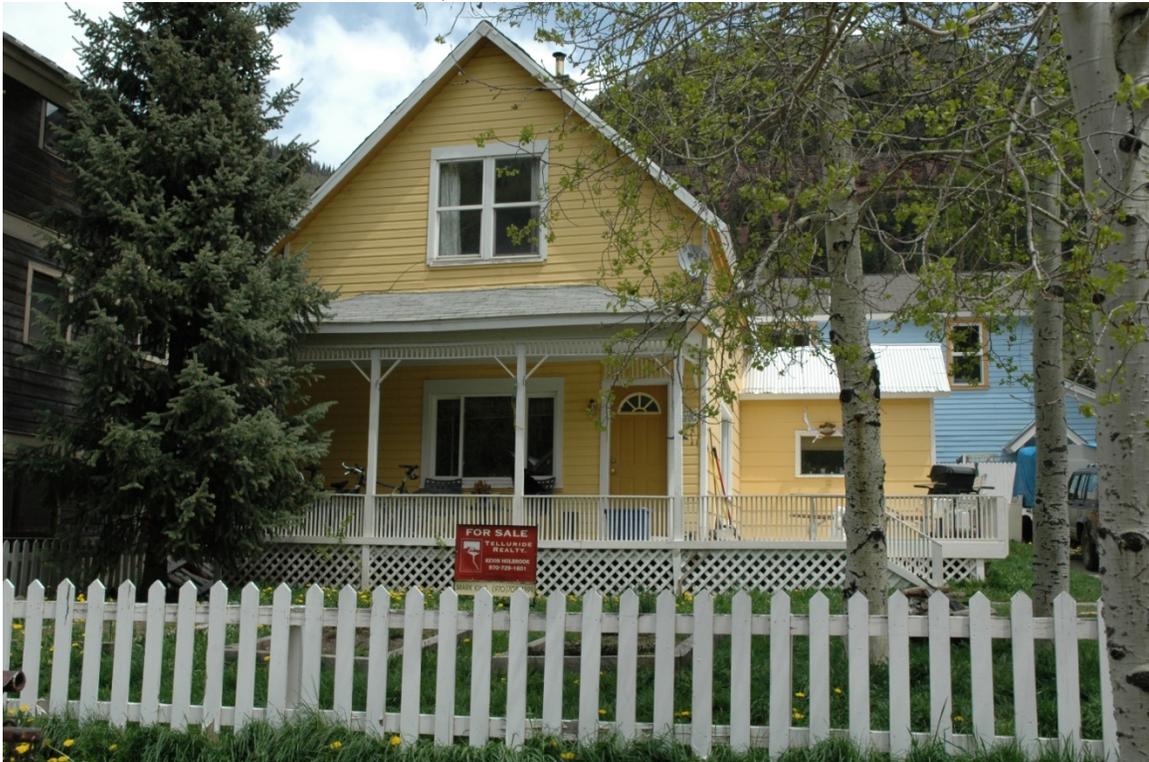
21. General architectural description:
This is a 1.5-story, rectangular-shaped, wood frame dwelling, with a historic saltbox-roofed extension to the north end of the east (side) elevation, and a low shed-roofed addition to the north (rear) elevation. The house is supported by a low coursed sandstone foundation, and it is covered by a steeply-pitched front gable roof with green asphalt composition shingles and painted white boxed eaves. A red brick chimney, with a corbelled cap, is located on the roof ridge, while a shed-roofed dormer, with a 1x1 horizontal sliding window, is located on the west-facing roof slope. The façade wall, on the south elevation, is clad with painted yellow horizontal weatherboard siding; the west elevation wall is covered with yellow asbestos shingle siding; the east and north elevation walls are clad with wide, painted yellow, horizontal composition board siding. A painted yellow wood-paneled door, with a fanlight, enters the east end of the façade from a full-width front porch. The front porch connects with a non-historic deck on the east elevation, and features a wood plank floor, a painted white open wood railing, 4" by 4" wood posts, with 2" by 2" braces, a wood frieze, and a low-pitched hipped roof. A non-historic single-light fixed-pane window, with flanking casement windows, penetrates the façade wall to the west of the entry door. A set of paired 1/1 double-hung sash windows are located in the façade's upper gable end. A non-historic single-light fixed-pane "picture window" penetrates the east elevation.
