COLORADO CULTURAL RESOURCE SURVEY

Architectural Inventory Form

- 1. Resource number: **5SM.5623**
- 2. Temporary resource number: **N/A**
- 3. County: **San Miguel**
- 4. City: **Telluride**
- 5. Historic Building Name: **Unknown**
- 6. Current Building Name: **Goldman House**
- 7. Building Address: **560 W Pacific Avenue**
- 8. Owner Name and Address: **Kenneth J. Goldman / The Goldman Group  
14 Main Street, Suite 100  
Madison, NJ 07940**

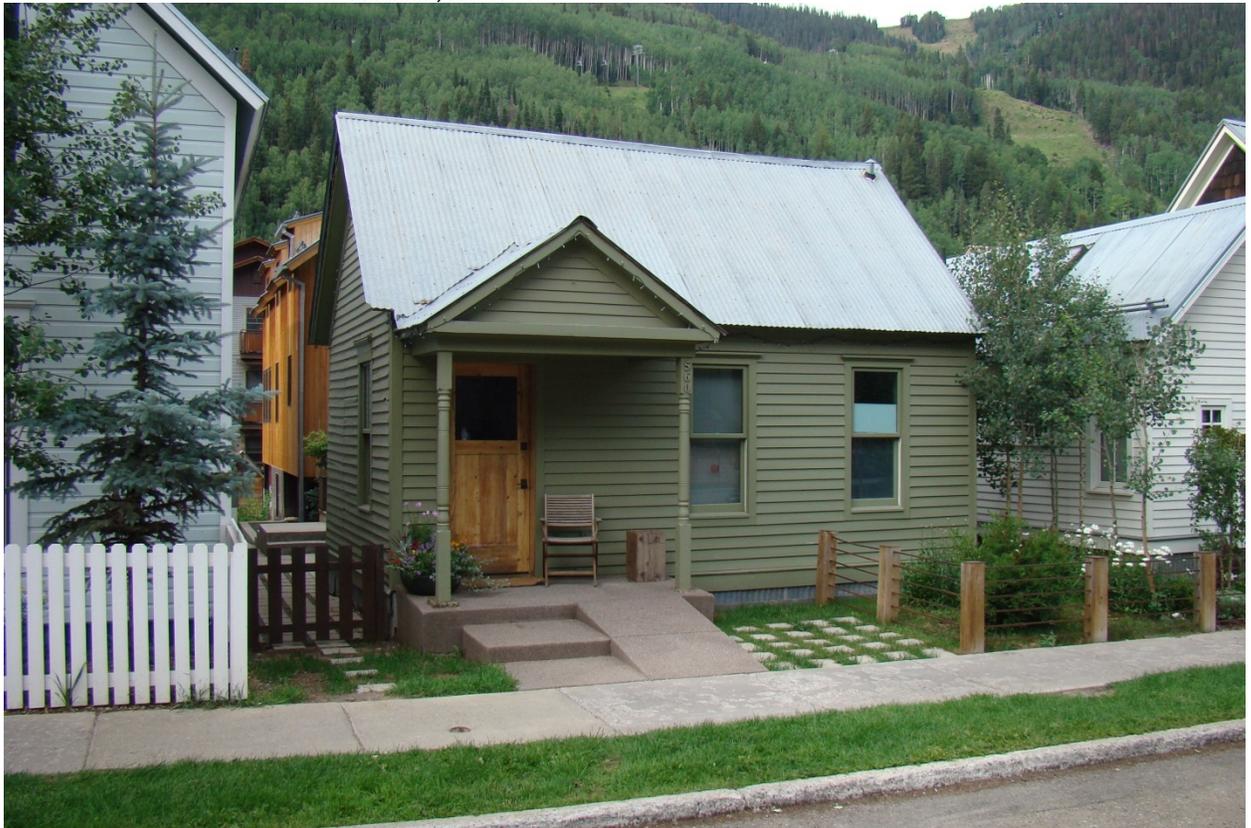
**This is a single-story wood frame dwelling which was recently moved to this location from 238 E. Colorado Avenue. The building's exterior walls are clad with painted grey horizontal wood siding, with 1" by 4" corner boards. The house's cross-gable roof is covered with corrugated metal roofing material, and its windows are predominantly 1/1 double-hung sash, with painted wood frames and surrounds. A wood-paneled door, with one upper sash light, enters the east end of the façade (north elevation) from a small porch, covered by a gable roof with turned column supports.**

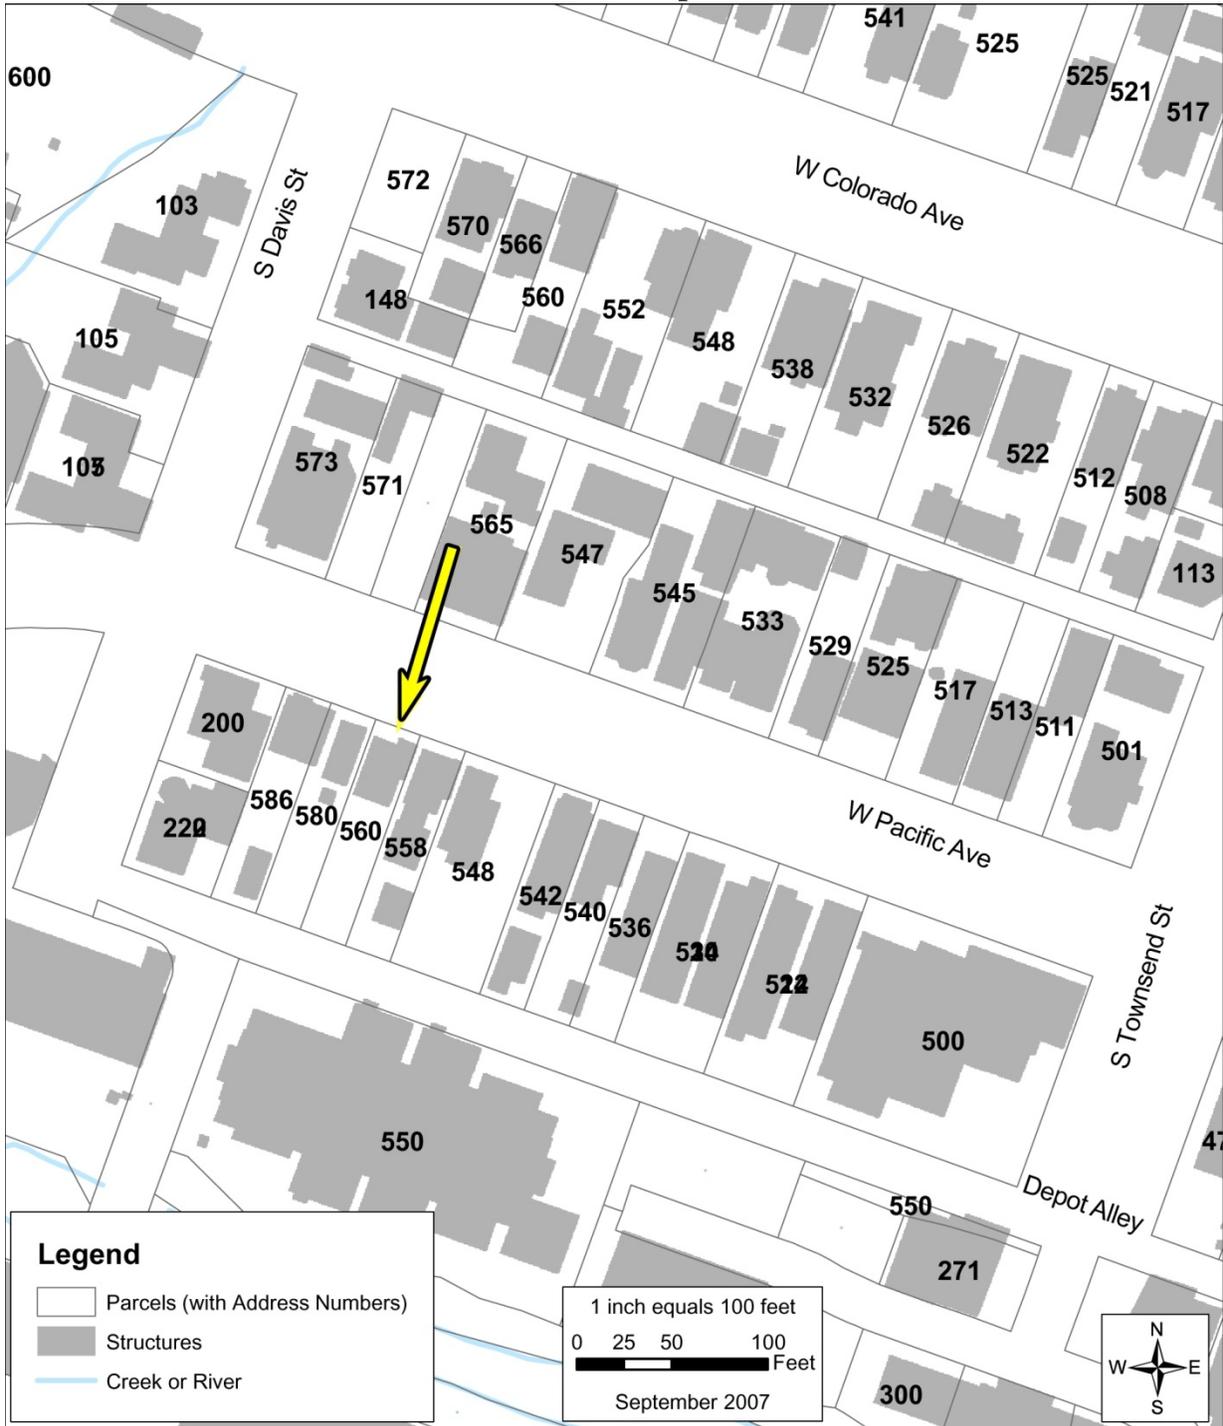
## Sketch Map

22. Architectural style: **Late Victorian**  
 Building type:
23. Landscape or special setting features:  
**This property is located on the south side of Pacific Avenue, in the block between Townsend and Davis Streets. This location is near the southwestern corner of the Telluride National Historic Landmark District.**
