COLORADO CULTURAL RESOURCE SURVEY

Architectural Inventory Form

- 1. Resource number: **5SM.1838/THAS.187** Parcel number(s):
- 2. Temporary resource number: **N/A**
- 3. County: **San Miguel**
- 4. City: **Telluride**
- 5. Historic Building Name: **Unknown**
- 6. Current Building Name: **586 West Pacific LLC House**
- 7. Building Address: **586 W. Pacific Avenue**
- 8. Owner Name and Address: **586 West Pacific LLC
P. O. Box 2849
Telluride, CO 81435**

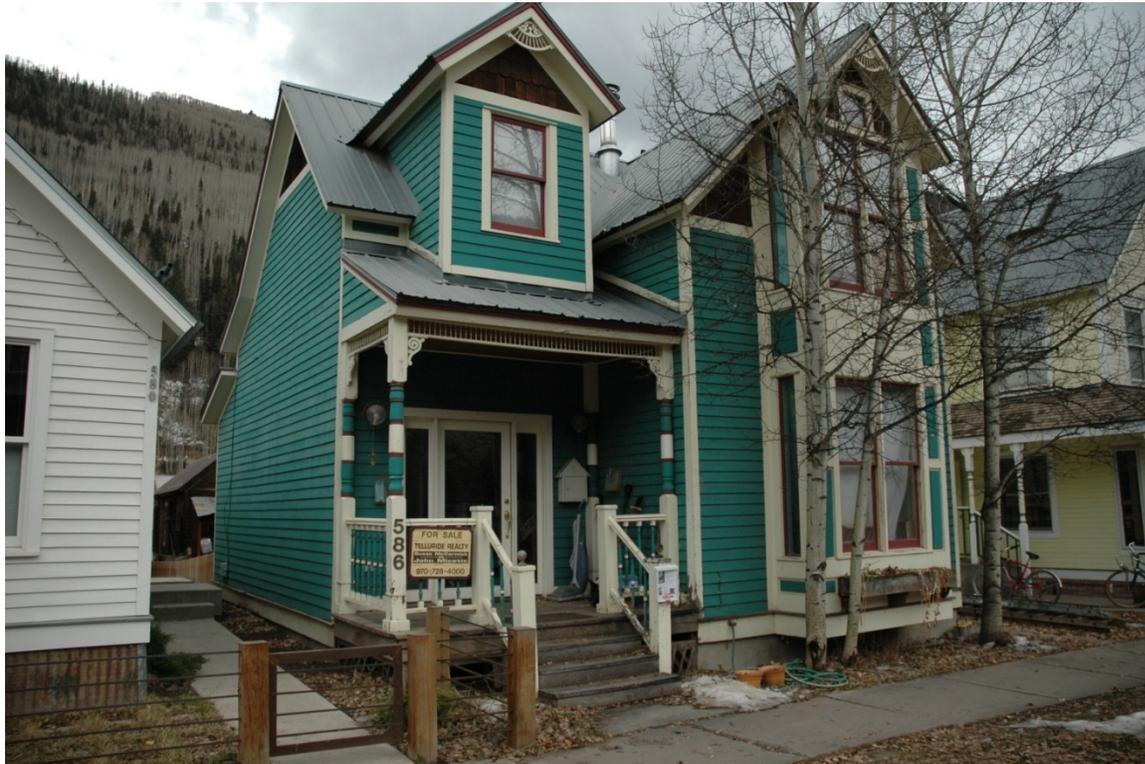
21. General architectural description:
This is a 1½-story, L-shaped, cross-gabled dwelling with a single-story shed-roofed extension to the south (rear) elevation. The house is supported by a low, unpainted, poured concrete foundation, while its exterior walls are clad with painted turquoise color horizontal wood siding with painted cream white 1" by 4" corner boards. A painted cream white 1x board with a water table lip separates the foundation from the siding. The cross-gabled roof is steeply-pitched, with corrugated metal roofing material, and with painted burgundy and cream white boxed eaves. A large, non-historic, gabled dormer, with a 1/1 double-hung sash window and a delicate gable ornament, overlooks the front porch on the north elevation. Non-historic skylights penetrate the south and west roof slopes. A non-historic, two-story, gabled, rectangular bay is a prominent architectural feature on the west end of the north elevation (façade) This bay features two 1/1 double-hung sash first story windows, two 1/1 double-hung sash second story windows, recessed panels, and a delicate gable ornament. A painted white glass-in-wood-frame door enters the east half of the façade from the front porch which is approached by four wood steps and features a wood plank floor, an open wood balustrade with turned balusters, turned columns, a spindle frieze and a shed roof. A rear entry door at the west end of the south elevation enters the single-story shed-roofed extension from an uncovered wood porch with a wood railing.
