COLORADO CULTURAL RESOURCE SURVEY

Architectural Inventory Form

- 1. Resource number: **5SM.1854**
- 2. Temporary resource number: **N/A**
- 3. County: **San Miguel**
- 4. City: **Telluride**
- 5. Historic Building Name: **Unknown**
- 6. Current Building Name: **Geldbaugh House**
- 7. Building Address: **401 E. Pandora Avenue**
- 8. Owner Name and Address: **Mark and Ellen Geldbaugh  
P. O. Box 3087  
Telluride, CO 814353087**

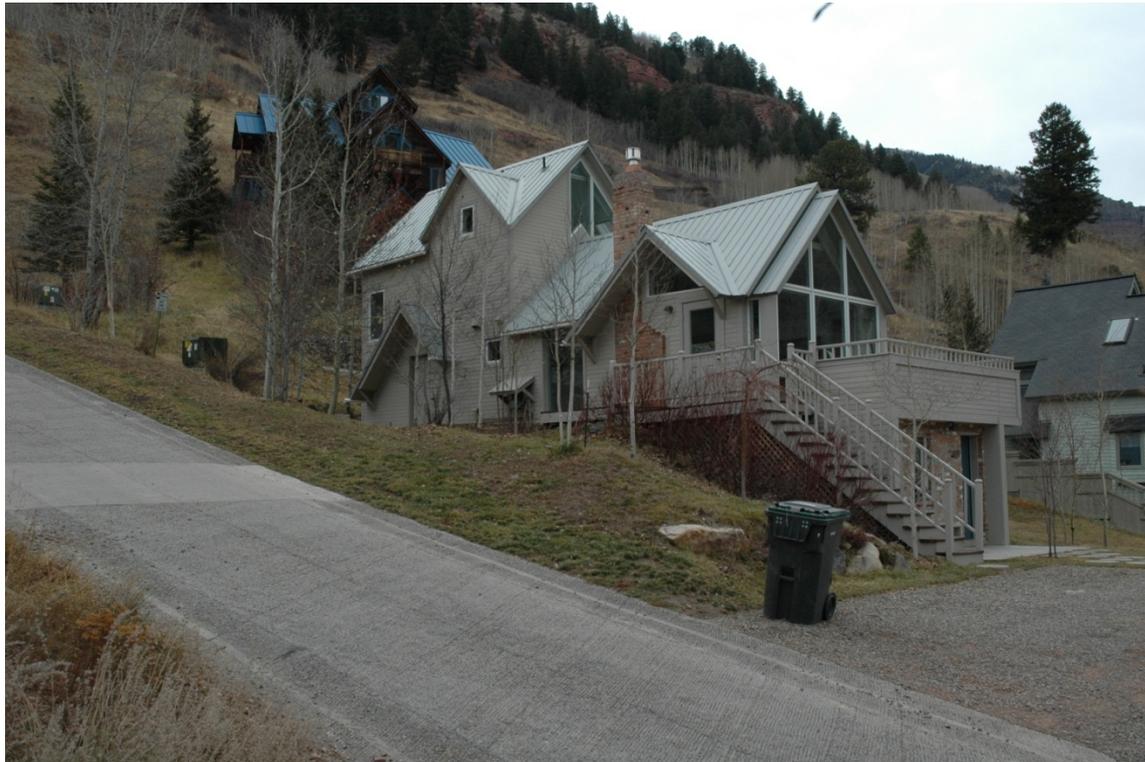
**This wood frame residence is composed of a 1½-story gabled front section (to the south), and a large, taller, 1½-story gabled rear section (to the north). It is supported by a low poured concrete foundation, while the exterior walls are clad with beige color horizontal wood siding with 1" by 4" corner boards. A brick fireplace chimney is located on the west elevation. The gable roofs are steeply-pitched, with lower intersecting gables, and they are covered with metal roofing material. A set of wooden stairs on the west elevation lead to a painted beige glass-in-wood-frame door which is the primary entry. Fixed-pane pentagon-shaped windows, typically set over casement type windows, appear in the upper gable ends, First story windows are also predominantly casements. A former greenhouse addition on the south elevation has been fully enclosed and faced with brick.**
