COLORADO CULTURAL RESOURCE SURVEY

Architectural Inventory Form

- 1. Resource number: **5SM.1757**
- 2. Temporary resource number: **N/A**
- 3. County: **San Miguel**
- 4. City: **Telluride**
- 5. Historic Building Name: **Unknown**
- 6. Current Building Name: **Courtney House**
- 7. Building Address: **229 N. Pine Street**
- 8. Owner Name and Address: **Sally P. Courtney  
P. O. Box 73  
Telluride, CO 814350073**

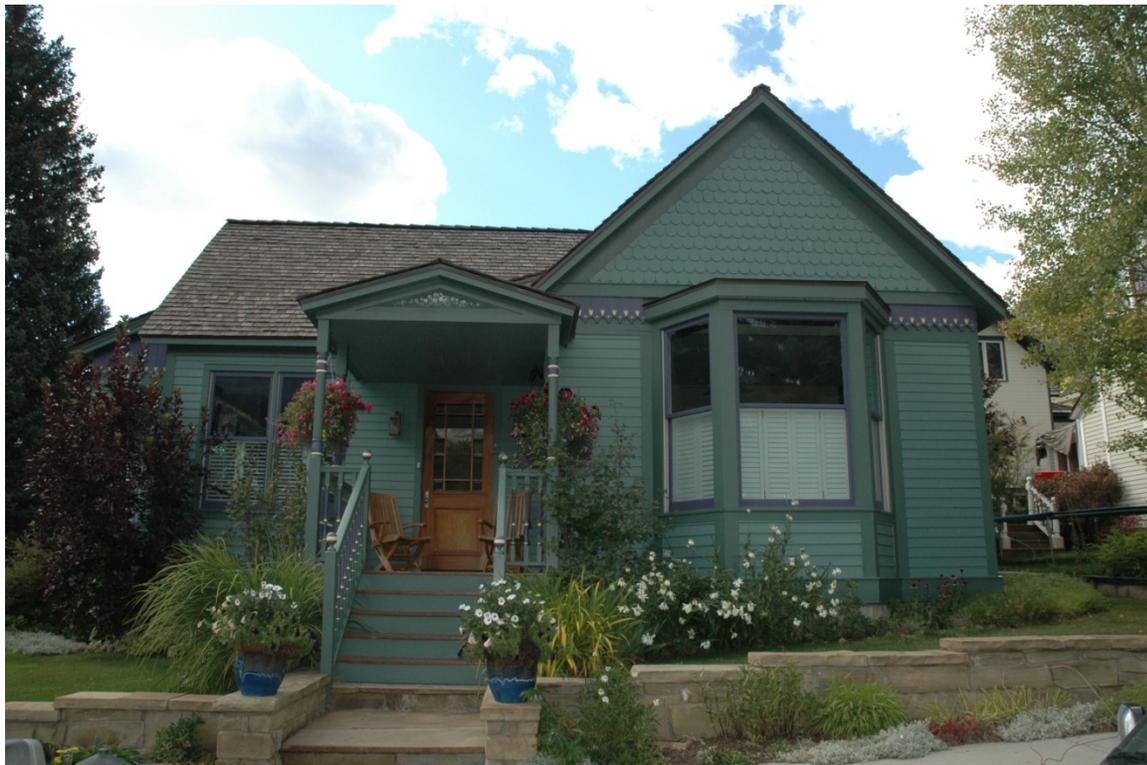
21. General architectural description:  
**This is a single-story, L-shaped, cross gabled dwelling with a gabled extension to the west (rear) elevation. The house is supported by an unpainted coursed sandstone foundation, while its exterior walls are clad with painted green horizontal wood siding with 1" by 4" corner boards. Painted green fish scale shingles appear in the facade's upper gable end on the east elevation. A painted green 1x board with a water table, separates the foundation from the horizontal siding. The cross gabled roof is covered with wood shingles, and the eaves are boxed with painted green wood trim. A stained brown wood-paneled front door, with four upper sash lights, and with a projecting locking rail, enters the asymmetrical facade from an open front porch. The porch is approached by four wood steps and features a wood plank floor, an open wood railing with turned balusters, turned columns, and a low-pitched gabled roof. A hipped-roof canted bay, with three 1/1 double-hung sash, is located on the facade, north of the entry porch. A large, rectangular-shaped, shed-roofed bay is located on the south elevation. This bay is penetrated by five 1/1 double-hung sash windows. Original windows elsewhere are primarily single and paired 1/1 double-hung sash with painted purple wood frames and painted green wood surrounds.**

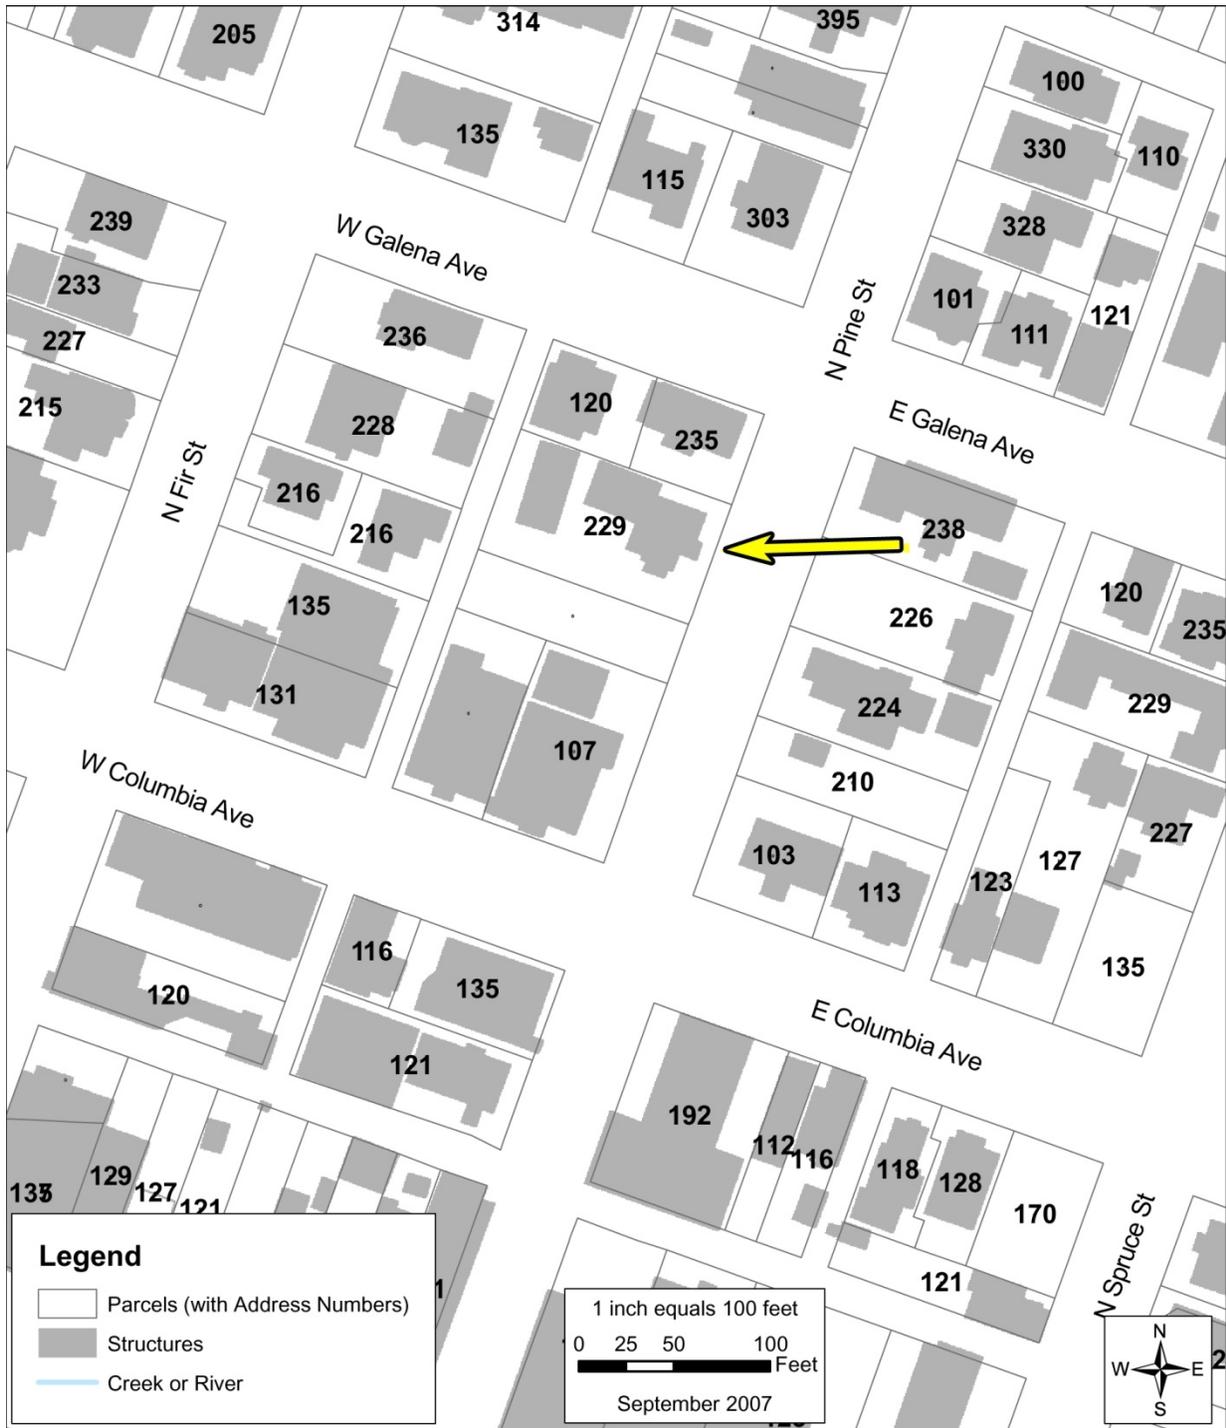
## Sketch Map

This property is located on the west side of N. Pine Street, the second house south of Galena Avenue. The lawn flanking the house is nicely landscaped with native plants, flowers, and large fir and spruce trees. A stone retaining wall parallels the front sidewalk which is approximately two feet above street level.
