COLORADO CULTURAL RESOURCE SURVEY

Architectural Inventory Form

- 1. Resource number: **5SM.1678**
- 2. Temporary resource number: **N/A**
- 3. County: **San Miguel**
- 4. City: **Telluride**
- 5. Historic Building Name: **Warehouse; Ice House**
- 6. Current Building Name: **La Marmotte Restaurant Francais**
- 7. Building Address: **150 W. San Juan Avenue**
- 8. Owner Name and Address: **Camels Garden Partnership  
EAT 0733 LLC  
330 W. Bridge Street, No. 504  
Hotchkiss, CO 81419**

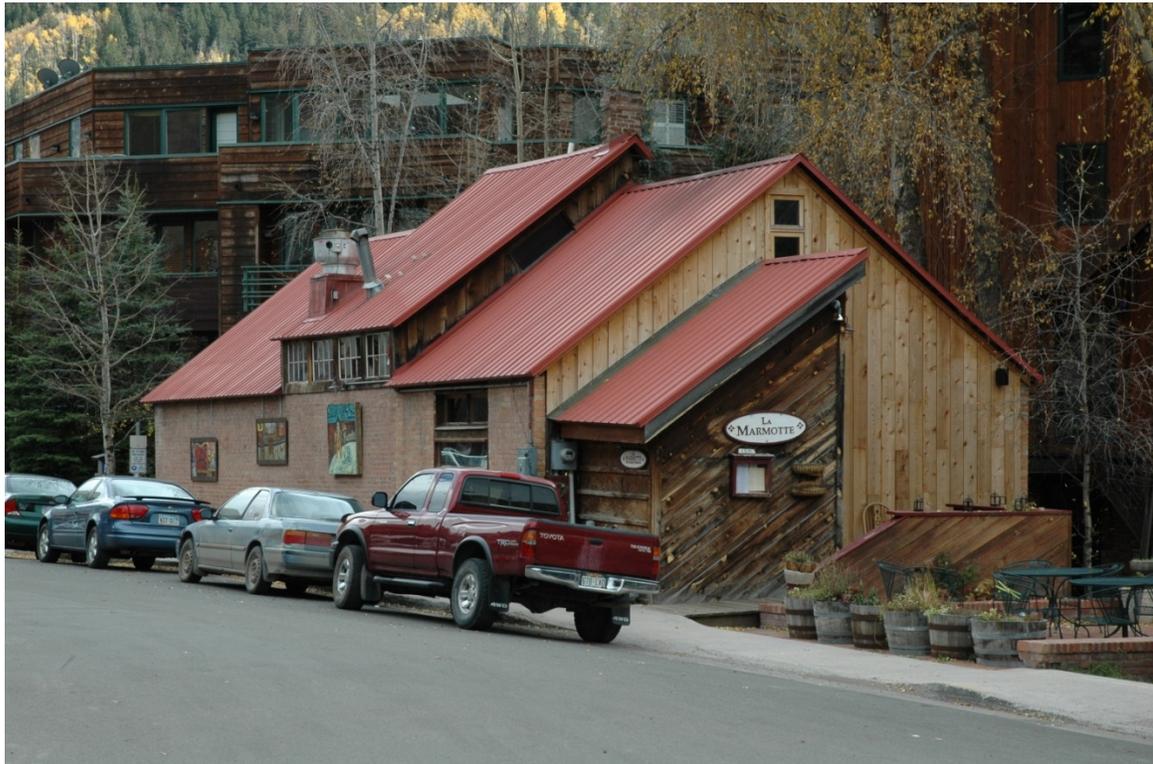
**This building consists of a historic, early 1890s, brick warehouse, with a circa 1970s wood frame gabled addition to its west elevation. The original warehouse rests on a low sandstone foundation, and there is apparently a cellar under at least part of the building as there is a bulkhead cellar entrance on the south elevation. The original building's walls, exposed on the north, south, and east elevations, are made of red brick laid in common bond. A side gable roof is moderately-pitched, and is covered with red metal roofing material laid over 1x wood decking, and with red metal-clad eaves. A monitor roof, with a band of four 8-light clerestory windows, projects above the main roof on the north elevation - facing San Juan Avenue. A red brick chimney is located on the roof ridge. Rusted corrugated metal appears in the upper gable end on the east elevation. A painted red plywood-shuttered window, side-hinged with metal strap hinges, penetrates the upper gable end on the east elevation. The east elevation also features a painted red glass-in-wood-frame door, with a transom light, which enters the building from a 5-step wood stoop. A utility door enters the south elevation. The circa 1970s gabled addition to the west elevation is supported by a concrete foundation, and has stained brown vertical wood plank walls. A stained brown glass-in-wood-frame door enters an enclosed 8' by 6' shed-roofed porch from a wood deck on the addition's west elevation. A large 20-light window penetrates the addition's south elevation.**

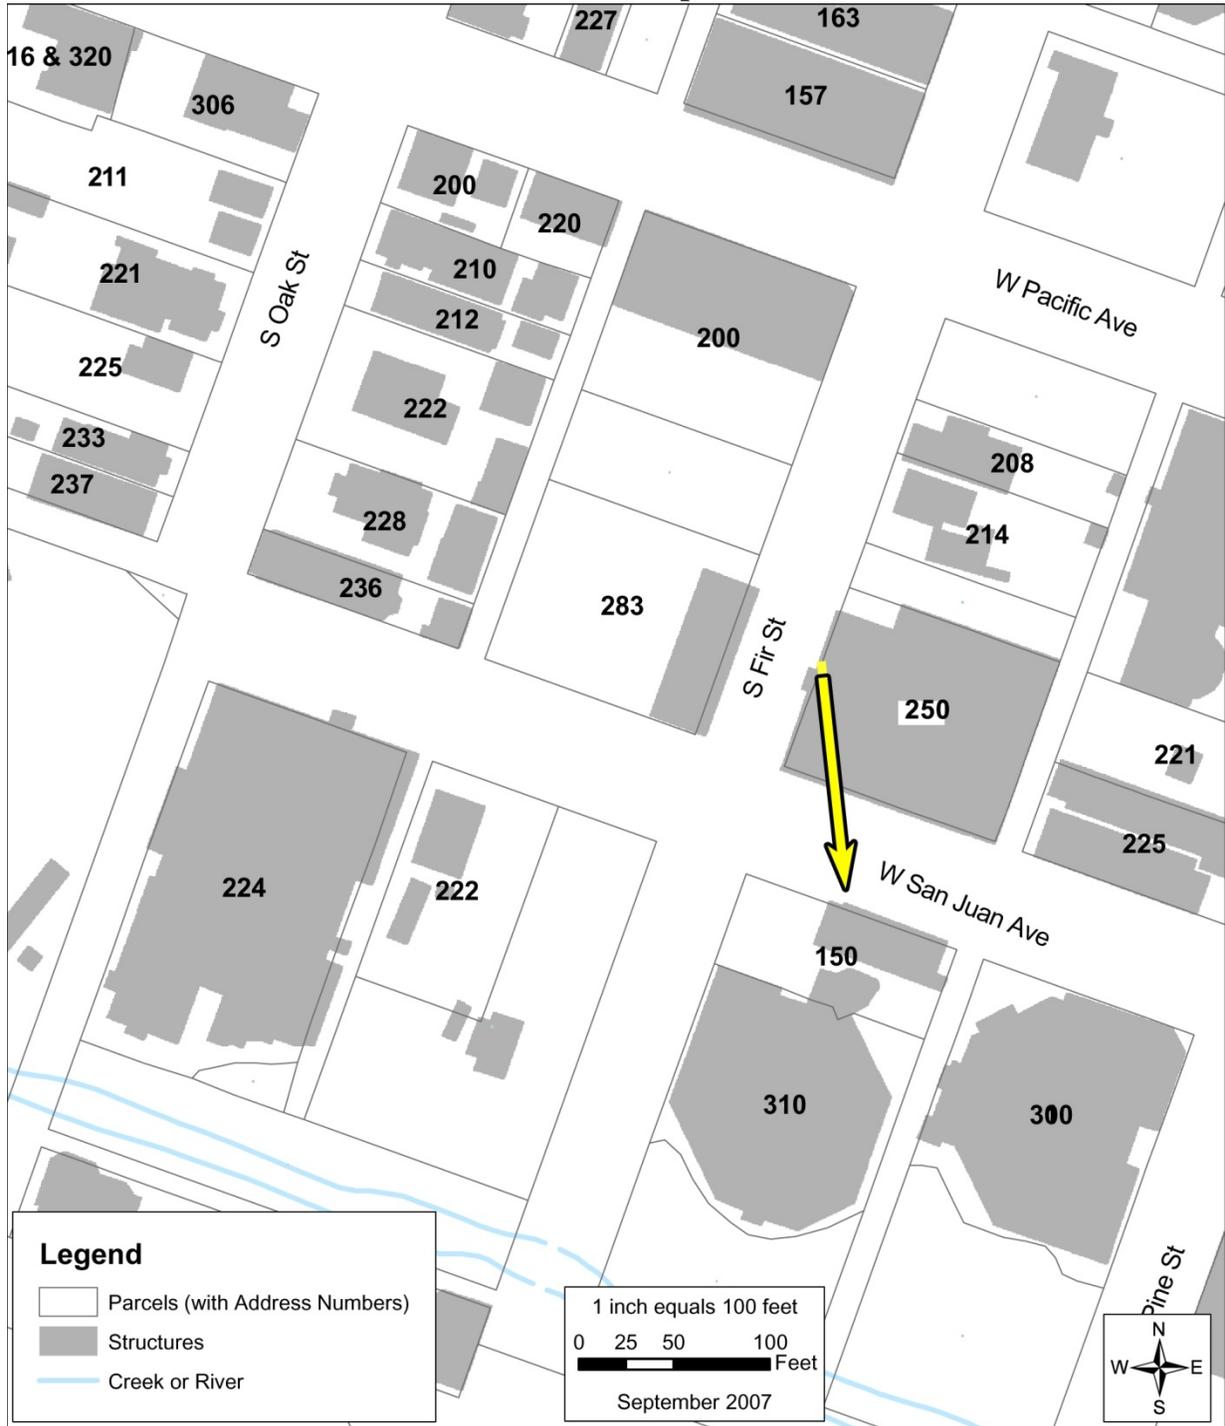
## Sketch Map

**This former warehouse building is located on the south side of San Juan Avenue between Pine and Fir Streets, at the southern end of the Telluride National Historic Landmark District.**
