COLORADO CULTURAL RESOURCE SURVEY

Architectural Inventory Form

- 1. Resource number: **5SM.1767/THAS.124**
- 2. Temporary resource number: **N/A**
- 3. County: **San Miguel**
- 4. City: **Telluride**
- 5. Historic Building Name: **Smith House, Werry House, Goldworthy House**
- 6. Current Building Name: **Potter House**
- 7. Building Address: **227 N. Spruce Street**
- 8. Owner Name and Address: **Brian J. And Kelley P. Potter
701 11th Street
Manhattan Beach, CA 90266**

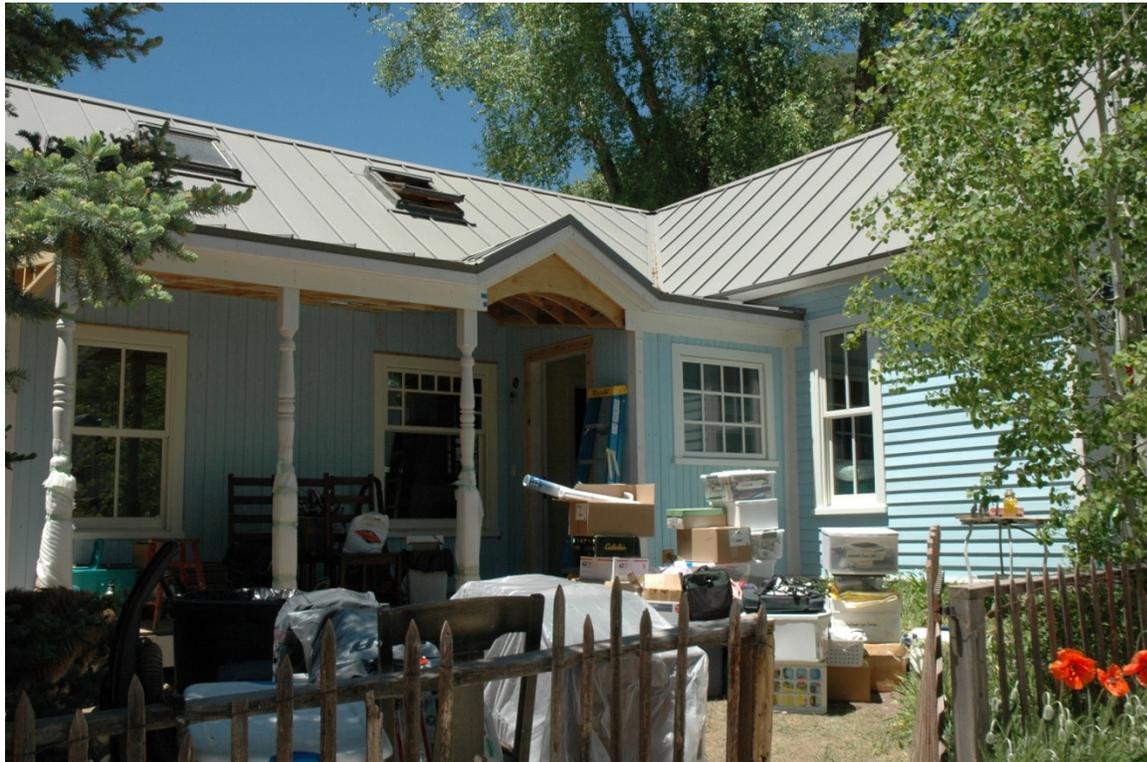
18. Roof configuration: **Gabled Roof / Cross Gabled Roof**
19. Primary external roof material: **Metal Roof**
20. Special features: **Porch, Fence**
21. General architectural description:
This building consists of an original (circa 1892) front gabled dwelling, with a (1982) side-gabled addition to the south (side) elevation, and with other alterations to the west (rear) elevation. The house is supported by an unpainted concrete foundation (portions of the original foundation are probably stone), and its exterior walls are clad with painted cream white horizontal wood siding with 1" by 4" corner boards. The original dwelling and its 1982 addition form an L-shaped plan, covered by a moderately-pitched cross gable roof with red metal roofing material. Two skylights penetrate the addition's east-facing roof slope. A painted blue paneled door, with nine upper sash lights, enters the addition, from an open front porch, near the south end of the east elevation. The porch measures approximately 10' N-S by 4' E-W, and features a poured concrete floor, painted white turned columns, and a shed roof with a small intersecting gable with a sunburst motif. The home's original windows are primarily 1/1 double-hung sash with painted blue wood frames and painted white wood surrounds. Windows in the addition include a large single-light fixed-pane on the south elevation and a single-light fixed-pane octagon-shaped window in the upper gable end.

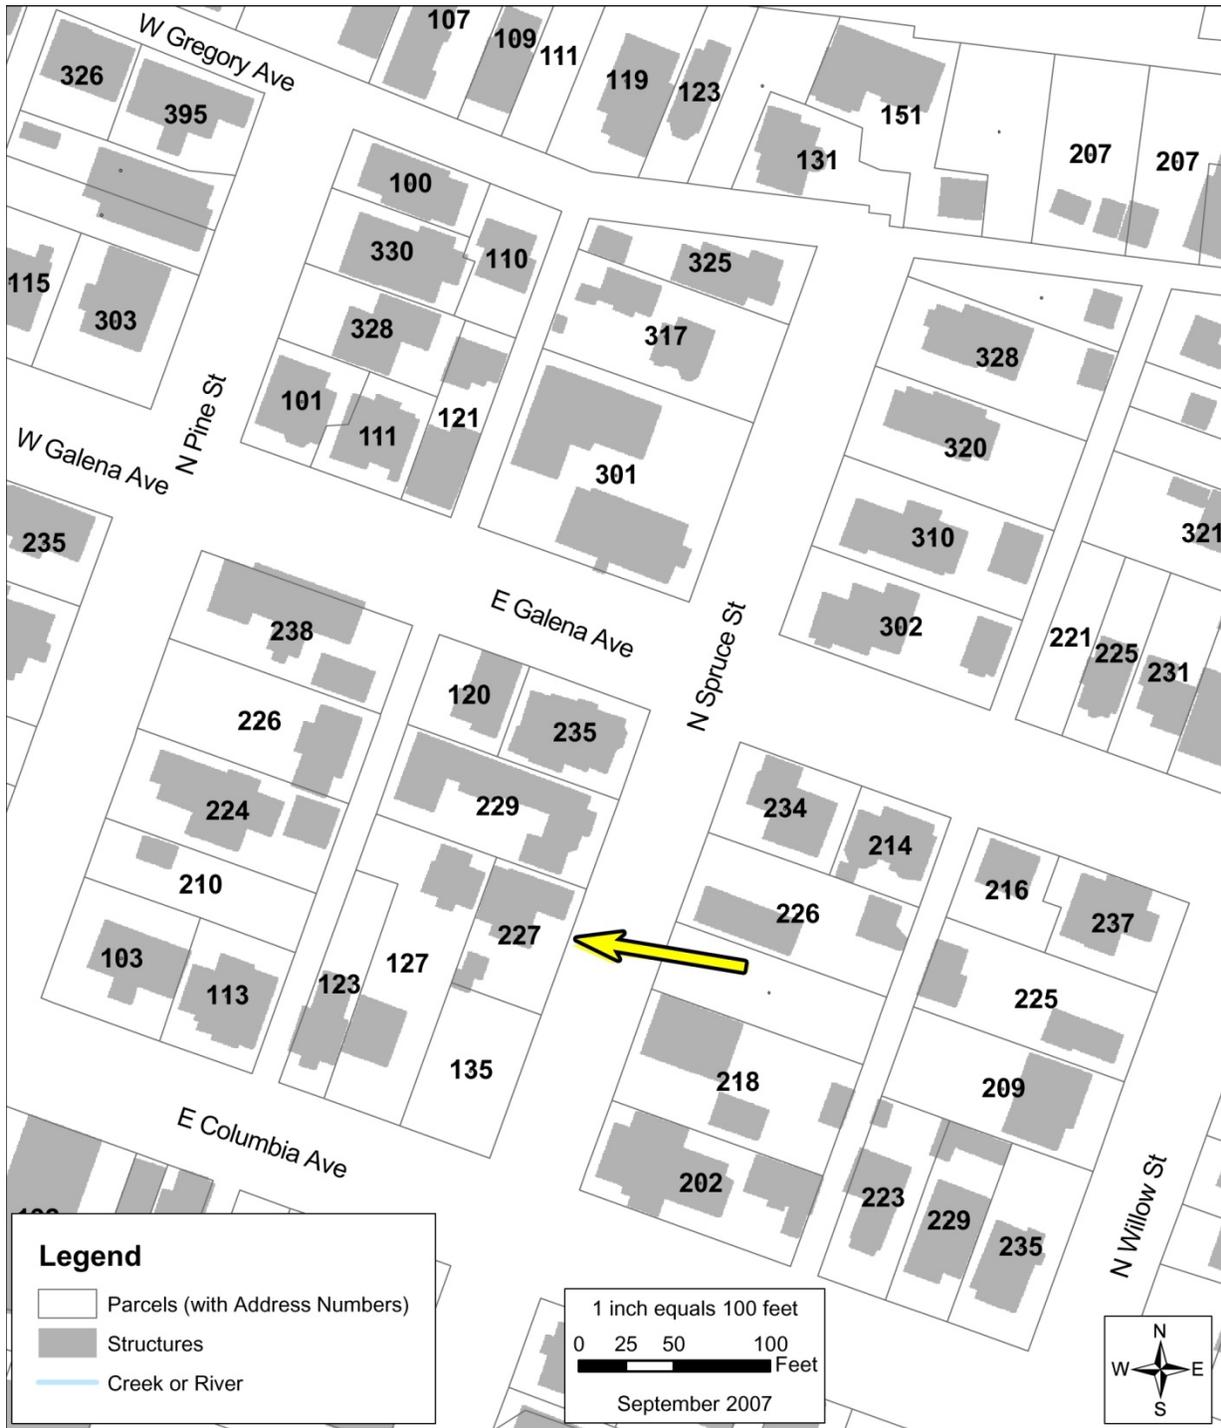
Sketch Map

This property is located on the west side of N. Spruce Street in the block south of Galena Avenue. A low picket fence encloses the front yard and side yard south of the house. The property is nicely landscaped with native plants, flowers, aspen trees, and spruce trees.

Shed (THAS #106)
<p>A historic shed (THAS #106) is located south of the dwelling. This structure measures approximately eight feet square, and it supported by a wood timbers on grade foundation. The shed's exterior walls are made of vertical wood planks, and board-and-batten, and it is covered by a shed roof with corrugated metal roofing material laid over 1x wood decking and 2x wood rafters. The rafter ends are exposed beneath the eaves. A vertical wood plank Dutch door, side-hinged with metal strap hinges, is at the west end of the south elevation. A vertical wood plank door, side hinged with metal strap hinges, is on the east elevation.</p>
Shed
<p>A modern shed (constructed in 1998) abuts the historic shed's north elevation. The modern shed measures approximately 8' N-S by 10' E-W. It is supported by a wood timbers on stone foundation, with a plywood floor and stained brown vertical wood plank exterior walls. It is covered by a shed roof with corrugated metal roofing material laid over plywood decking. A wood-paneled door enters the east end of the south elevation. The roof of this shed is taller than the roof of the adjacent historic shed.</p>
