COLORADO CULTURAL RESOURCE SURVEY

Architectural Inventory Form

- 1. Resource number: **5SM.1777**
- 2. Temporary resource number: **N/A**
- 3. County: **San Miguel**
- 4. City: **Telluride**
- 5. Historic Building Name: **Miners' Hospital**
- 6. Current Building Name: **Glenn House**
- 7. Building Address: **234 N. Spruce Street**
- 8. Owner Name and Address: **Jerome L. Glenn
P. O. Box 1174
Telluride, CO 814351174**

| 48. Report title: | Town of Telluride Re-Survey of Historic Structures | | Planning and Building

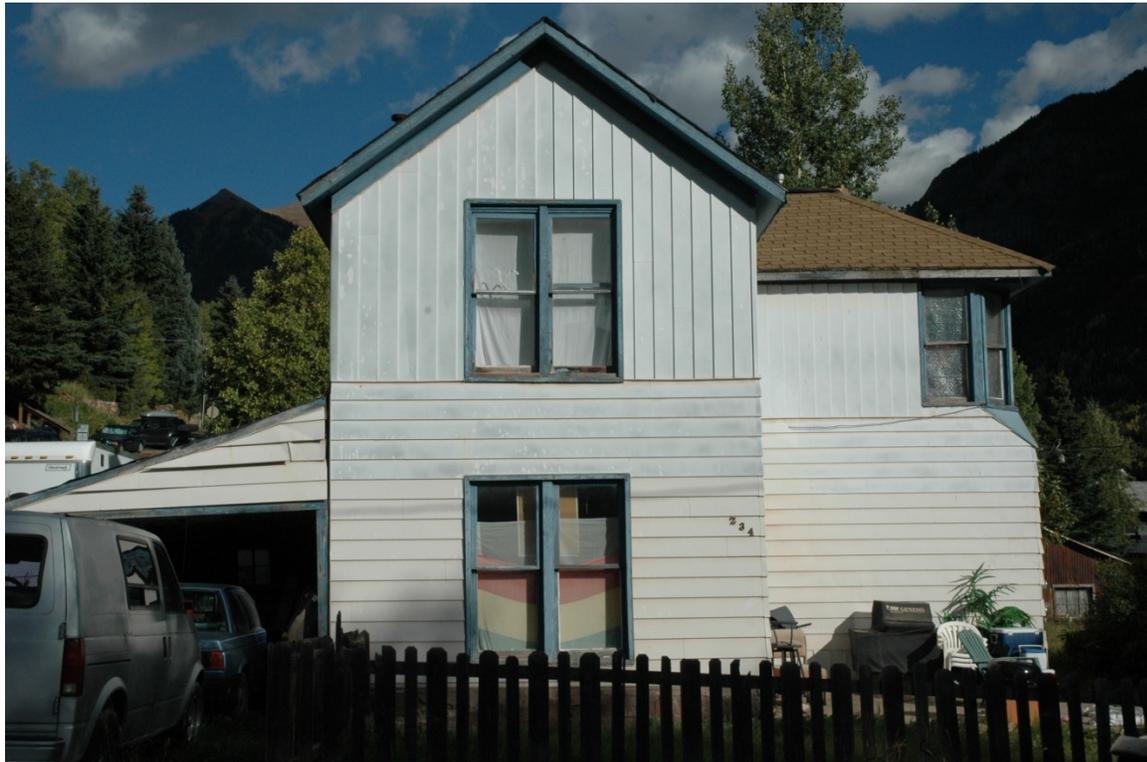
21. General architectural description:
This two story wood frame residence is supported by a low unpainted poured concrete foundation (or possibly concrete pargeting over a stone foundation). The first story walls are clad with wide, white, horizontal metal siding, while the second story walls are clad with wide, white, vertical metal siding. The main roof form is a low-pitched truncated hipped roof, and there is a large intersecting gable on the west elevation. The roof is finished with brown asphalt composition shingles and with painted blue boxed eaves. A brown brick chimney with a corbelled cap is located near the base of the north-facing roof slope. A painted white wood-paneled corner entry door enters the southwest corner of the building from an uncovered concrete porch/patio which measures twelve feet square. A wood-paneled door enters the east (rear) elevation from a shed-roofed porch. An 11' by 18' single-story shed-roofed addition at the west end of the north elevation comprises a single-stall attached garage. An open garage bay door on the west elevation opens onto a gravel driveway which extends to Spruce Street. The house's windows feature painted blue wood frames and surrounds. Windows are predominantly 1/1 and 2/2 double-hung sash.
