COLORADO CULTURAL RESOURCE SURVEY

Architectural Inventory Form

- 1. Resource number: **5SM.1718**
- 2. Temporary resource number: **N/A**
- 3. County: **San Miguel**
- 4. City: **Telluride**
- 5. Historic Building Name: **Unknown**
- 6. Current Building Name: **Cowart House**
- 7. Building Address: **100 Block N. Townsend Street**
- 8. Owner Name and Address: **Trent E. and Janice R. Cowart
2805 Oak Trail Court #6458
Arlington, TX 76106**

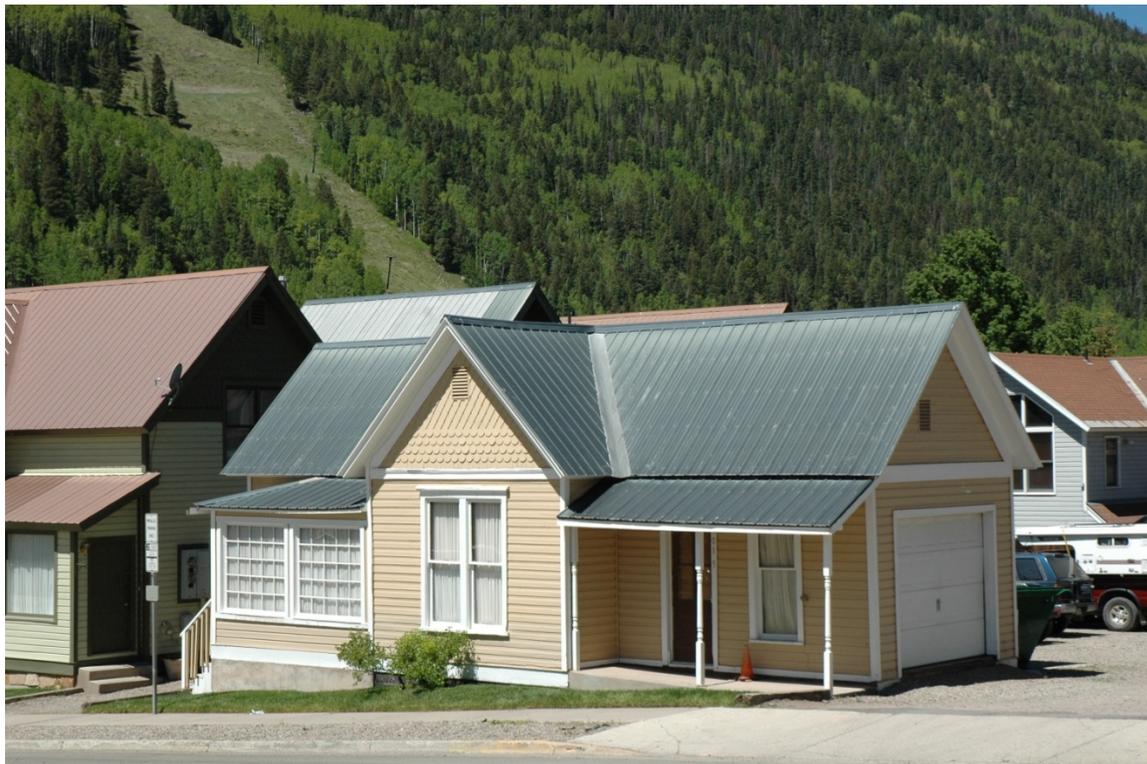
THLD RATING:

Supporting to District

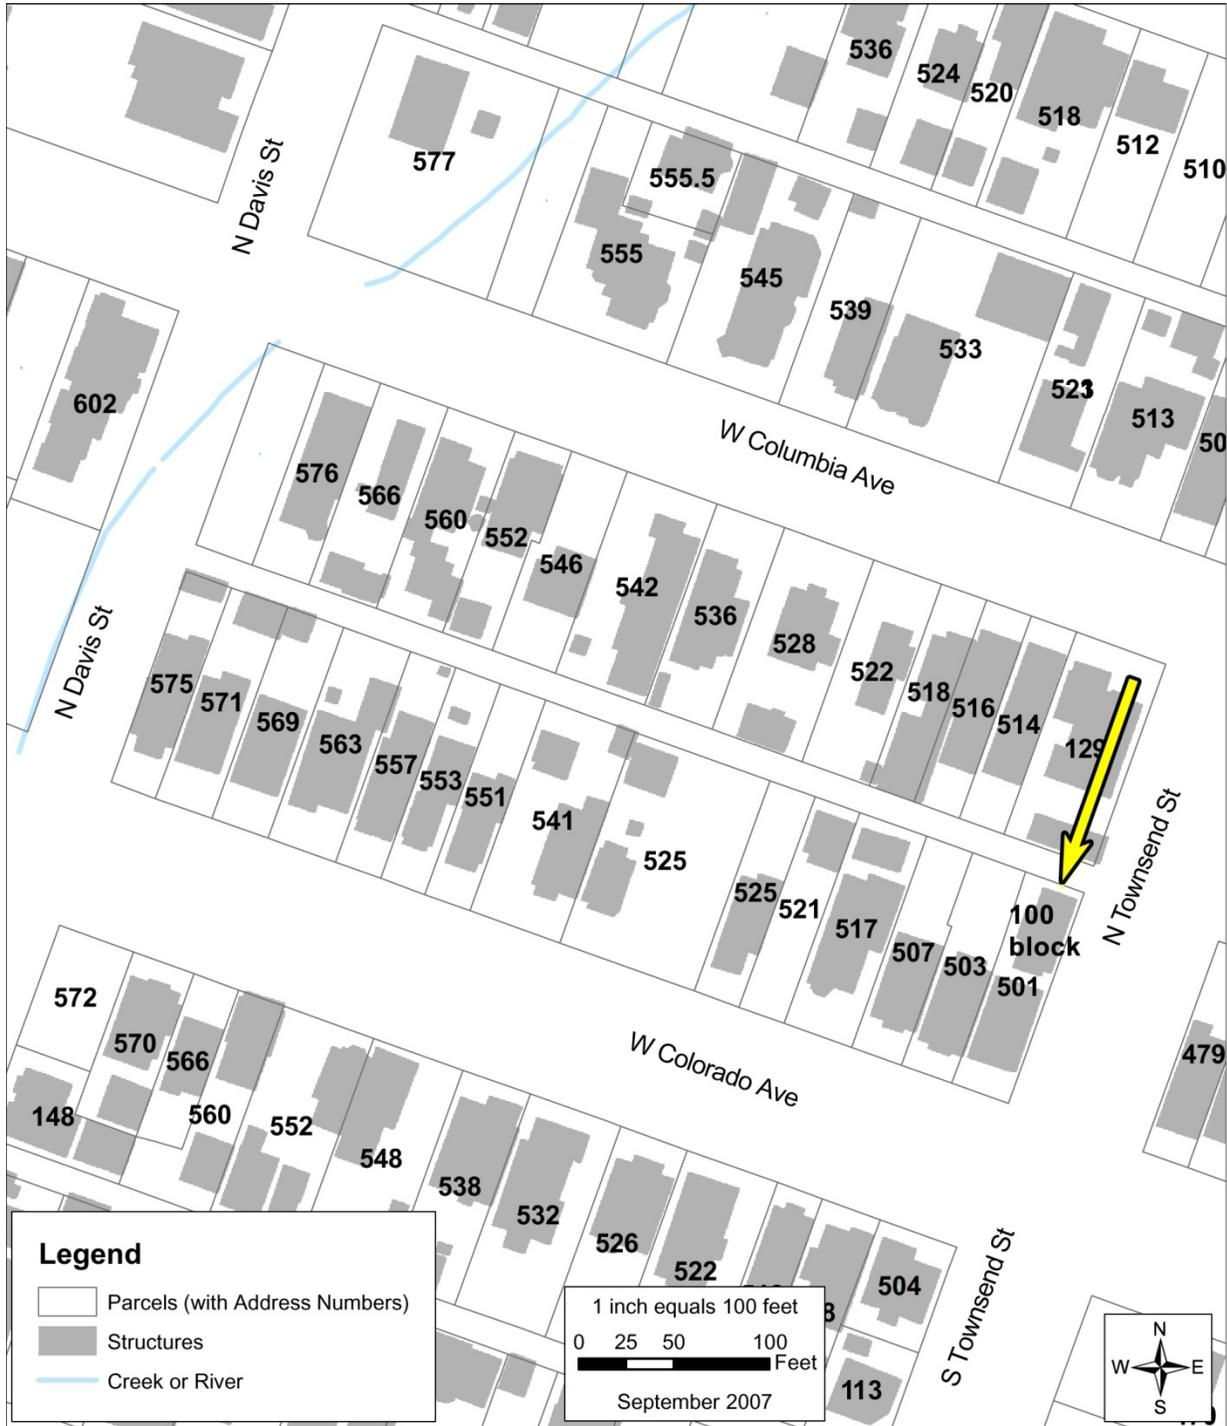
Sketch Map

This dwelling is located on the west side of Townsend Street, just south of the alley between Colorado and Columbia Avenues. There is a small planted grass front yard, and a gravel parking lot behind the dwelling to the west.
