COLORADO CULTURAL RESOURCE SURVEY

Architectural Inventory Form

- 1. Resource number: **5SM.1835**
- 2. Temporary resource number: **N/A**
- 3. County: **San Miguel**
- 4. City: **Telluride**
- 5. Historic Building Name: **Unknown**
- 6. Current Building Name: **Somerville Properties LLP Building**
- 7. Building Address: **129 N. Townsend Street**
- 8. Owner Name and Address: **Somerville Properties, LP
101 Moore Lane
Arroyo Grande, CA 93420**

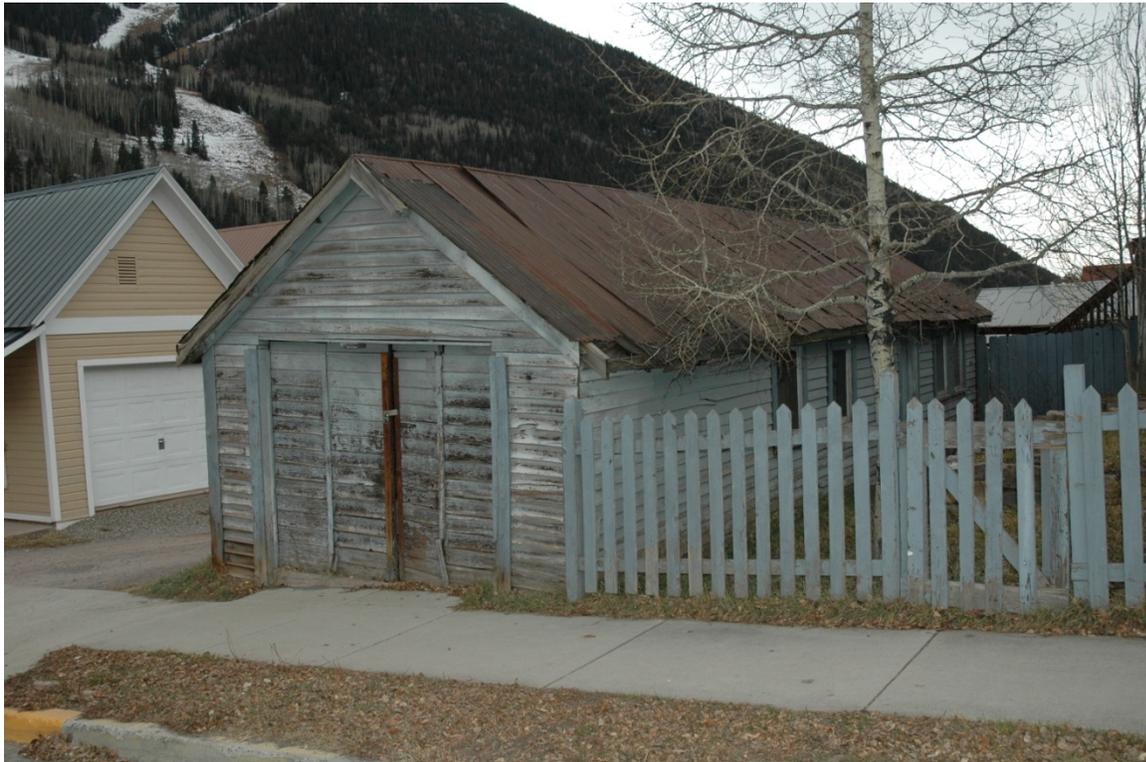
THLD RATING:	Contributing to District
---------------------	---------------------------------

18. Roof configuration: **Gabled Roof / Front Gabled Roof**
19. Primary external roof material: **Metal Roof**
20. Special features: **N/A**
21. General architectural description:
This single-story wood frame building measures approximately 14' N-S by 37' E-W. It rests on wood timbers on grade foundation, and its exterior walls are clad with painted pale blue horizontal wood siding with 1" by 4: corner boards. The front gabled roof is moderately-pitched, with metal roofing material laid over 1x wood decking and 2x wood rafters. The rafter ends are covered by a fascia board, and are exposed beneath the eaves. Two painted pale blue wood-paneled doors open toward the alley on the south elevation. A set of paired horizontal weatherboard bi-fold garage doors open toward Townsend Street on the east elevation. A painted pale blue wood-paneled door is near the west end of the north elevation. A set of paired window openings and a single window opening (with panes removed) penetrate the south elevation. A set of paired windows and two single-light windows penetrate the north elevation. All windows have painted pale blue wood surrounds.

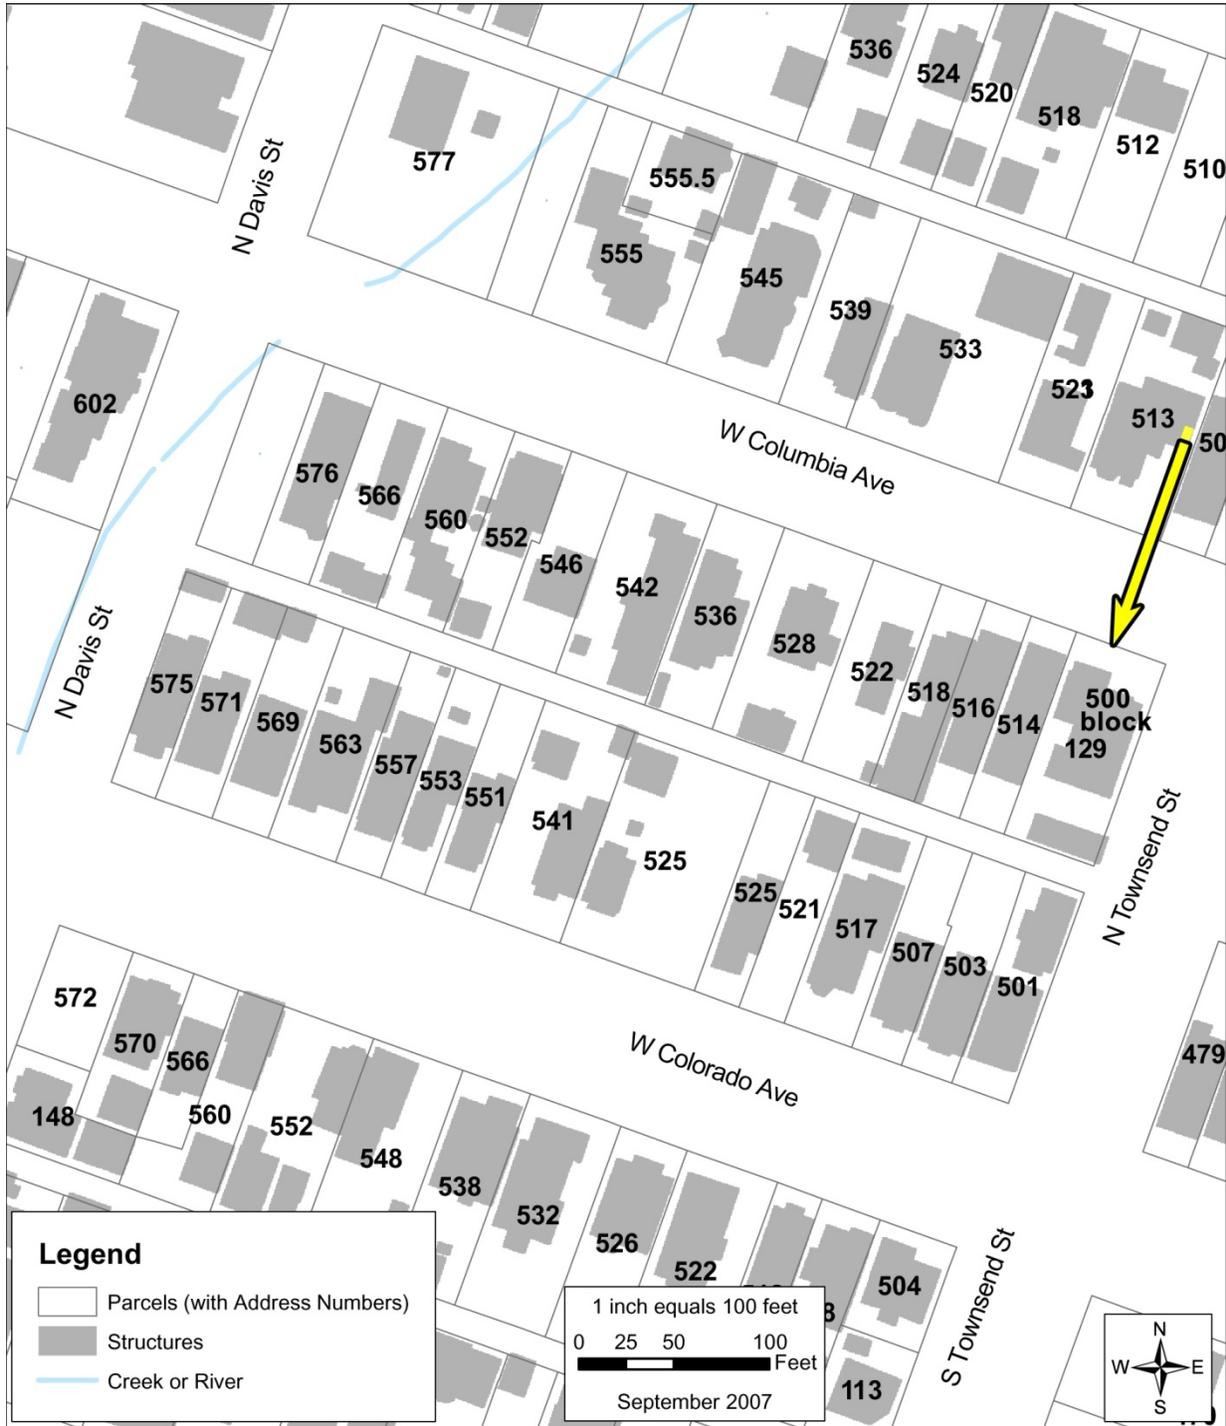
Sketch Map

This building is located on the west side of N. Townsend Street, immediately north of the alley between Colorado and Columbia Avenues.
