COLORADO CULTURAL RESOURCE SURVEY

Architectural Inventory Form

- 1. Resource number: **5SM.1736**
- 2. Temporary resource number: **N/A**
- 3. County: **San Miguel**
- 4. City: **Telluride**
- 5. Historic Building Name: **Swanson House**
- 6. Current Building Name: **McManemin House**
- 7. Building Address: **231 N Townsend St**
- 8. Owner Name and Address: **William Casey and Megan L. McManemin  
3838 Oak Lawn Avenue, Suite 425  
Dallas, TX 752194523**

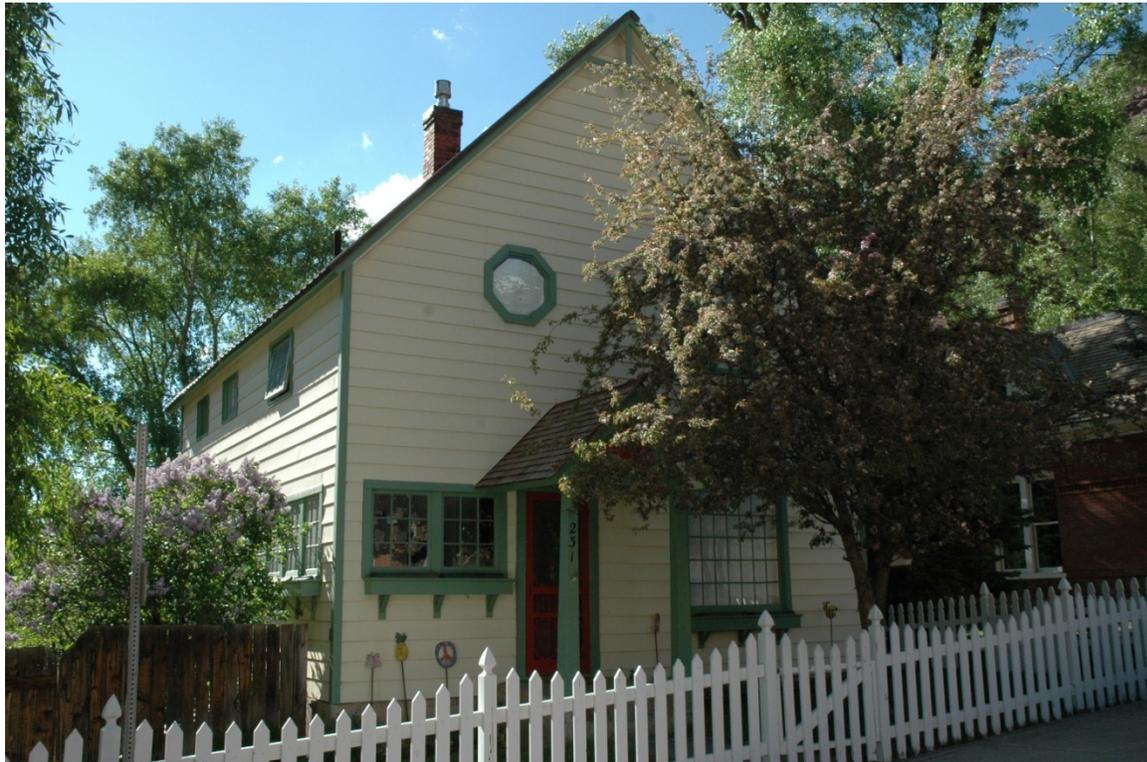
21. General architectural description:  
**This wood frame residence features a basic rectangular plan which measures 24½' N-S (across) by 41' E-W (deep). It is supported by a stacked stone foundation, and its exterior walls are clad with yellow horizontal metal siding with green 1" by 4" vertical corner pieces. The roof is a steeply-pitched front gable, with brown metal roofing material and painted yellow and green boxed eaves. A red brick chimney with a corbelled cap is located just below the ridge on the south-facing roof slope. The house's asymmetrical facade faces toward Townsend Street on the east elevation. A painted red wood-paneled door, with one upper sash light, and covered by a painted red wood screen door, enters the facade from an open front porch. This 5' by 5' porch is approached by two poured concrete steps, and features a poured concrete floor, two painted green tapered wood posts, and a gabled roof. A painted red wood-paneled door, with one upper sash light, enters the west (rear) elevation from a non-historic 6-step wooden stoop. All of the home's windows feature painted green wood frames and surrounds, and all except one have been altered from the original. A 42-light fixed-pane window, decorated with a flower box, penetrates the facade wall north of the entry porch. A set of paired 9-light windows penetrate the facade wall south of the entry porch. An octagon-shaped window and a set of paired 1/1 double-hung sash windows penetrate the facade's second story. Windows on the south elevation's first story include a hipped-roof oriel window, and a band of three 9-light windows. Three awning type windows penetrate the second story on the south elevation. The west elevation contains a 1/1 double-hung sash first story window and two 1/1 double-hung**

**sash second story windows. One large single-light fixed-pane window is located on the north elevation.**

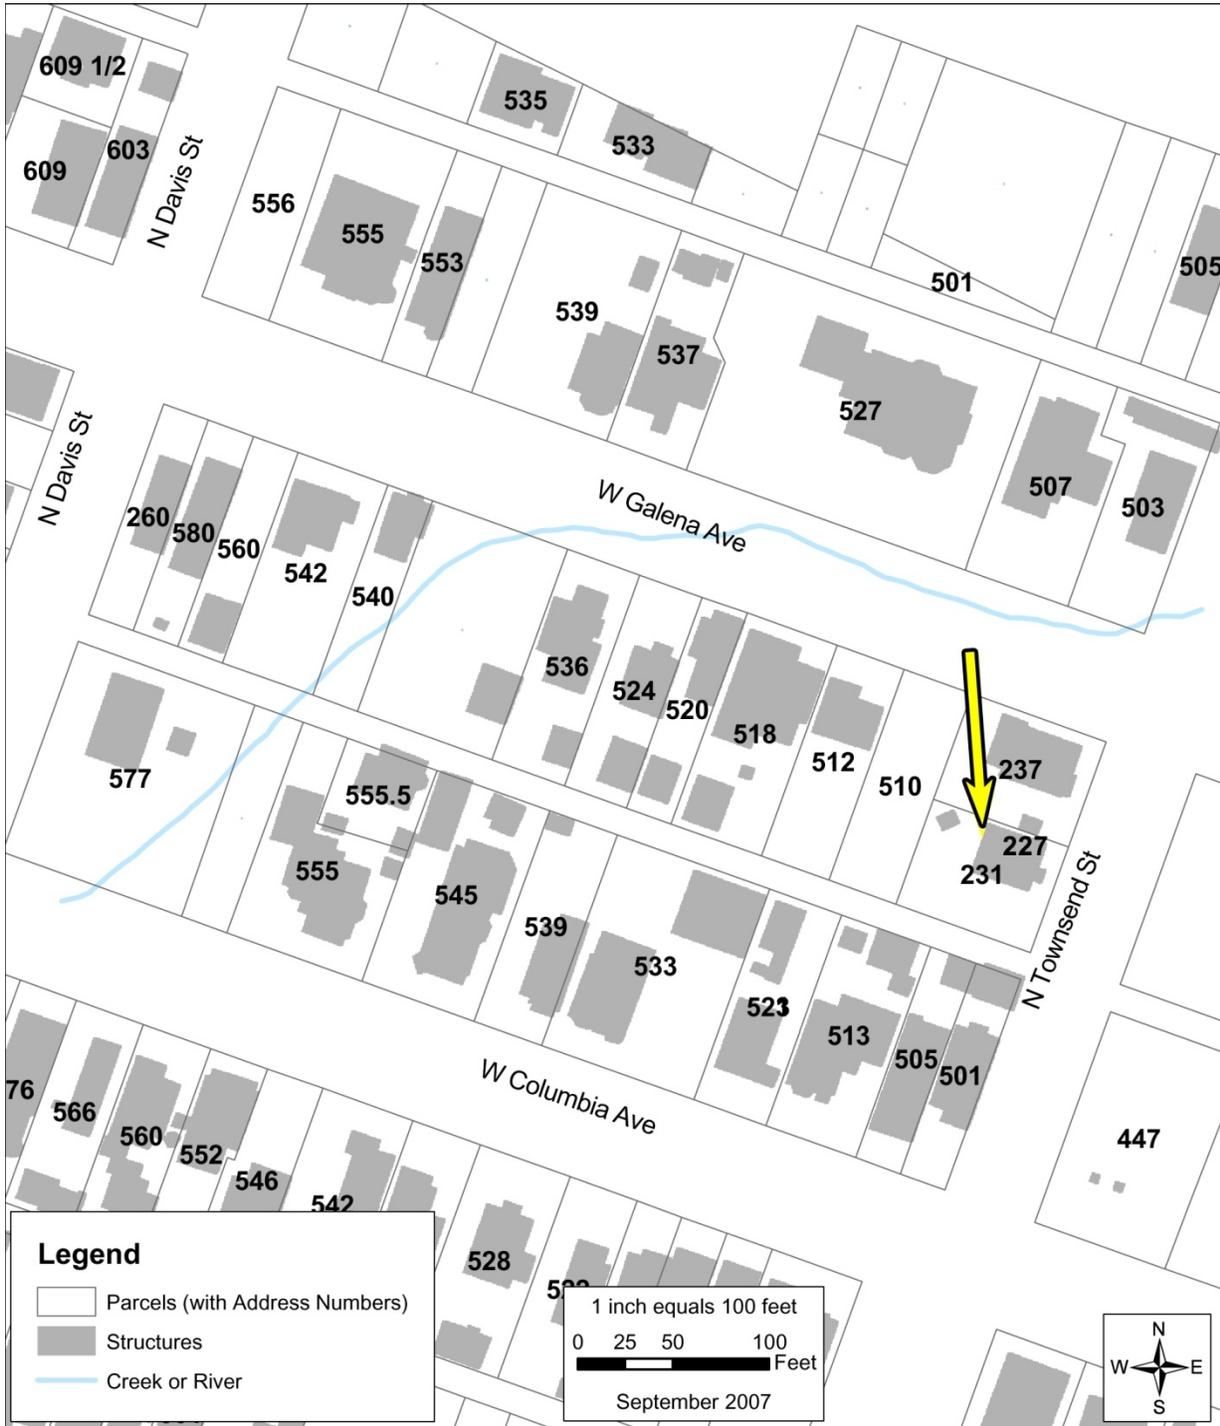
## Sketch Map

**This well-maintained property is located on the west side of N. Townsend Street, just north of the alley between Columbia and Galena Streets. A painted white picket fence encloses a nicely-landscaped yard with native plants and flowers, and aspen and willow trees.**
