COLORADO CULTURAL RESOURCE SURVEY

Architectural Inventory Form

- 1. Resource number: **5SM.1606**
- 2. Temporary resource number: **N/A**
- 3. County: **San Miguel**
- 4. City: **Telluride**
- 5. Historic Building Name: **Barn**
- 6. Current Building Name: **Town of Telluride Barn**
- 7. Building Address: **100 Block S. Willow Street**
- 8. Owner Name and Address: **Town Of Telluride
P. O. Box 397
Telluride, CO 814350397**

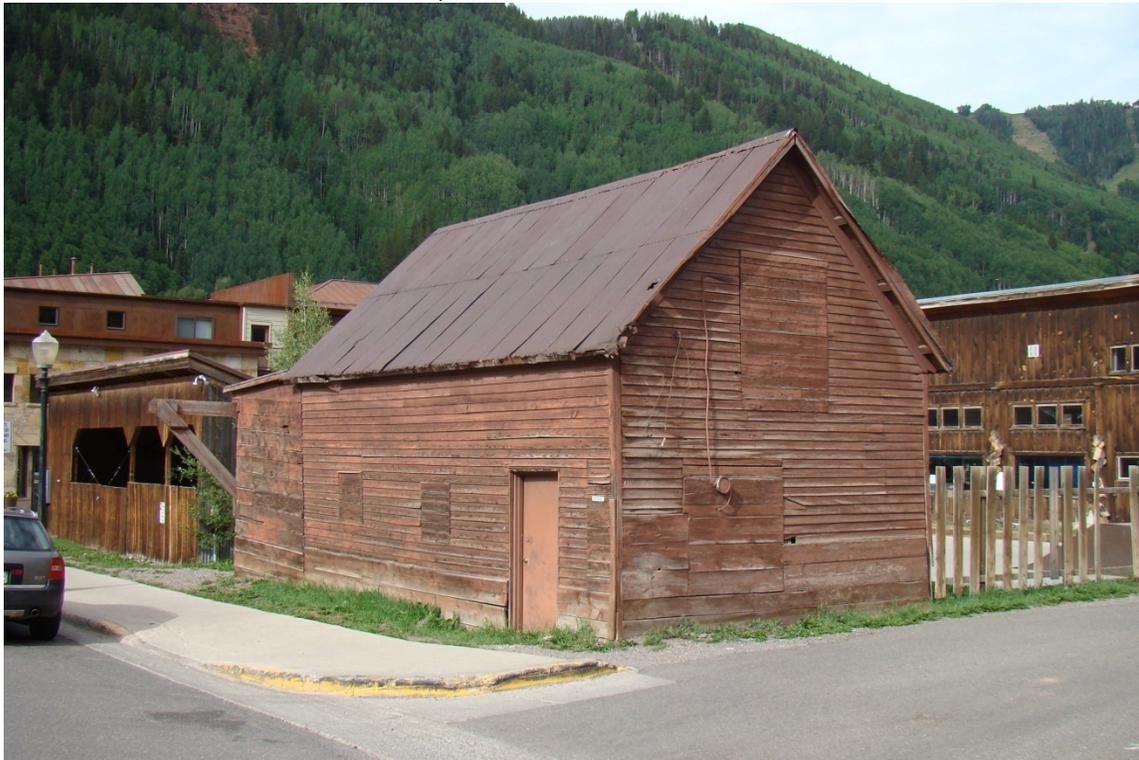
18. Roof configuration: **Gabled Roof**
19. Primary external roof material: **Metal Roof**
20. Special features:
21. General architectural description:
This historic wood frame barn consists of a main 1.5-story gable-roofed section, which measures approximately 24' N-S by 16' E-W, and a single-story shed-roofed extension to the south elevation which measures approximately 10' N-S by 16' E-W. The building is supported by a wood timbers on grade foundation, and its exterior walls are clad with painted red horizontal wood planks. The gable roof is steeply-pitched, and is covered with corrugated metal roofing material laid over 1x wood decking and 2x wood rafters. A set of paired vertical wood plank, horizontal sliding, barn doors, with their historic track hardware still intact, are located on the south elevation. A smaller vertical wood plank door, side-hinged with metal strap hinges, is set within the larger horizontal sliding doors. A non-historic metal door enters the building at the north end of the east elevation. A former hayloft opening in the north elevation's upper gable end has been covered with horizontal wood planks. A 4/1 double-hung sash window penetrates the south elevation's upper gable end.

Although it is in deteriorating condition, this building displays a high standard of physical integrity, relative to the seven aspects of integrity as defined by the National Park Service and the Colorado Historical Society, Office of Archaeology and Historic Preservation - setting, location, design, materials, workmanship, feeling and association. There have been no additions, and no apparent adverse alterations, to the historic building.

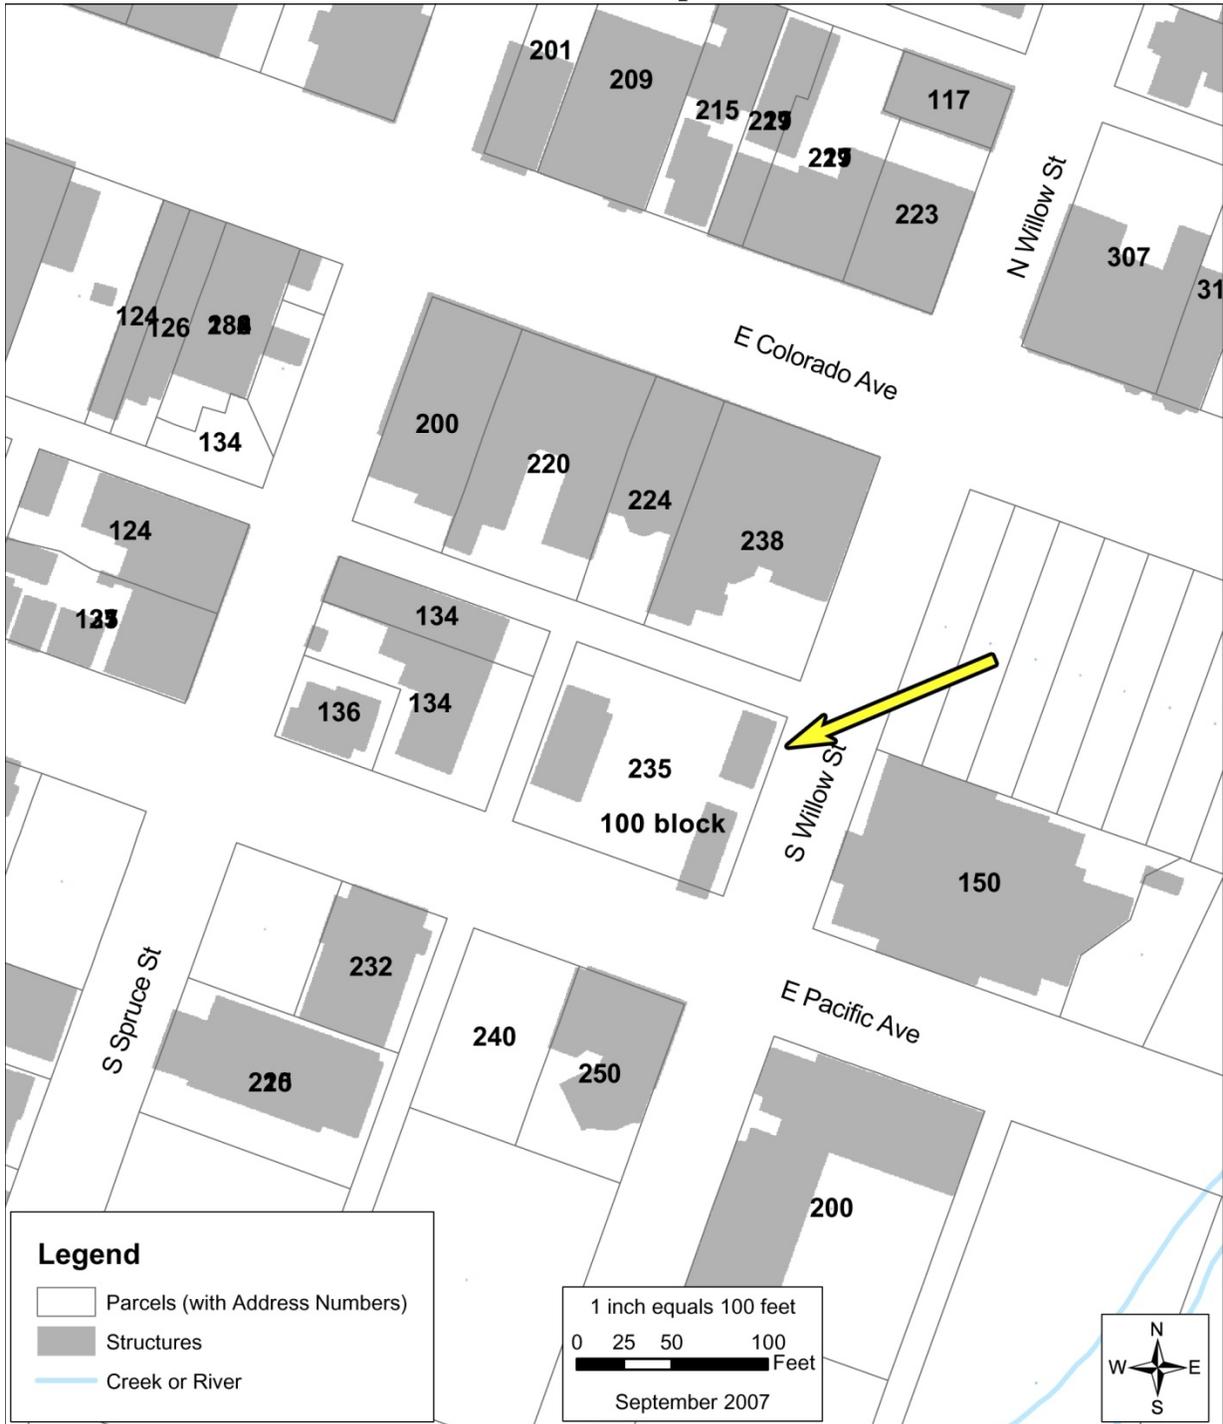
Sketch Map

Building type:
23. Landscape or special setting features: **This building is located on the west side of South Willow Street in the block between Pacific and Colorado Avenues. It is the first building south of the alley.**
