Architectural Inventory Form

- 1. Resource number: **5SM.1789**
- 2. Temporary resource number: **N/A**
- 3. County: **San Miguel**
- 4. City: **Telluride**
- 5. Historic Building Name: **N/A**
- 6. Current Building Name: **Kerr House**
- 7. Building Address: **119 N. Willow Street**
- 8. Owner Name and Address: **Robert Graham Kerr  
P. O. Box 683  
Telluride, CO 814350683**

47. Photograph number(s):	<b>CD #5, Images 305-309</b>	CDs filed at:	<b>Town of Telluride</b>
48. Report title:	<b>Town of Telluride Re-Survey of Historic Structures</b>		<b>Planning and Building Department</b>
49. Date(s):	<b>June 1, 2011</b>		<b>113 West Columbia Avenue</b>
50. Recorder(s):	<b>Carl McWilliams Timothy Wilder</b>		<b>Telluride, CO 81435</b>
51. Organization:	<b>Cultural Resource Historians</b>		
52. Address:	<b>Dogwood Court Fort Collins, CO 80525</b>		
53. Phone number(s):	<b>(970) 493-5270</b>

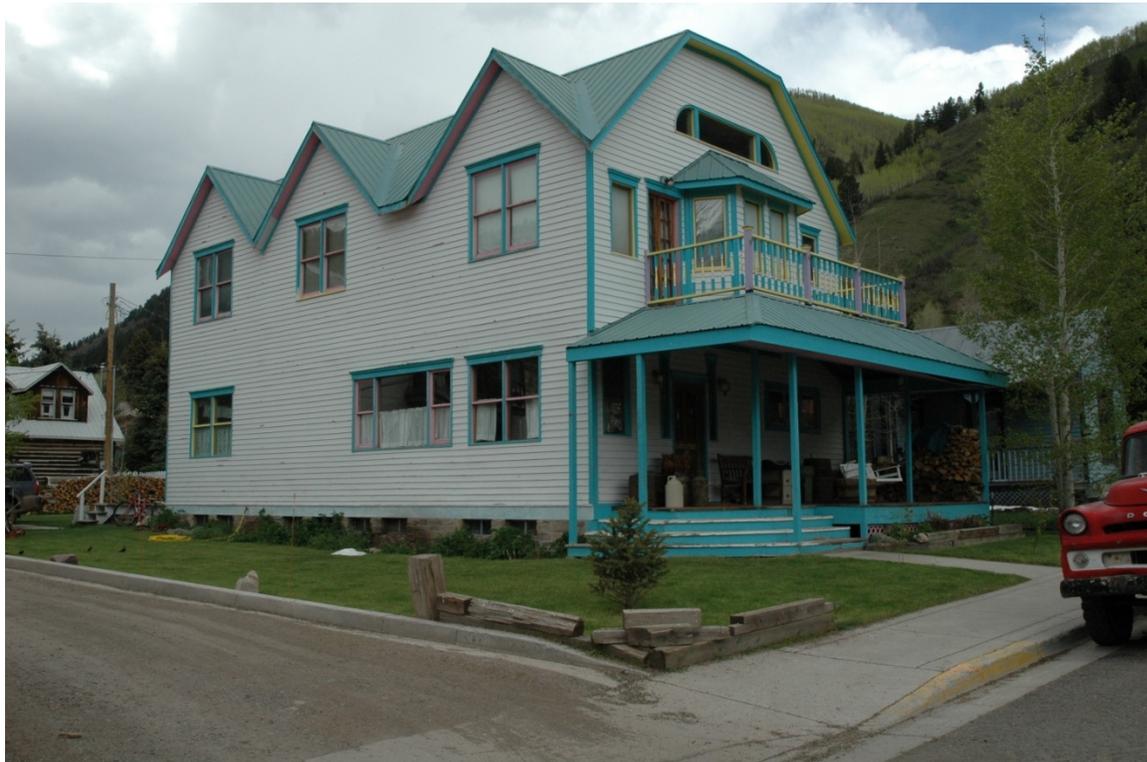
**This 2½-story wood frame residence features a rectangular plan which measures 26½' N-S (across) by 45½' E-W (deep). It is supported by a poured concrete foundation, faced with stone, and its exterior walls are clad with painted white horizontal wood siding, with painted turquoise 1" by 4" corner boards. The roof is a steeply-pitched truncated front gable, with green metal roofing material and painted turquoise boxed eaves. Three intersecting gables, each with a set of paired 1/1 double-hung sash windows, are on the south elevation. One intersecting gable, with a set of paired 1/1 double-hung sash windows, is near the west end of the north elevation. A red brick chimney is also on the north elevation. The building's facade faces Willow Street on the east elevation. A stained natural brown wood-paneled front door, with two leaded glass upper sash lights, and with slender sidelights, enters the facade from a full-width open front porch. The porch is approached by three wood steps, and features a tongue-in-groove wood floor, painted turquoise 4" by 4" wood posts, and a truncated hipped roof. The porch roof serves as a second story porch which is enclosed by an open wood railing with turned balusters. A set of paired, narrow, 10-light glass-in-wood-frame doors open onto the second story porch adjacent to a canted hipped-roof second story bay with four single-light windows. A set of paired, stained natural brown, 15-light, glass-in-wood-frame doors enter the west elevation from an uncovered wood deck on the west elevation. Windows consist of single-light fixed-panes, casements, and 1/1 double-hung sash, with painted turquoise wood surrounds.**

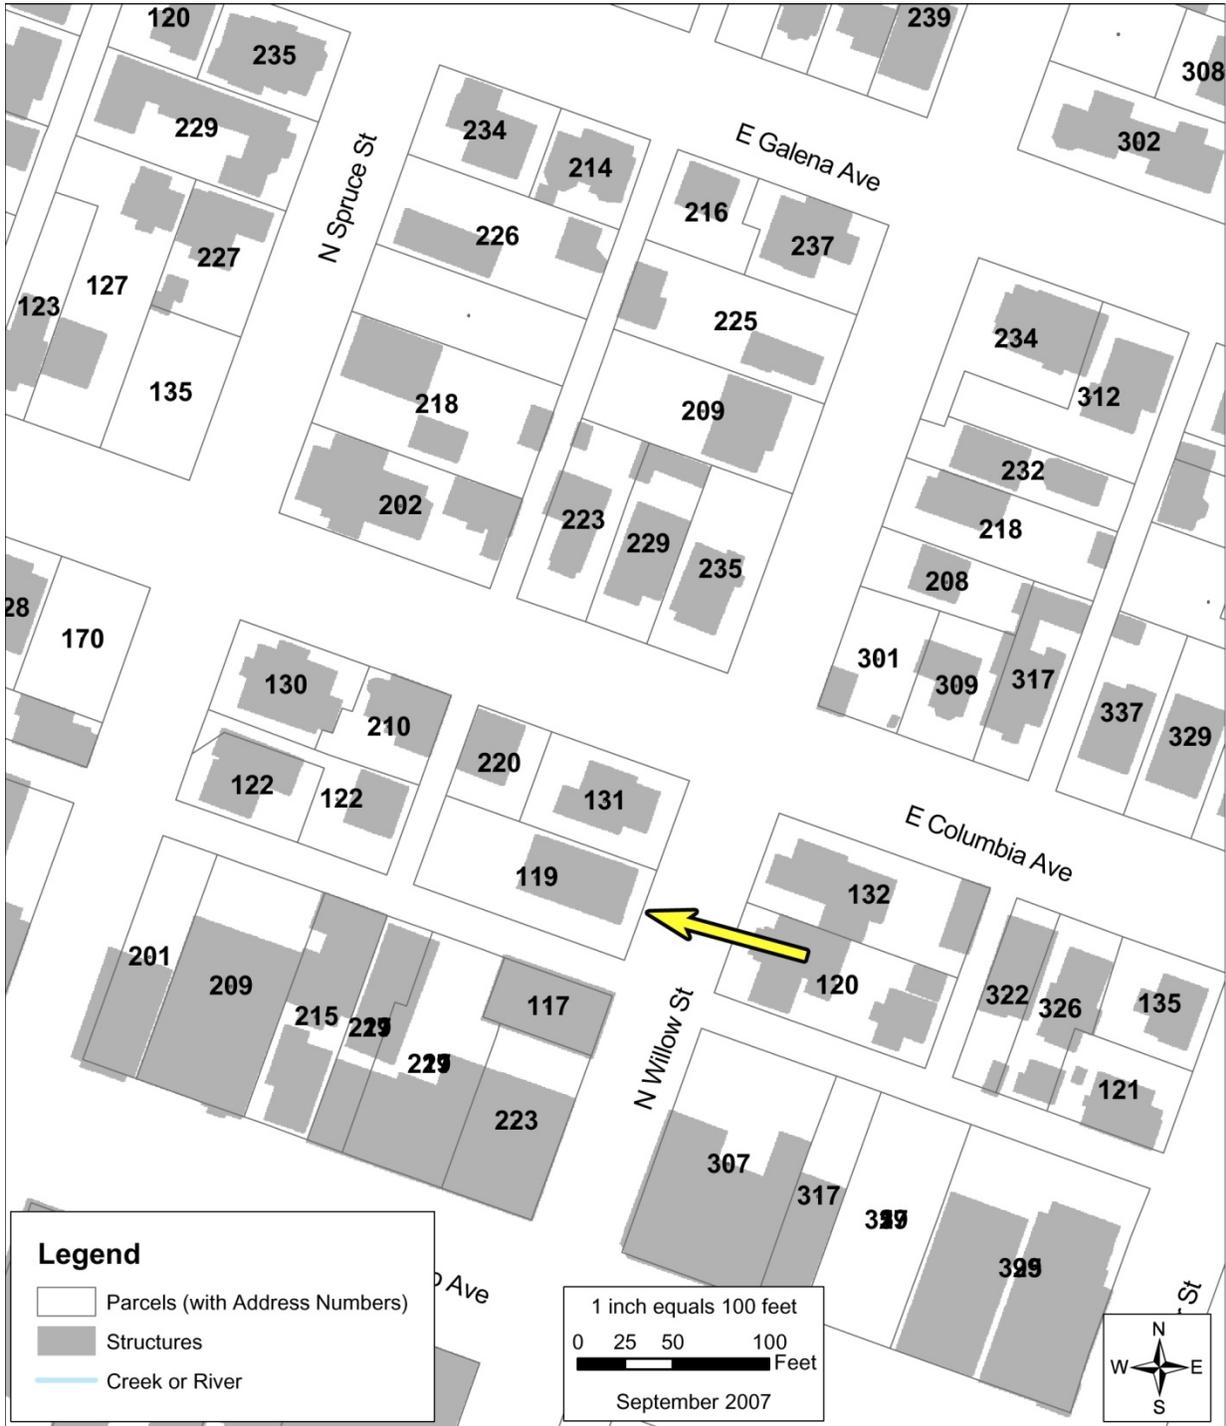
## Sketch Map

**This well-maintained property is located on the west side of Willow Street, just north of the alley between Columbia and Colorado Avenues. A planted grass lawn displays mature landscaping features including twin aspen trees in the front yard.**
