COLORADO CULTURAL RESOURCE SURVEY

Architectural Inventory Form

- 1. Resource number: **5SM.1787/THAS.131**
- 2. Temporary resource no.: **N/A**
- 3. County: **San Miguel**
- 4. City: **Telluride**
- 5. Historic Building Name: **Glenn House**
- 6. Current Building Name: **120 N. Willow Street LLC Building**
- 7. Building Address: **120 N. Willow Street**
- 8. Owner Name and Address: **120 N. Willow Street LLC, , 1711 Laurel St, South Pasadena, CA 91030**
120 N. Willow Street LLC, P. O. Box 3683, Telluride, CO 81435

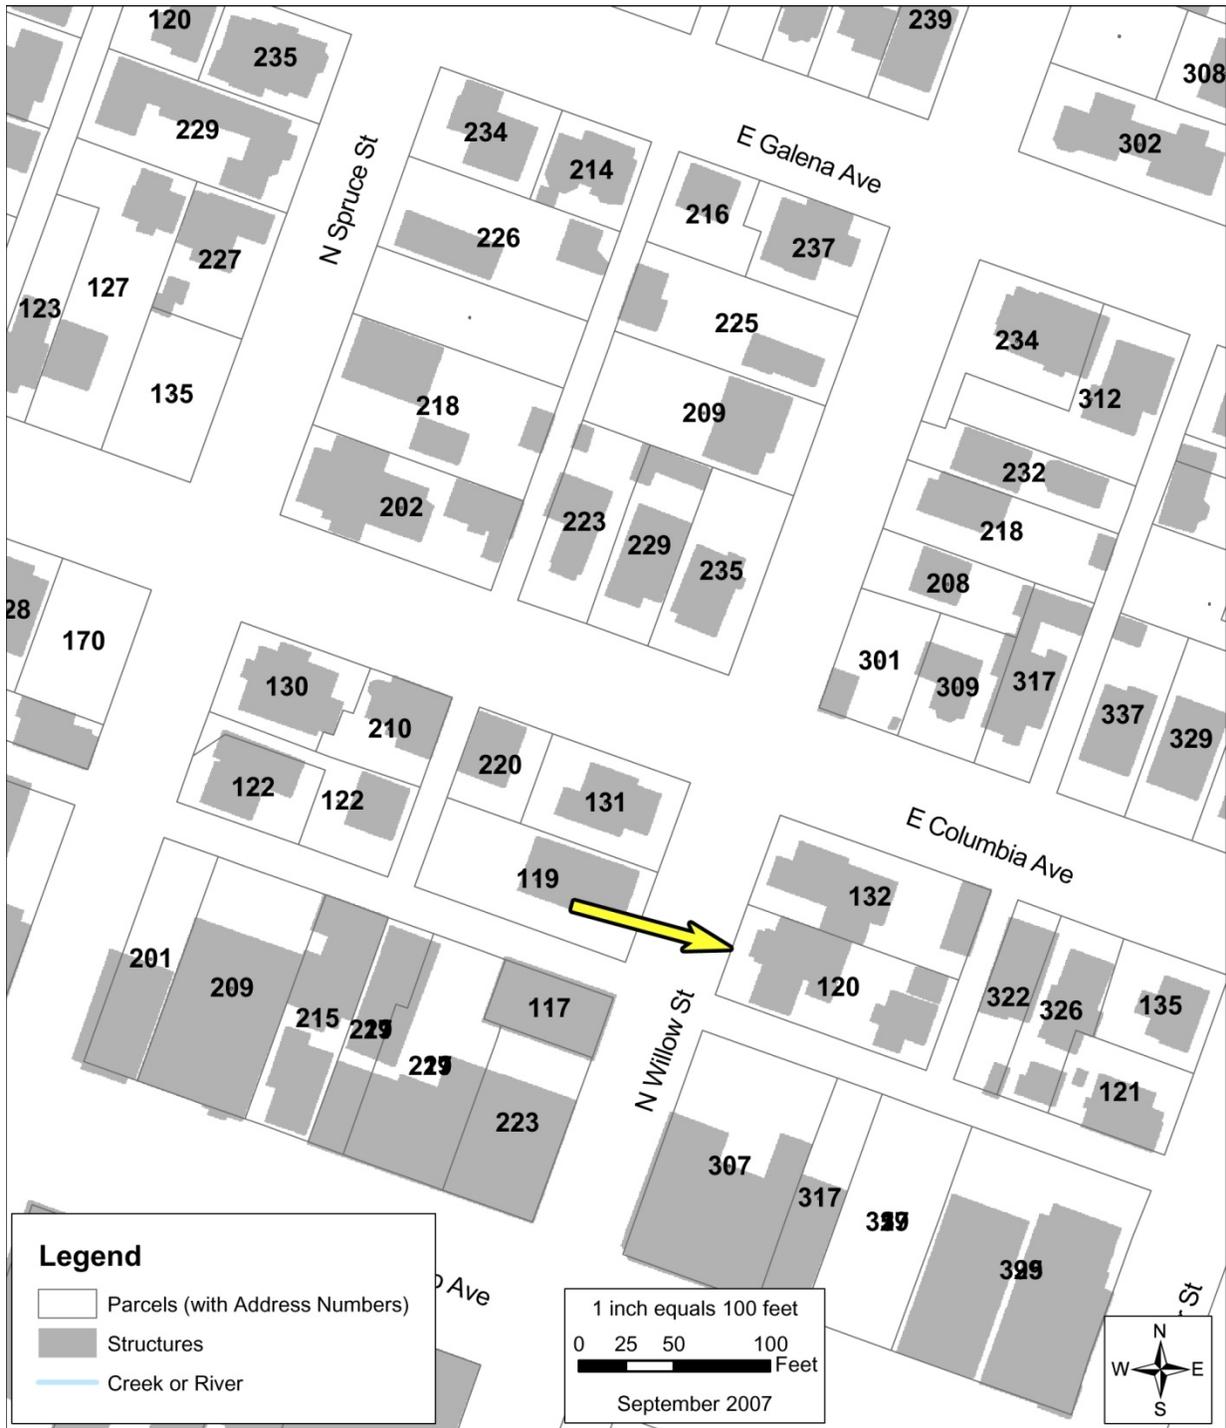
Sketch Map

This property is located on the east side of Willow Street, immediately north of the alley between Colorado and Columbia Avenues. Improvements on the property include two residences (units A and B), and a historic shed (THAS #131). The planted grass front yard, with twin aspen trees and a spruce tree, is enclosed by a painted white picket fence. The back yard is enclosed by a wood privacy fence.

Secondary Residence (Unit B, 120½ N. Willow Street)
A secondary residence is located near the rear southeast corner of the property. This building is supported by a low poured concrete foundation which is faced with stone. Its exterior walls are clad with painted grey horizontal wood siding, with painted white 1" by 4" corner boards, and with painted grey fish scale shingles in the upper gable ends. The roof is a steeply-pitched cross gable, with metal roofing material and boxed eaves. A painted white glass-in-wood-frame door enters the south elevation from a shed-roofed porch with a wood plank floor. The secondary residence was constructed with an attached garage at the south end; however, this part of the building has been converted into living space and is no longer a garage. Windows are primarily 1/1 double-hung sash and small 1x1 horizontal sliders, with painted white wood frames and surrounds..

Shed (THAS #131)
A historic shed (THAS #131) is located at the rear northeast corner of the property. This 1½-story wood frame structure measures approximately 12' N-S by 20' E-W. Its exterior walls are clad with rusted corrugated metal, except for the north elevation which is clad with board and batten. The roof is a steeply-pitched gable, with corrugated metal roofing material and closed eaves. Non-historic skylights are on the north and south-facing roof slopes. A painted brown wood-paneled door, with one upper sash light, enters the east elevation from an uncovered 3-step wood stoop. The east elevation is also penetrated by a single-light window. A band of multi-paned windows penetrate the west elevation. The upper gable ends are penetrated by 4-light windows.
