COLORADO CULTURAL RESOURCE SURVEY

Architectural Inventory Form

- 1. Resource number: **5SM.1794**
- 2. Temporary resource number: **N/A**
- 3. County: **San Miguel**
- 4. City: **Telluride**
- 5. Historic Building Name: **Unknown**
- 6. Current Building Name: **Kritikos House**
- 7. Building Address: **208 N. Willow Street**
- 8. Owner Name and Address: **Jacqueline Kritikos
P. O. Box 421
Ridgway, CO 814320421**

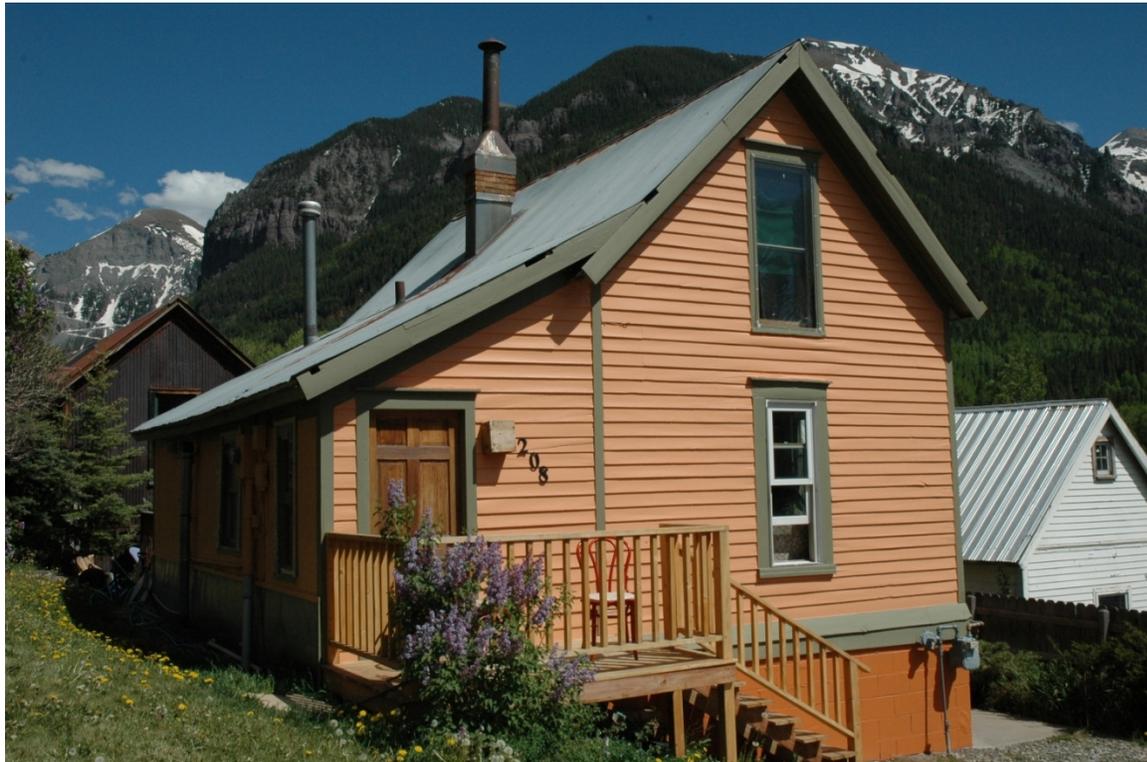
18. Roof configuration: **Gabled Roof / Front Gabled Roof**
19. Primary external roof material: **Metal Roof**
20. Special features: **Porch, Chimney**
21. General architectural description:
This dwelling consists of a main 1½-story front gabled section, which measures 20' N-S (across) by 24' E-W (deep), and a shed-roofed extension to the north elevation, which measures 8' N-S by 24' E-W. The house is supported by a concrete block foundation which is painted a dark salmon color. The exterior walls are clad with painted salmon color horizontal wood siding, with painted green 1" by 4' corner boards. The front gabled roof and its shed roof extension are covered with metal roofing material, and the eaves are boxed with painted green wood trim. A brown brick chimney, with a metal cap and stovepipe flue, is on the north-facing roof slope. The home's asymmetrical facade faces Willow Street on the west elevation. A stained brown wood-paneled door enters the north end of the facade from an 8-step uncovered front porch which measures 8' N-S by 5' E-W. The porch consists of a wood plank floor and an open wood railing. A stained brown glass-in-wood-frame door enters the east (rear) elevation from an uncovered wood deck which measures 20' N-S by 7' E-W. Windows are primarily 1/1 double-hung sash with painted green wood surrounds; however, a non-historic 2-light window with a silver metal frame penetrates the east elevation's upper gable end.

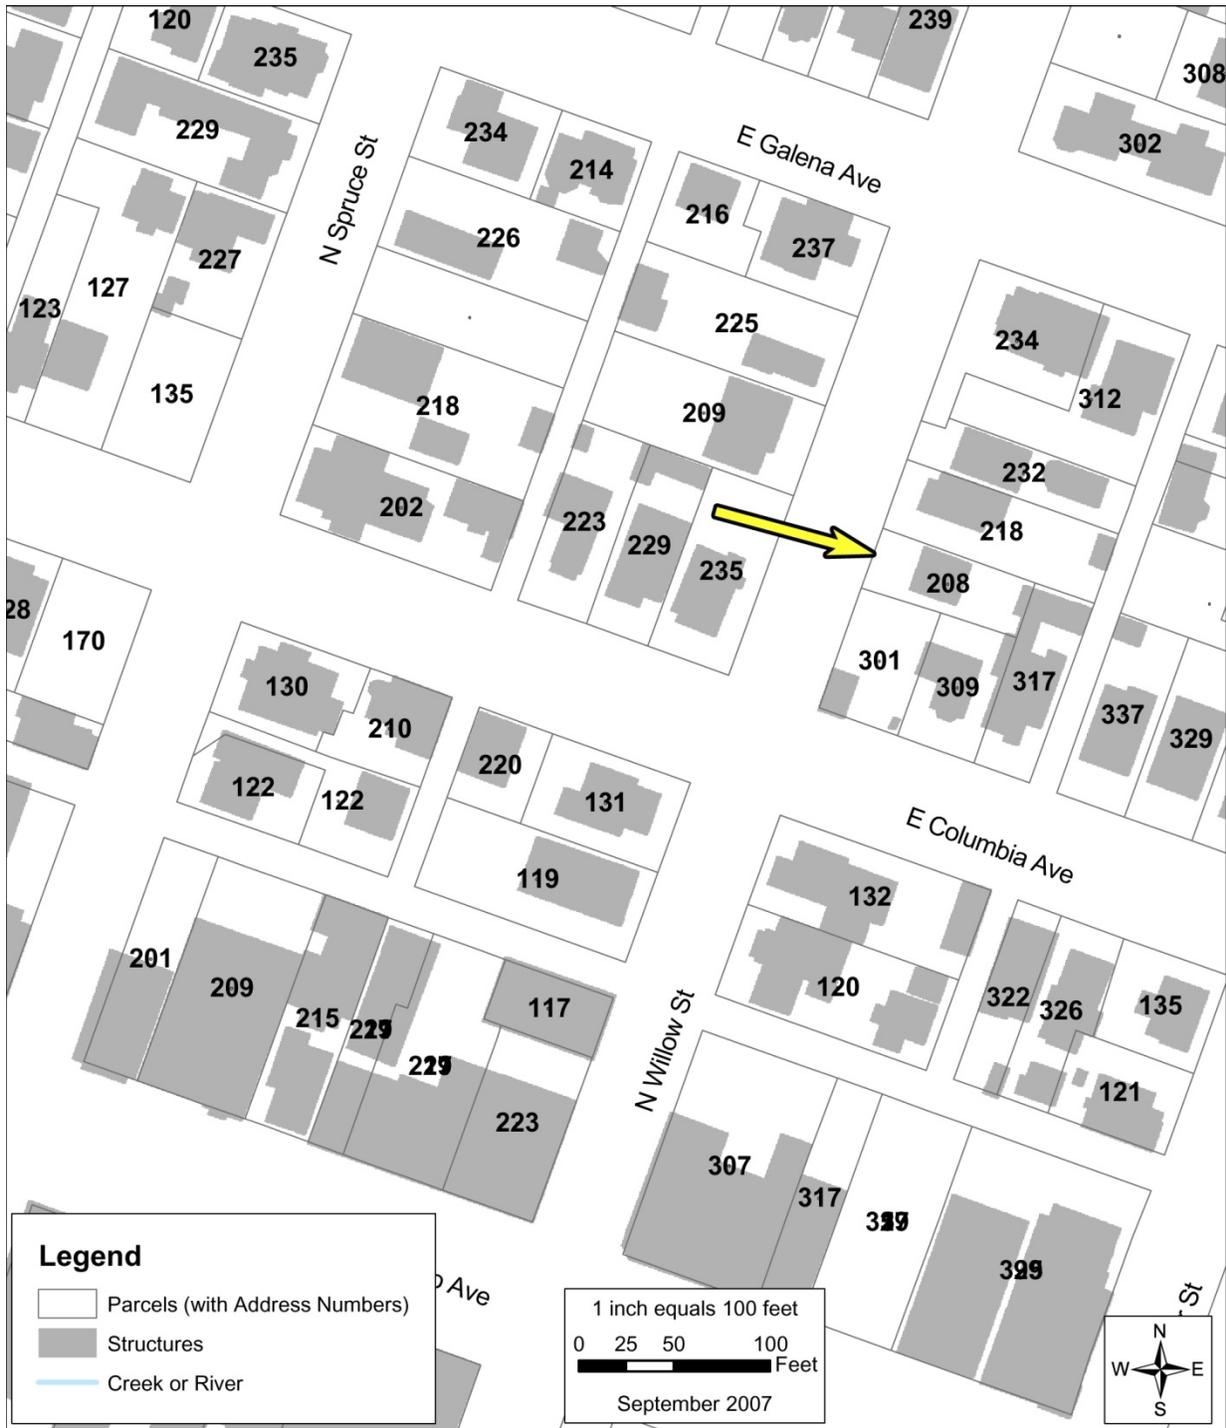
Sketch Map

This dwelling is located on the east side of Willow Street in the block north of Columbia Avenue. A gravel parking lot is between the street and the dwelling. A narrow planted grass side yard is to the north.
