COLORADO CULTURAL RESOURCE SURVEY

Architectural Inventory Form

- 1. Resource number: **5SM.1793/THAS.137**
- 2. Temporary resource number: **N/A**
- 3. County: **San Miguel**
- 4. City: **Telluride**
- 5. Historic Building Name: **McLellan House**
- 6. Current Building Name: **Pitts House**
- 7. Building Address: **218 N. Willow Street**
- 8. Owner Name and Address: **Peter Pitts
P. .O Box 564
Telluride, CO 814350564**

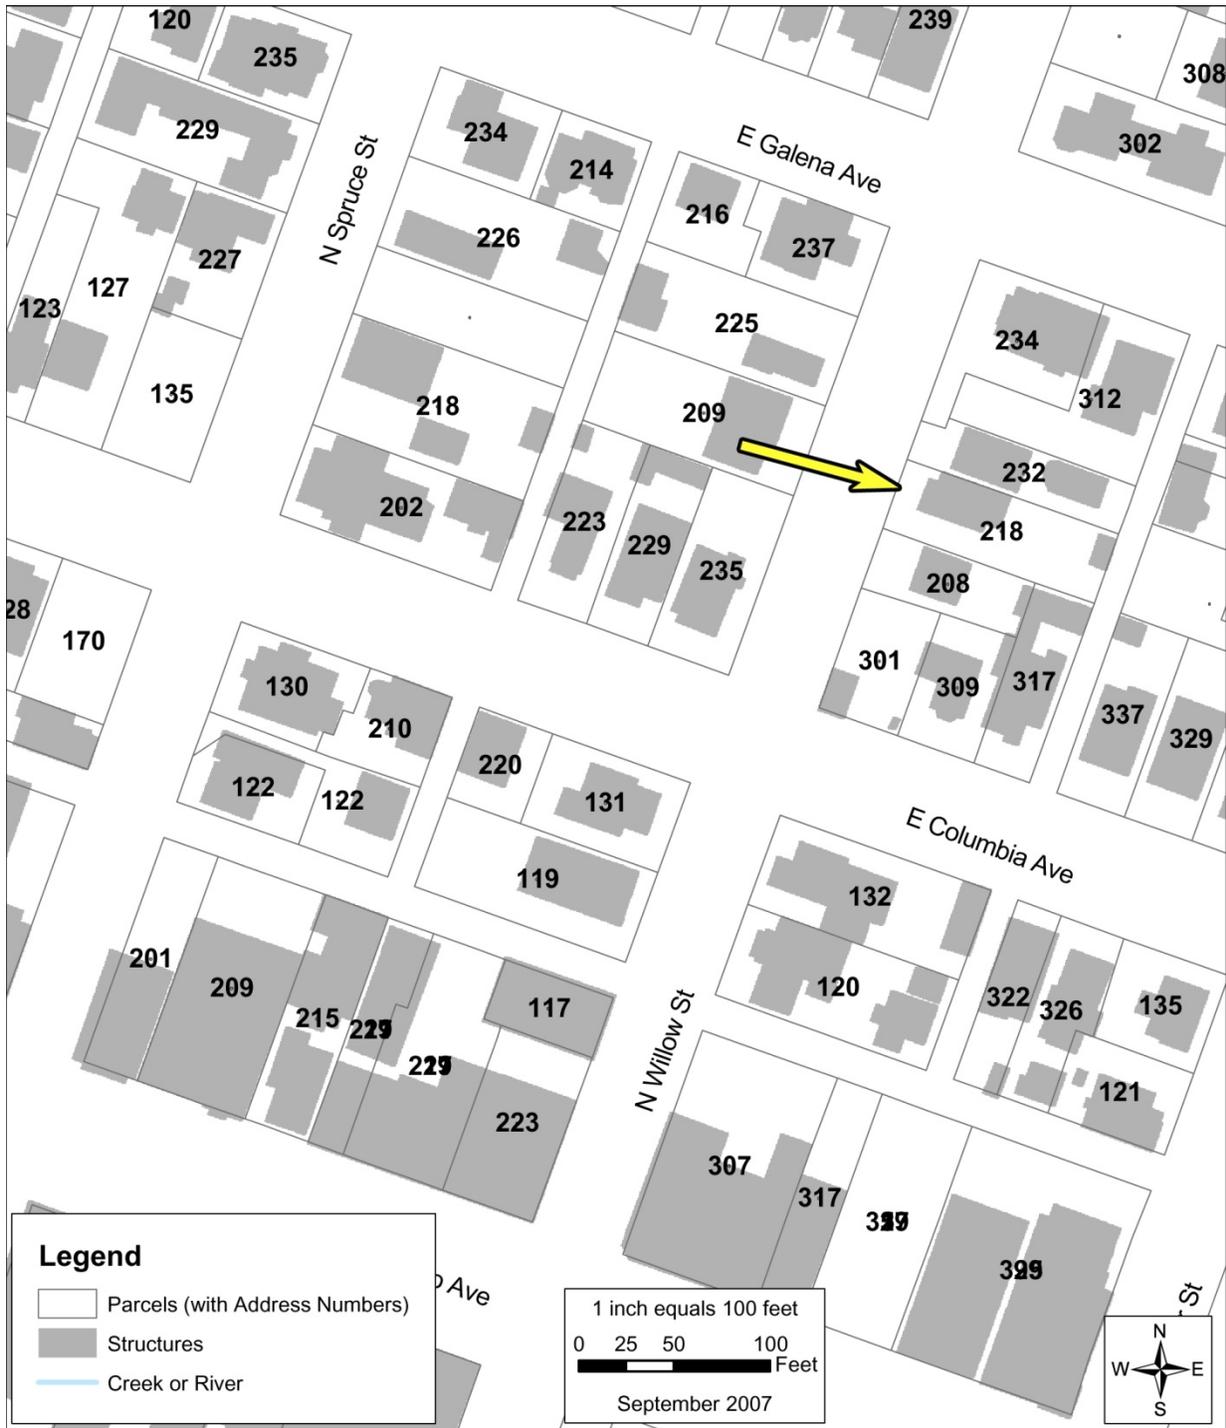
Sketch Map

A shed (THAS #137) is located adjacent to the alley at the rear east end of the property. This single-story wood frame structure measures 16' N-S by 9' E-W. It is supported by a low stone foundation, and its exterior walls are made of board-and-batten. It is covered by a shed roof, with corrugated metal roofing material laid over 1x wood decking. A vertical wood plank door enters the south end of the west elevation. A window opening near the north end of the east elevation is covered by a horizontal wood plank shutter, side-hinged with metal strap hinges. A metal-covered window opening is on the west elevation.
