COLORADO CULTURAL RESOURCE SURVEY

Architectural Inventory Form

- 1. Resource number: **5SM.1791/THAS.123**
- 2. Temporary resource number: **N/A**
- 3. County: **San Miguel**
- 4. City: **Telluride**
- 5. Historic Building Name: **Calhoun House**
- 6. Current Building Name: **Smith House**
- 7. Building Address: **225 N. Willow Street**
- 8. Owner Name and Address: **Smith Mark and Linda 2003 Trust Dated Fe  
P. O. Box 622  
Rancho Santa Fe, CA 92607**

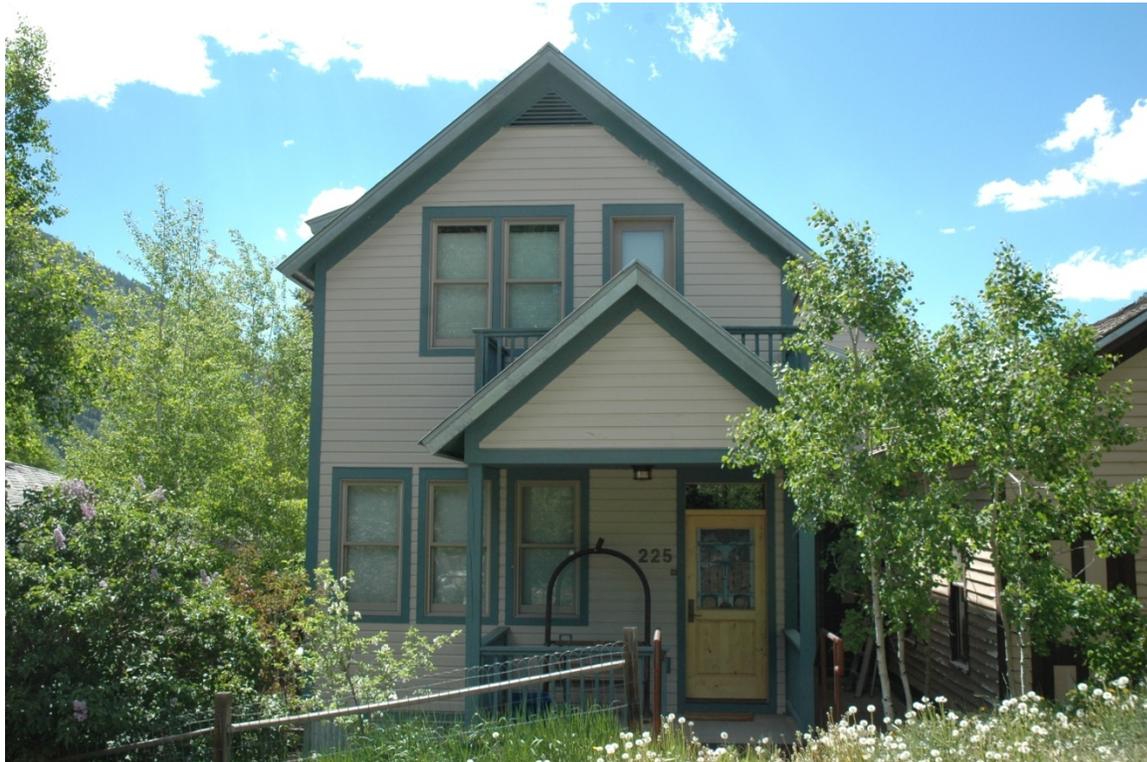
**THLD RATING: Primary - Noncontributing Without Qualifications  
Garage/Secondary Residence - Noncontributing Without Qualifications**
