COLORADO CULTURAL RESOURCE SURVEY

Architectural Inventory Form

- 1. Resource number: **5SM.1817**
- 2. Temporary resource number: **N/A**
- 3. County: **San Miguel**
- 4. City: **Telluride**
- 5. Historic Building Name: **Shaw House**
- 6. Current Building Name: **North Willow LLC House**
- 7. Building Address: **302 N. Willow Street**
- 8. Owner Name and Address: **North Willow LLC  
5100 North Bay Road  
Miami Beach, FL 33140**

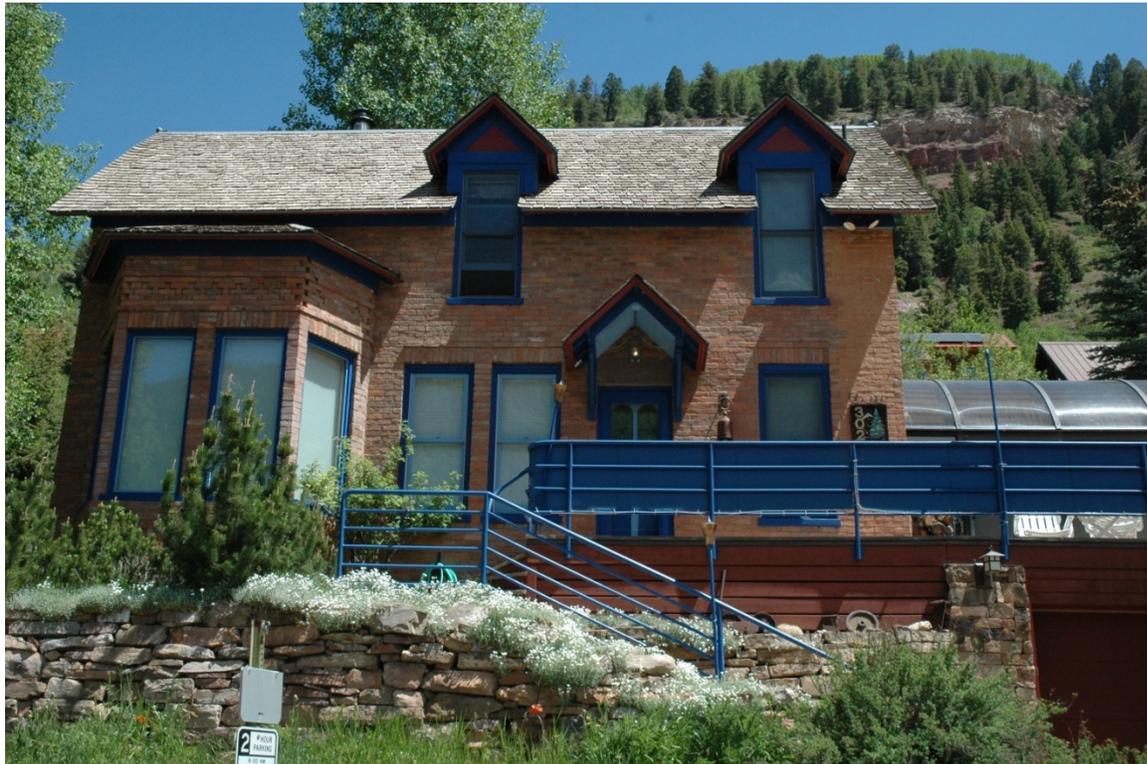
21. General architectural description:  
**This residence consists of a late nineteenth century brick dwelling, with multiple large additions and alterations, primarily to the east elevation, which date from the early 1990s. The residence's original brick portion measures approximately 16' N-S by 32' E-W, with a prominent canted bay window near the west end of the south elevation. The red brick walls are laid in running bond, while painted red diamond-shaped wood shingles appear in the upper gable ends on the east and west elevations. The original house is covered by a steeply-pitched front gable roof, with wood shingles and painted green boxed eaves. Two gabled wall dormers, each with a 1/1 double-hung sash window with painted blue wood frames and surrounds, are located on the south elevation. A painted blue glass-in-wood-frame door enters the original west elevation from a small uncovered porch. Windows include some original 1/1 double-hung sash, along with non-historic, vertically-oriented, single-light windows. The current primary entry is on the original south elevation. Here, a painted light blue with red trim wood-paneled door, with two vertically-oriented upper sash lights, and covered by a wood storm door, enters the house from a wood porch/deck. The deck extends east above a walkout basement-level garage which is incorporated into the addition. The main level of the large addition has painted cream white horizontal wood siding with painted blue 1" by 4" corner boards. The addition is covered by a steeply-pitched gabled roof, with a large intersecting gable on the south elevation. The roof is covered with wood shingles, and the eaves are boxed with painted blue wood trim**

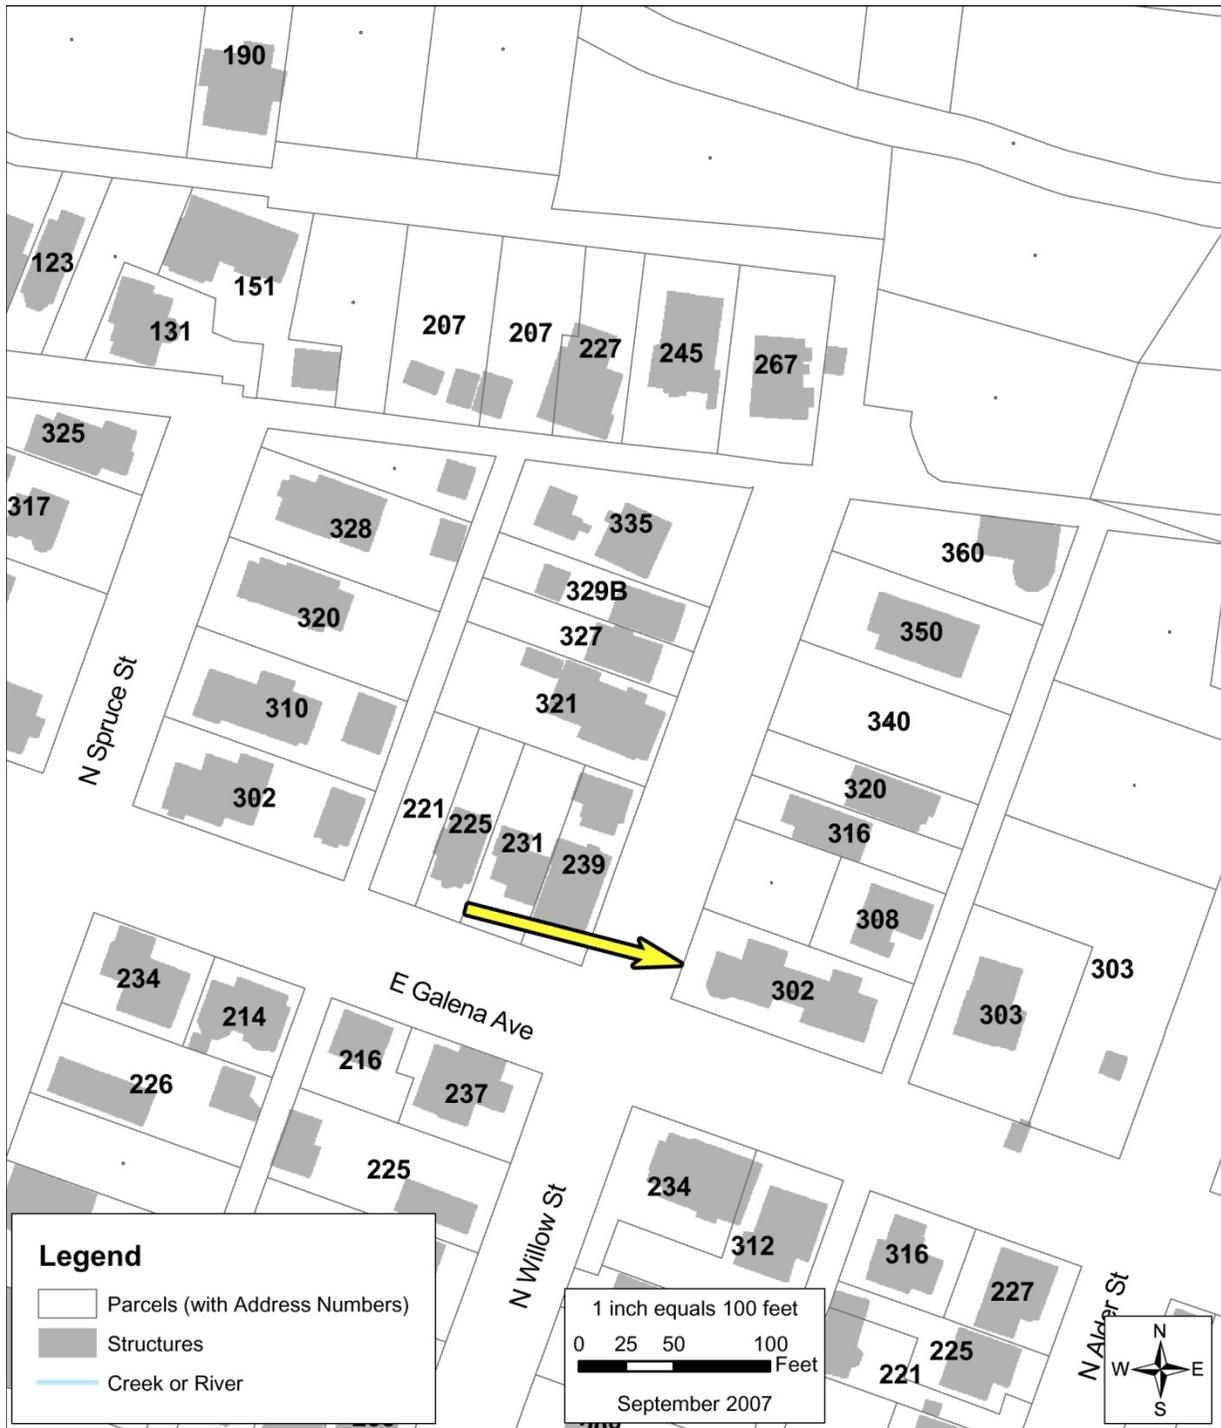
## Sketch Map

**This well-maintained property is located at the northeast corner of Willow Street and Galena Avenue. The grounds are nicely landscaped with stone terracing, low native plants, flowers and shrubs, and with aspen and spruce trees. An open wood fence encloses the back yard.**
