COLORADO CULTURAL RESOURCE SURVEY

Architectural Inventory Form

- Date _____ Initials _____
- Determined Eligible – National Register
- Determined Not Eligible – National Register
- Determined Eligible – State Register
- Determine Not Eligible – State Register
- Need Data
- Contributes to eligible National Register District
- Noncontributing to eligible National Register District

- 1. Resource number: **5SM.1820/THAS.119**
- 2. Temporary resource number: **N/A**
- 3. County: **San Miguel**
- 4. City: **Telluride**
- 5. Historic Building Name: **Burcaw House**
- 6. Current Building Name: **Willow Street LLC House**
- 7. Building Address: **335 N. Willow Street**
- 8. Owner Name and Address: **Willow Street LLC
P. O. Box 3515
Telluride, CO 81435**

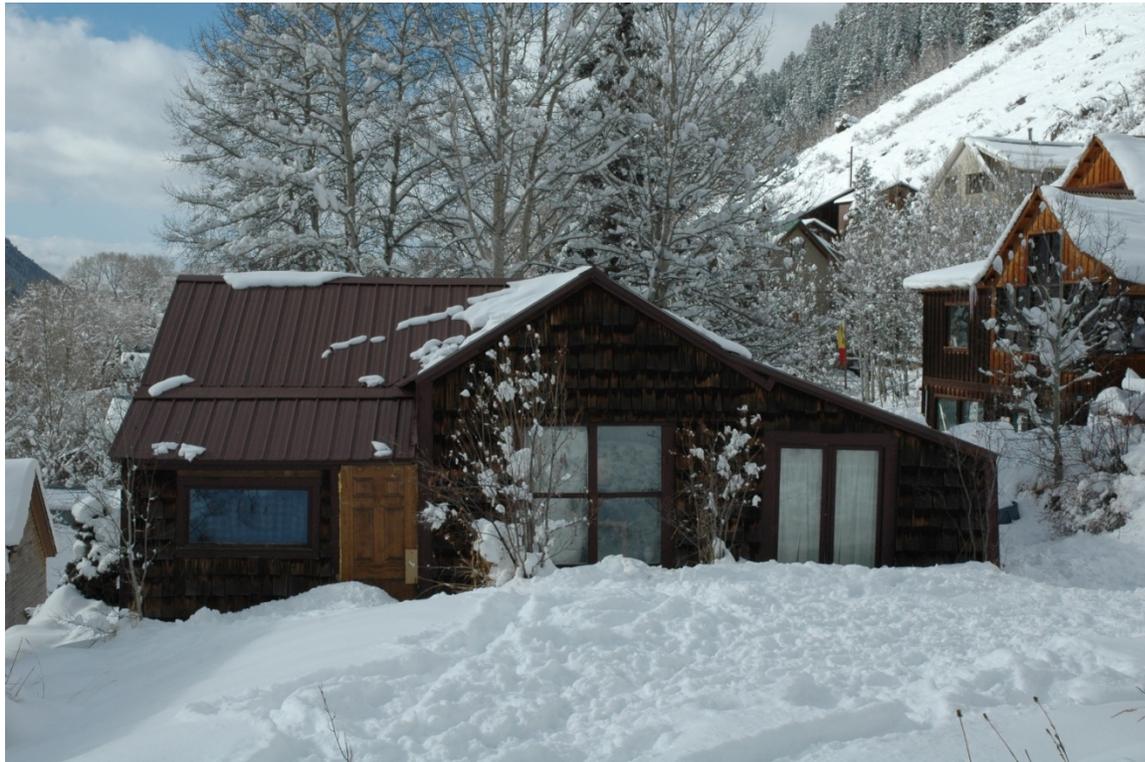
18. Roof configuration: **Gabled Roof / Cross Gabled Roof**
19. Primary external roof material: **Metal Roof**
20. Special features: **Porch, Fence**
21. General architectural description:
This single-story residence measures 30½' N-S (across) by 28½' E-W (deep). An L-shaped cross-gabled section, shed-roofed extensions to the north and west elevations, and an enclosed shed-roofed porch at the south end of the east elevation are included within these dimensions. The house is supported by a low poured concrete foundation, and its exterior walls are clad with stained brown square-cut wood shingle siding. Portions of the north and west elevations, however, are covered with brown asphalt shingle siding. The roof is covered with meta and the eaves are boxed. The house's facade faces Willow Avenue on the east elevation, with the main entry through a wood-paneled door into the enclosed shed-roofed porch, which measures 8½' by 3½', at the south end of the facade. A wood-paneled door enters the west (rear) elevation. A set of paired, vertically-oriented, 2-light windows penetrate the north end of the facade wall. A horizontally-oriented fixed-pane window penetrates the wall of the enclosed front porch, south of the front door.

This property is historically significant for its association with Telluride's residential development dating from the time of its development in 1913. Due to a substantial loss of integrity, the primary structure and the shed rate as "noncontributing without qualifications" resource within the Telluride National Historic Landmark District.

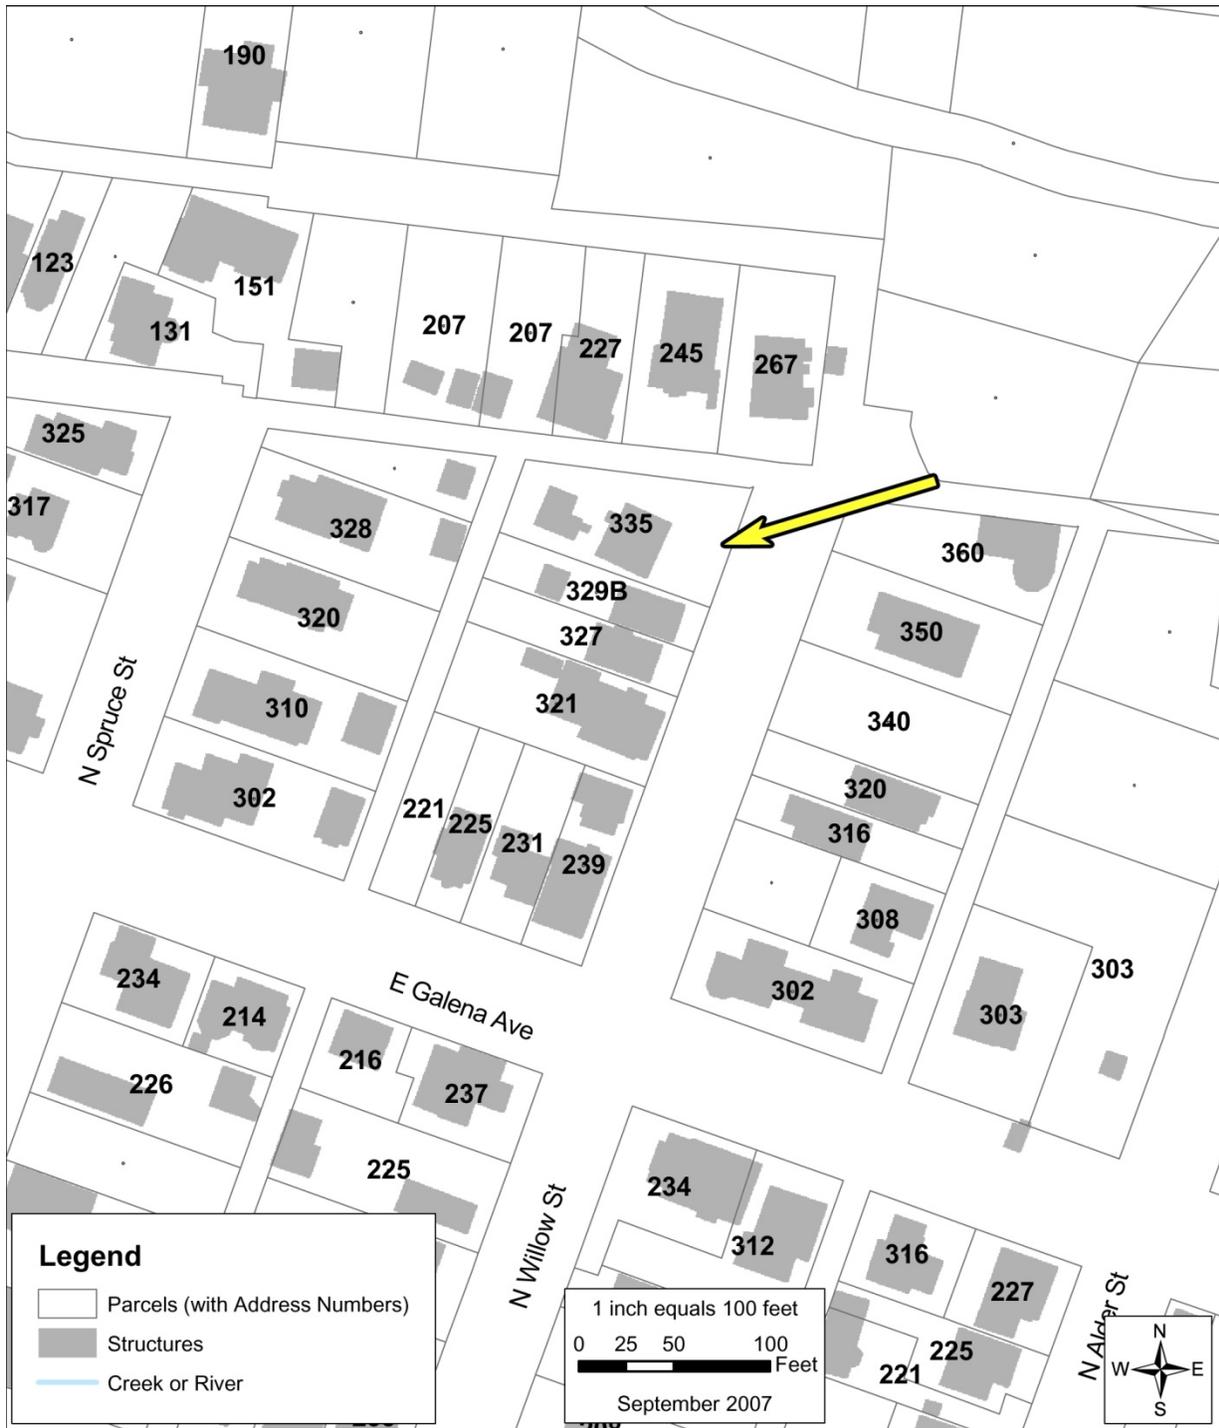
Sketch Map

This property is located at the southwest corner of Willow Street and Gregory Avenue. A tall fir tree is at the rear northwest corner of the property. The backyard, where there are large aspen trees, is enclosed by a wood fence.

A historic shed (THAS #119) is located near the west end of the property . This wood frame structure measures approximately 16' by 12'. Its exterior walls are clad with square-cut wood shingle siding, and it is covered by a shed roof. A wood-paneled door, with one upper sash light, enters the east elevation from the backyard. The west elevation is penetrated by a 4-light window. Paired 6-light windows penetrate the south elevation.
