COLORADO CULTURAL RESOURCE SURVEY

Architectural Inventory Form

- 1. Resource number: **5SM.1842**
- 2. Temporary resource number: **N/A**
- 3. County: **San Miguel**
- 4. City: **Telluride**
- 5. Historic Building Name: **Unknown**
- 6. Current Building Name: **Robbins House**
- 7. Building Address: **415 W. Pacific Avenue**
- 8. Owner Name and Address: **BGR 415 LLC Robert T. and Gloria M. Robbins  
P. O. Box 676088  
Ranch Santa Fe, CA 92067**

<b>THLD RATING:</b>	<b>Primary - Noncontributing Without Qualifications Secondary Residence – Non-Designated – New Construction</b>
---------------------	---

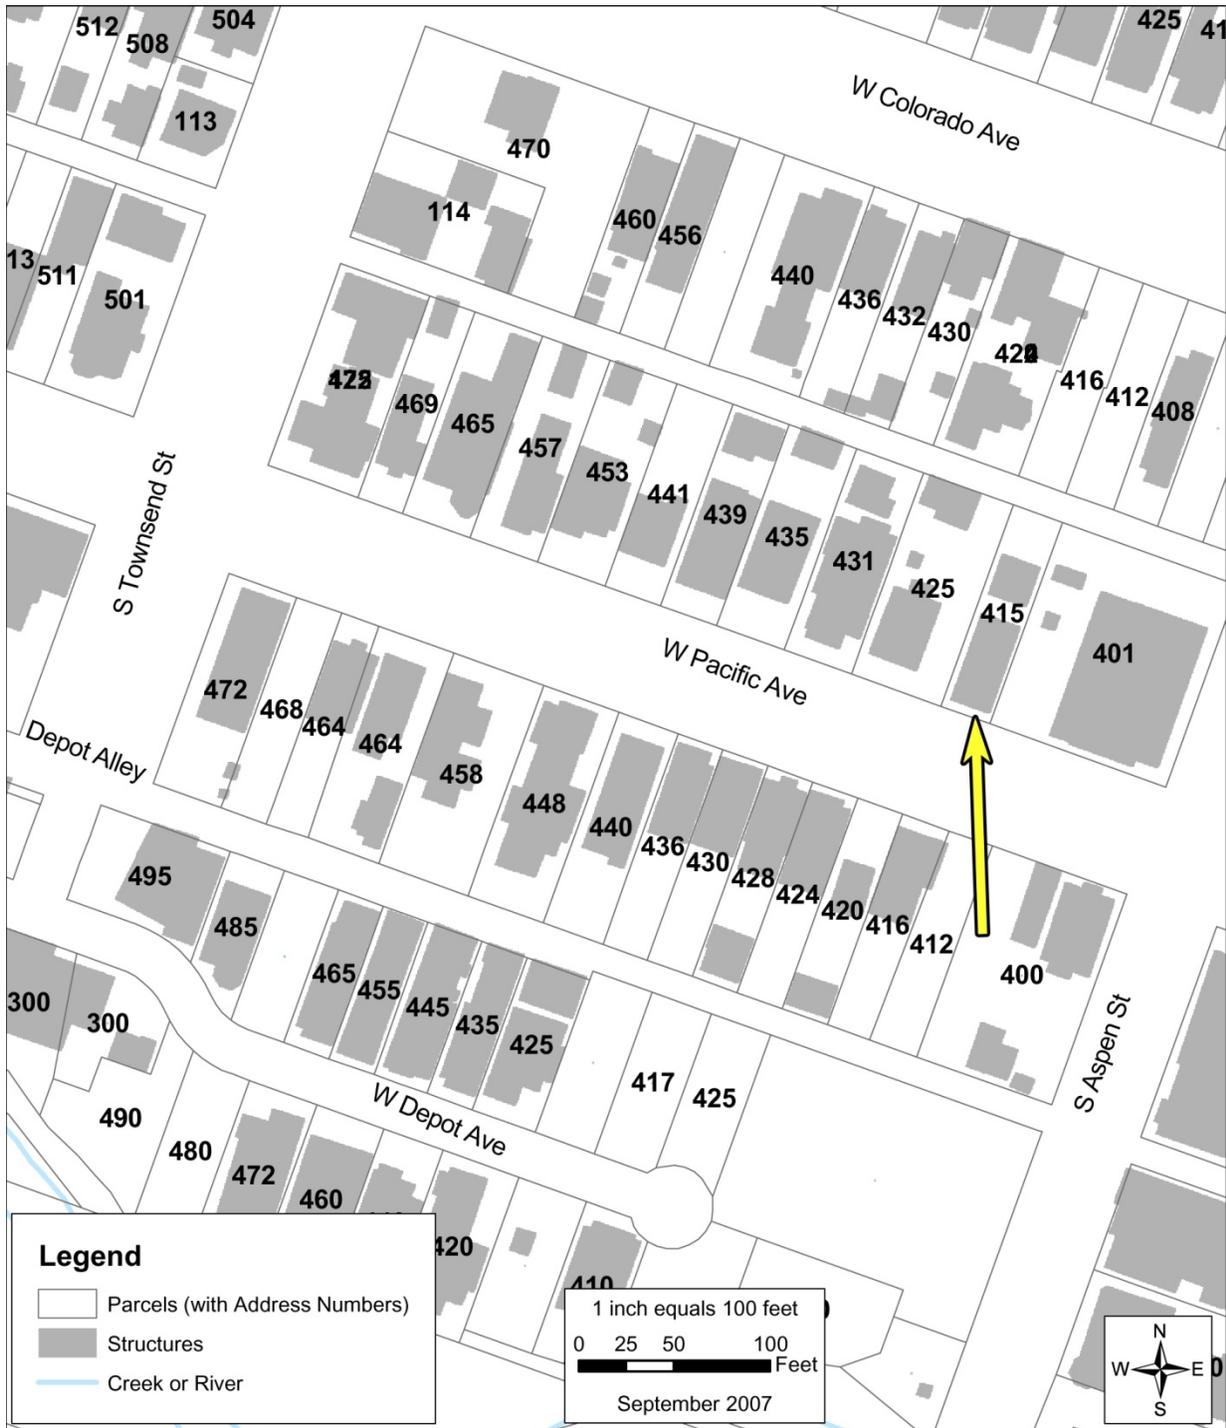
## Sketch Map

22. Architectural style: **Late Victorian**  
 Building type:
23. Landscape or special setting features:  
**This building is located on the north side of Pacific Avenue, the second property west of Aspen Street. A planted grass side yard is east of the building.**
