COLORADO CULTURAL RESOURCE SURVEY

Architectural Inventory Form

- 1. Resource number: **5SM.1661/THAS.186**
- 2. Temporary resource number: **N/A**
- 3. County: **San Miguel**
- 4. City: **Telluride**
- 5. Historic Building Name: **Unknown**
- 6. Current Building Name: **Cahill Services House**
- 7. Building Address: **558 W. Pacific Avenue**
- 8. Owner Name and Address: **Cahill Services Inc
12082 N. 133rd Way
Scottsdale, AZ 85259**

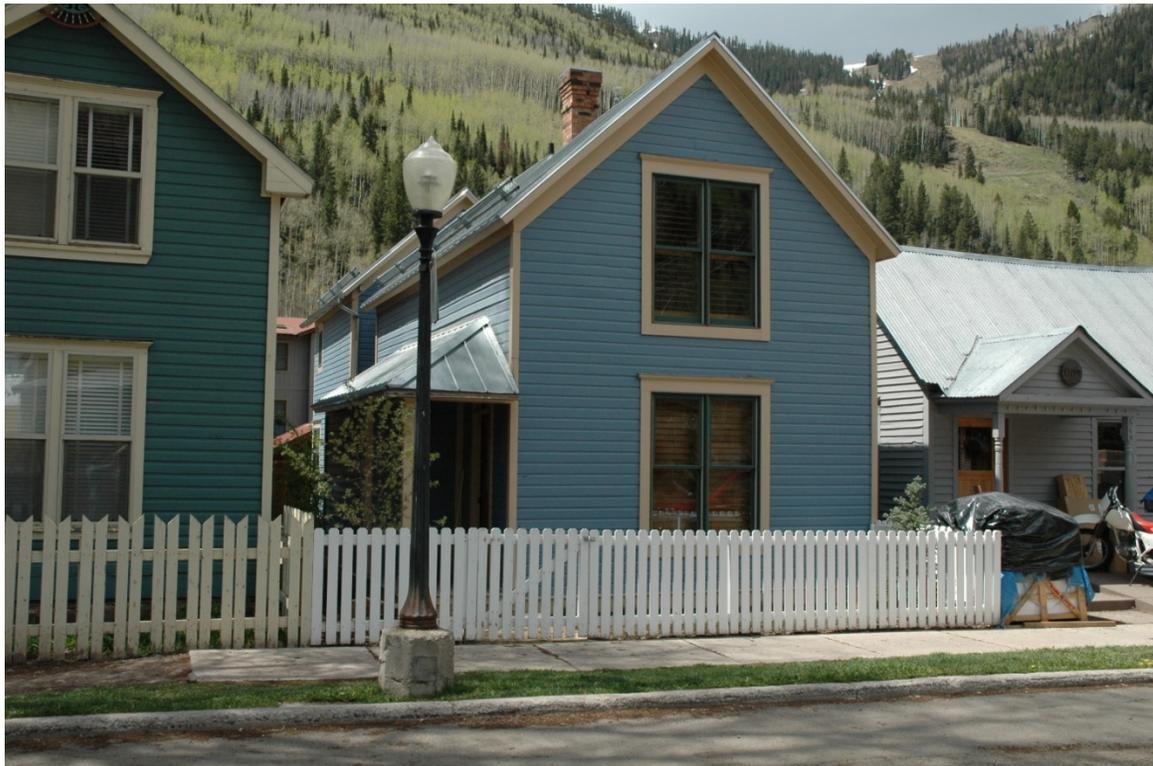
THLD RATING:	Primary - Supporting to District Privy – Moved to 560 W Pacific Garage – Non-Designated – New Construction
---------------------	---
