COLORADO CULTURAL RESOURCE SURVEY

Architectural Inventory Form

- 1. Resource number: **5SM.1766**
- 2. Temporary resource number: **N/A**
- 3. County: **San Miguel**
- 4. City: **Telluride**
- 5. Historic Building Name: **N/A**
- 6. Current Building Name: **Wakeland House**
- 7. Building Address: **122 / 122½ N. Spruce Street**

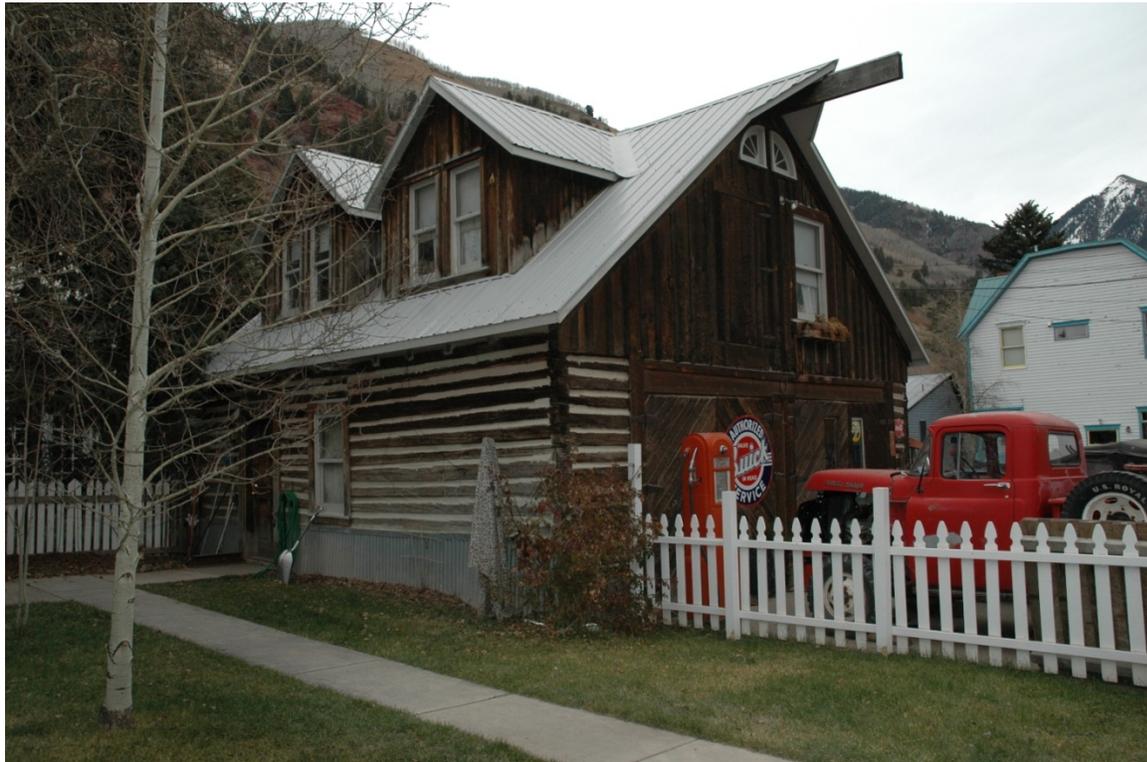
<b>THLD RATING:</b>	<b>Front Residence – Non-Designated – New Construction Rear Residence - Noncontributing Without Qualifications</b>
---------------------	--

**Previously surveyed under site # THAS #130, this 1½-story log and wood frame building measures 27' by 24'. It is supported by a poured concrete foundation, and its walls are made of squared logs with flush corners and with concrete chinking. Stained brown board-and batten appears in the upper gable ends. The building is covered by a gabled roof, with metal roofing material, and with exposed rafter ends and a fascia board beneath the eaves. There are four large, non-historic, gabled dormers each with a 1/1 double-hung sash window. Two dormers are located on the west elevation and the other two opposite on the east elevation. An entry door, covered by a painted white wood screen door, enters the north end of the west elevation. Two sets of paired diagonal plank garage doors, side-hinged with metal strap hinges, on the south elevation, open onto a concrete driveway which extends to the alley. An opening in the upper gabled end above the garage doors is covered by a vertical wood plank shutter, side-hinged with metal strap hinges. A non-historic fanlight window penetrates the south elevation's upper gable end. The east elevation is penetrated by a set of paired 6-light windows and a small single-light window.**

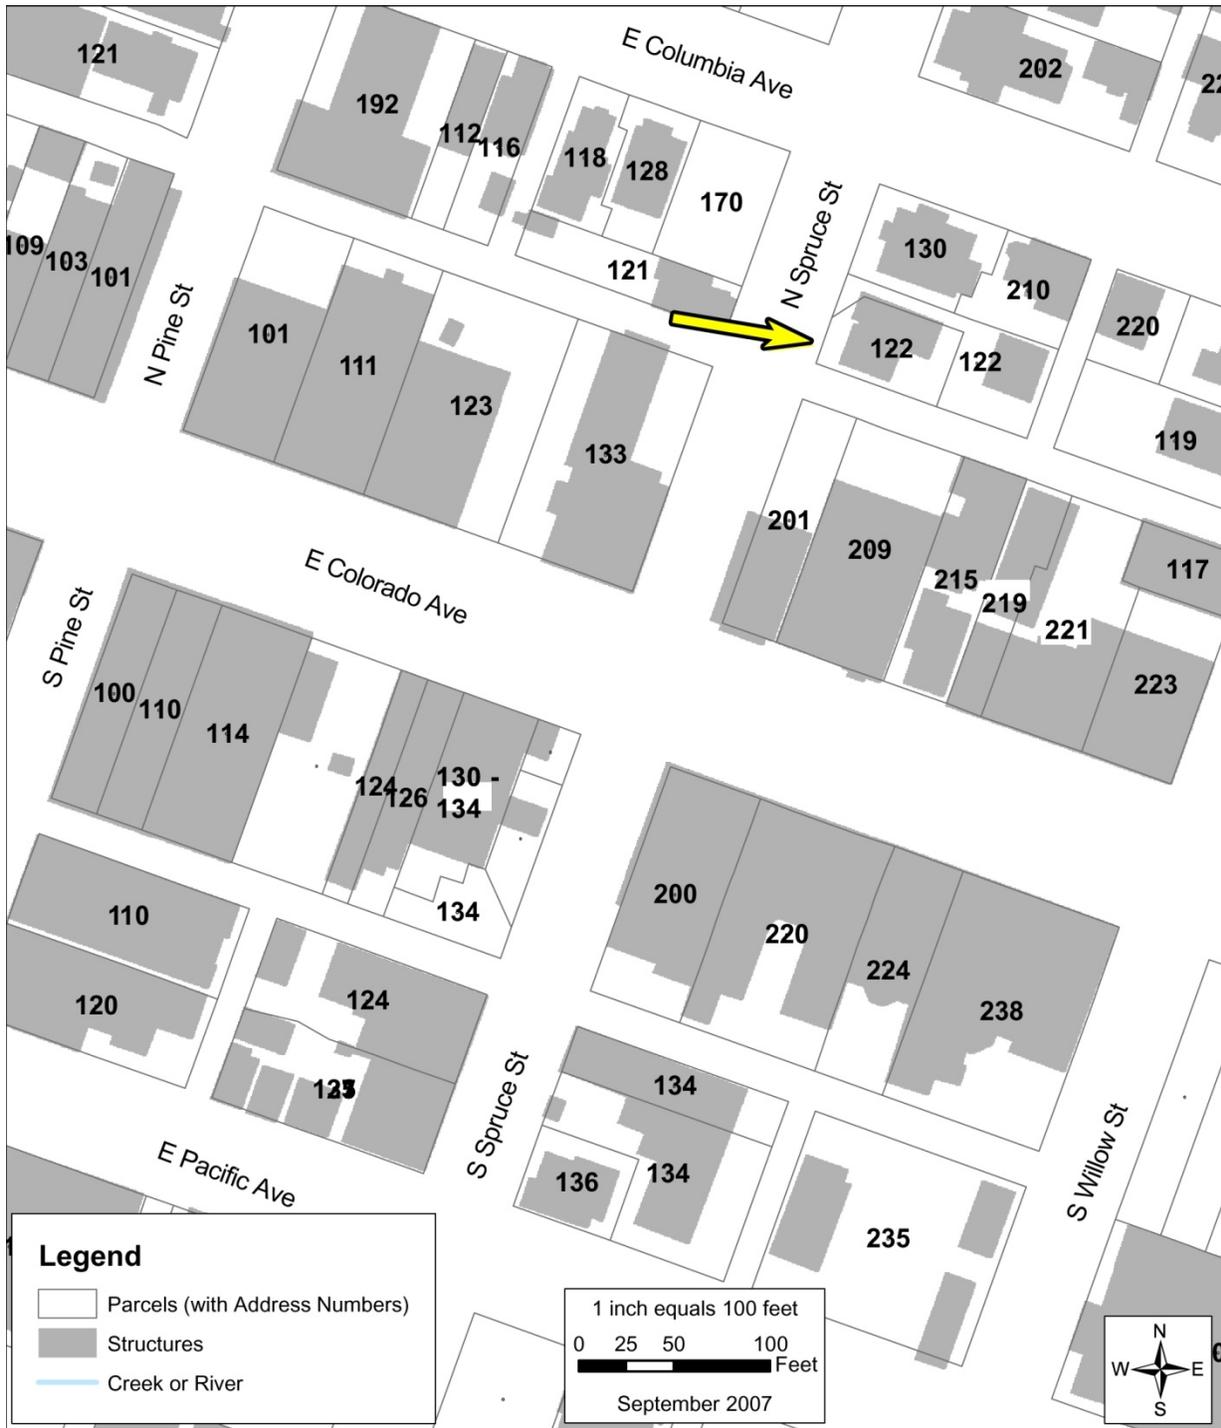
## Sketch Map

22. Architectural style: **No Defined Style**  
 Building type:
23. Landscape or special setting features:  
**This building is located on the rear half of the property on the east side of Spruce Street immediately north of the alley between Colorado and Columbia Avenues. A modern residence is located on the front half of the property.**
