COLORADO CULTURAL RESOURCE SURVEY

Architectural Inventory Form

- 1. Resource number: **5SM.1788**
- 2. Temporary resource number: **N/A**
- 3. County: **San Miguel**
- 4. City: **Telluride**
- 5. Historic Building Name: **Porterfield Building**
- 6. Current Building Name: **Old Stone LLC Building**
- 7. Building Address: **117 N. Willow Street**
- 8. Owner Name and Address: **Old Stone LLC, c/o Berkshire Par  
200 Clarendon Street  
Boston, MA 02116**

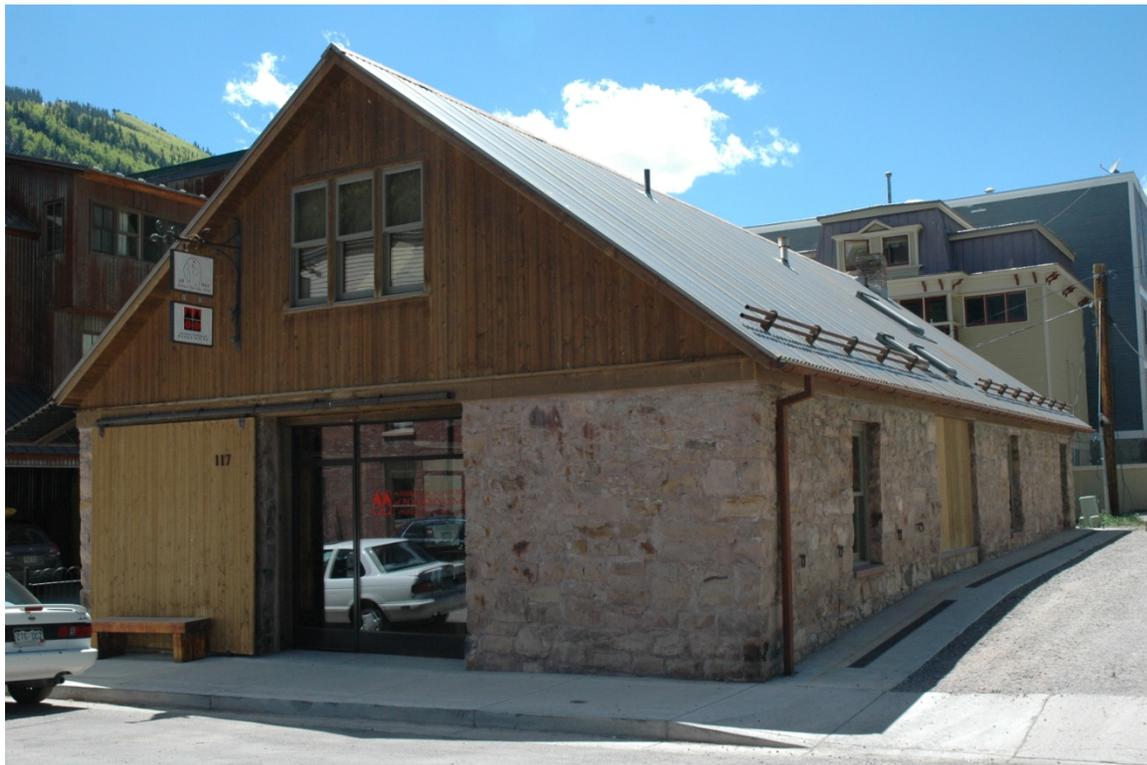
**This 1½-story building features a rectangular plan which measures 30' N-S by 60' E-W. Its walls are made of roughly-coursed sandstone blocks, and it is covered by a moderately-pitched front gabled roof with corrugated metal roofing material. A red brick chimney is at the west end of the roof ridge. The north and south facing roof slopes are both penetrated by three non-historic skylights. Cream color corrugated metal appears in the upper gable ends on the east and west elevations. The building's east elevation (facade) fronts directly onto the concrete sidewalk which parallels Willow Street. A painted green wood-paneled door, with one upper sash light, a transom light, and a sidelight, enters the center of the facade from within what historically was a garage bay door. A vertical wood plank horizontal sliding door (no longer in use) hangs from its historic track hardware at the south end of the facade. Three 1/1 double-hung sash windows penetrate the facade's upper gable end. Doors and windows on the south elevation include: a painted green wood-paneled door with one upper sash light; a set of paired, painted green, glass-in-wood-frame doors, three 1/1 double-hung sash windows, with painted white wood frames and painted blue wood surrounds. Doors and windows on the north elevation, facing the alley, include: a painted blue wood-paneled door with one upper sash light, two 1/1 double-hung sash windows with painted white wood frames and painted blue wood surrounds; a large window opening which has been filled in with painted cream white horizontal weatherboard. The west (rear) elevation is penetrated by two 1/1 double-hung sash first story windows, with painted white wood frames and painted blue wood surrounds, and by a 2-light window in the upper gable end.**

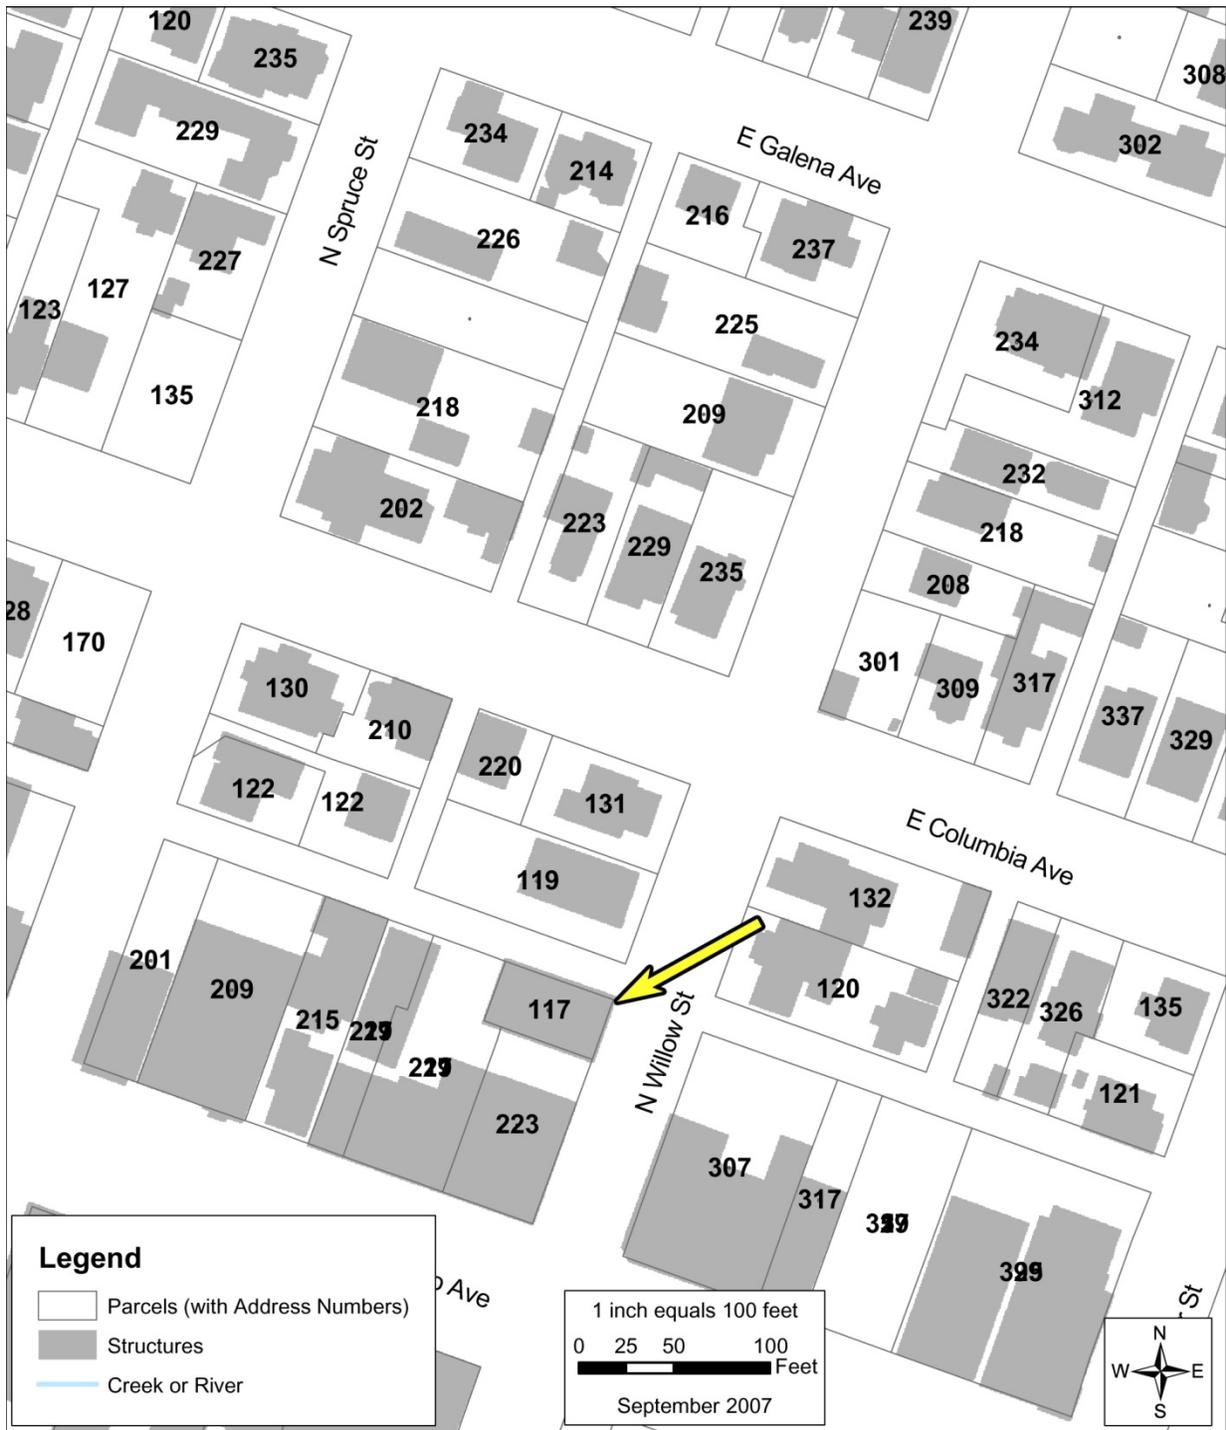
## Sketch Map

**This building fronts directly onto the concrete sidewalk along the west side of N. Willow Street. It is directly south of the alley between Colorado Avenue to the south and Columbia Avenue to the west. This area is near the east end of Telluride's downtown commercial district.**
