COLORADO CULTURAL RESOURCE SURVEY

Architectural Inventory Form

- 1. Resource number: **5SM.1801**
- 2. Temporary resource number: **N/A**
- 3. County: **San Miguel**
- 4. City: **Telluride**
- 5. Historic Building Name: **Unknown**
- 6. Current Building Name: **Chism House**
- 7. Building Address: **121 N. Alder Street**
- 8. Owner Name and Address: **Earl K. Chism, Sr.
11407 Hounds Way
North Bethesda, MD 20852**

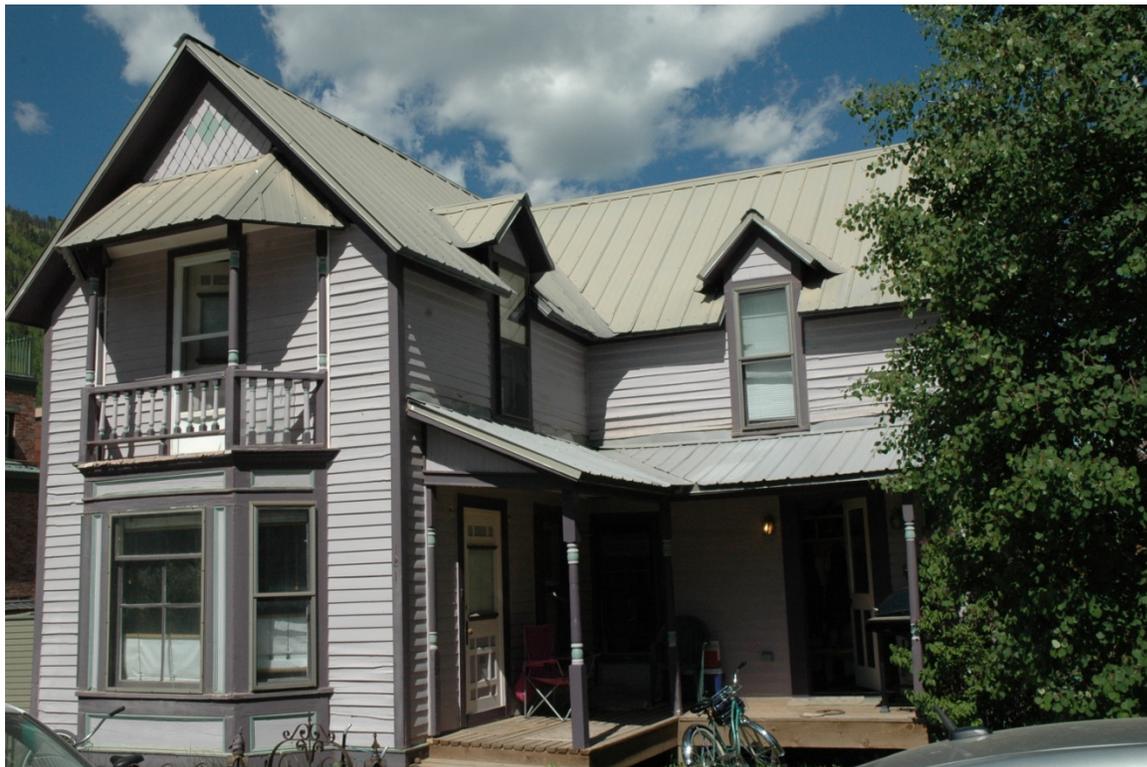
21. General architectural description:
This residence consists of a 1½-story, cross-gabled, L-shaped section, with a single-story shed-roofed extension to the west (rear) elevation. The front gabled south wing measures 14' N-S by 27½' E-W; the side-gabled north wing measures 14' N-S by 14' E-W; the single-story shed-roofed extension measures 28' N-S by 10' E-W. The house is supported by an unpainted poured concrete foundation, while its exterior walls are clad with painted lavender color horizontal wood siding with painted purple 1" by 4" corner boards. A painted purple 1x board with a painted green water table separates the foundation from the siding. Painted lavender and green diamond-shaped wood shingles appear in the east elevation's upper gable end. The main cross gabled roof and the shed-roof are covered with metal roofing material, and the eaves are boxed with painted purple wood trim. There are three gabled wall dormers, each with a 1/1 double-hung sash window, one each on the north, east, and north elevations. A red brick chimney is on the south-facing roof slope. An L-shaped front porch comprises the north half of the facade on the east elevation. A distinctive painted white wood-paneled front door, covered by a metal storm door, enters the dwelling from the front porch. Another door, no longer in use and covered with vertical wood planks, also once entered the dwelling from the front porch. The porch is approached by three wood steps, and features a wood plank floor, painted green, purple, and white turned columns, and intersecting shed roofs. A rear entry door leads into the shed-roofed extension on the west elevation. A canted bay penetrates the facade wall south of the front porch. This bay's flat roof is enclosed by an open wood railing and serves as a small upper half story porch. A distinctive painted white wood-paneled door, with one upper sash light, opens from the upper half story onto this porch. Windows elsewhere are primarily 1/1 double-hung sash with painted purple wood surrounds.
