COLORADO CULTURAL RESOURCE SURVEY

Architectural Inventory Form

I. IDENTIFICATION

- 1. Resource number: **5SM.1852**
- 2. Temporary resource number: **N/A**
- 3. County: **San Miguel**
- 4. City: **Telluride**
- 5. Historic Building Name: **Unknown**
- 6. Current Building Name: **Herrick House**
- 7. Building Address: **117 N. Aspen Street**
- 8. Owner Name and Address: **Jan Alyn Herrick  
P. O. Box 2675  
Telluride, CO 81435**

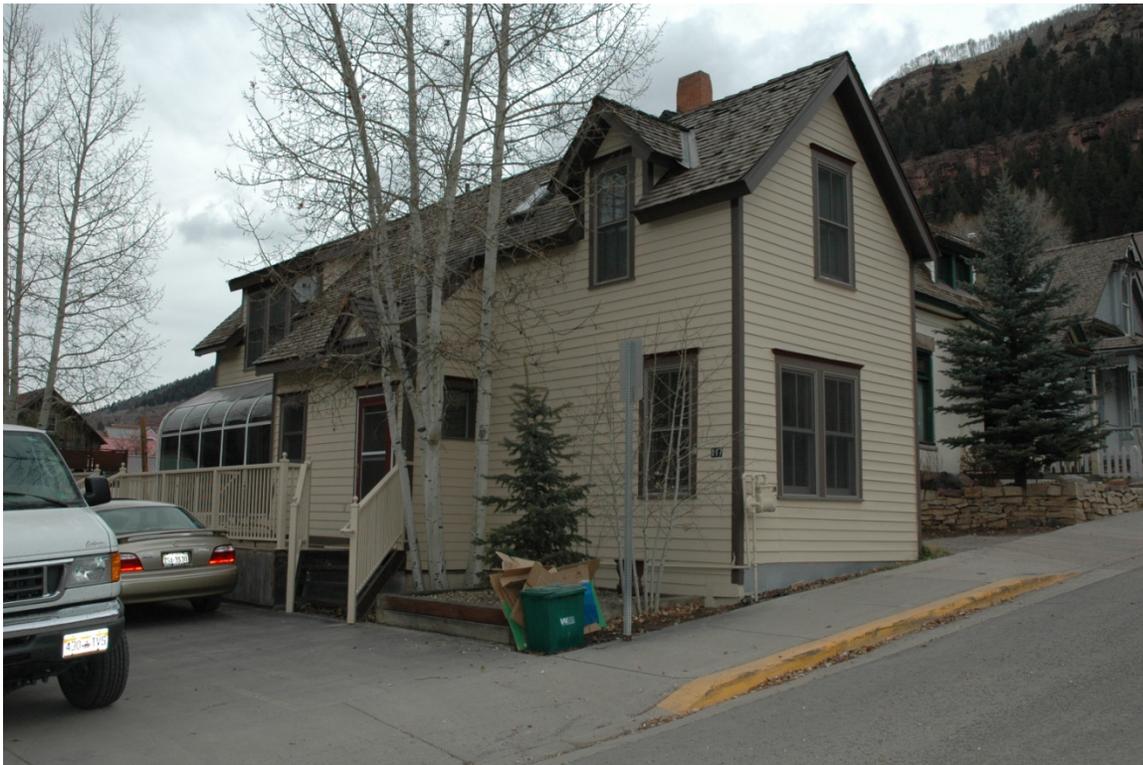
20. Special features: **Porch, Dormers**
21. General architectural description:  
**This 1½-story wood frame dwelling overall measures 20' N-S by 50' E-W, including a glassed-in addition at the west end of the south elevation. It is supported by a low poured concrete foundation, while its exterior walls are clad with painted beige horizontal wood siding with painted brown 1" by 4" corner boards. The roof is a steeply-pitched side gable, with wood shingles and with painted brown rafter ends and a fascia board exposed beneath the eaves. Two gabled wall dormers, each with a 2/2 double-hung sash window, are located on the south elevation. A shed-roofed wall dormer, with three 2/2 double-hung sash windows, and another gabled wall dormer with one 2/2 double-hung sash window, are located on the south elevation. A red color exterior storm door enters an enclosed porch from an open uncovered wood porch which covers the western 2/3s of the south elevation (façade) and wraps around to cover the west elevation. The porch is approached by metal steps and features a wood plank floor, and an open metal railing with cannonball finials. The building's windows are predominantly 2/2 double-hung sash with simple wood cornices.**

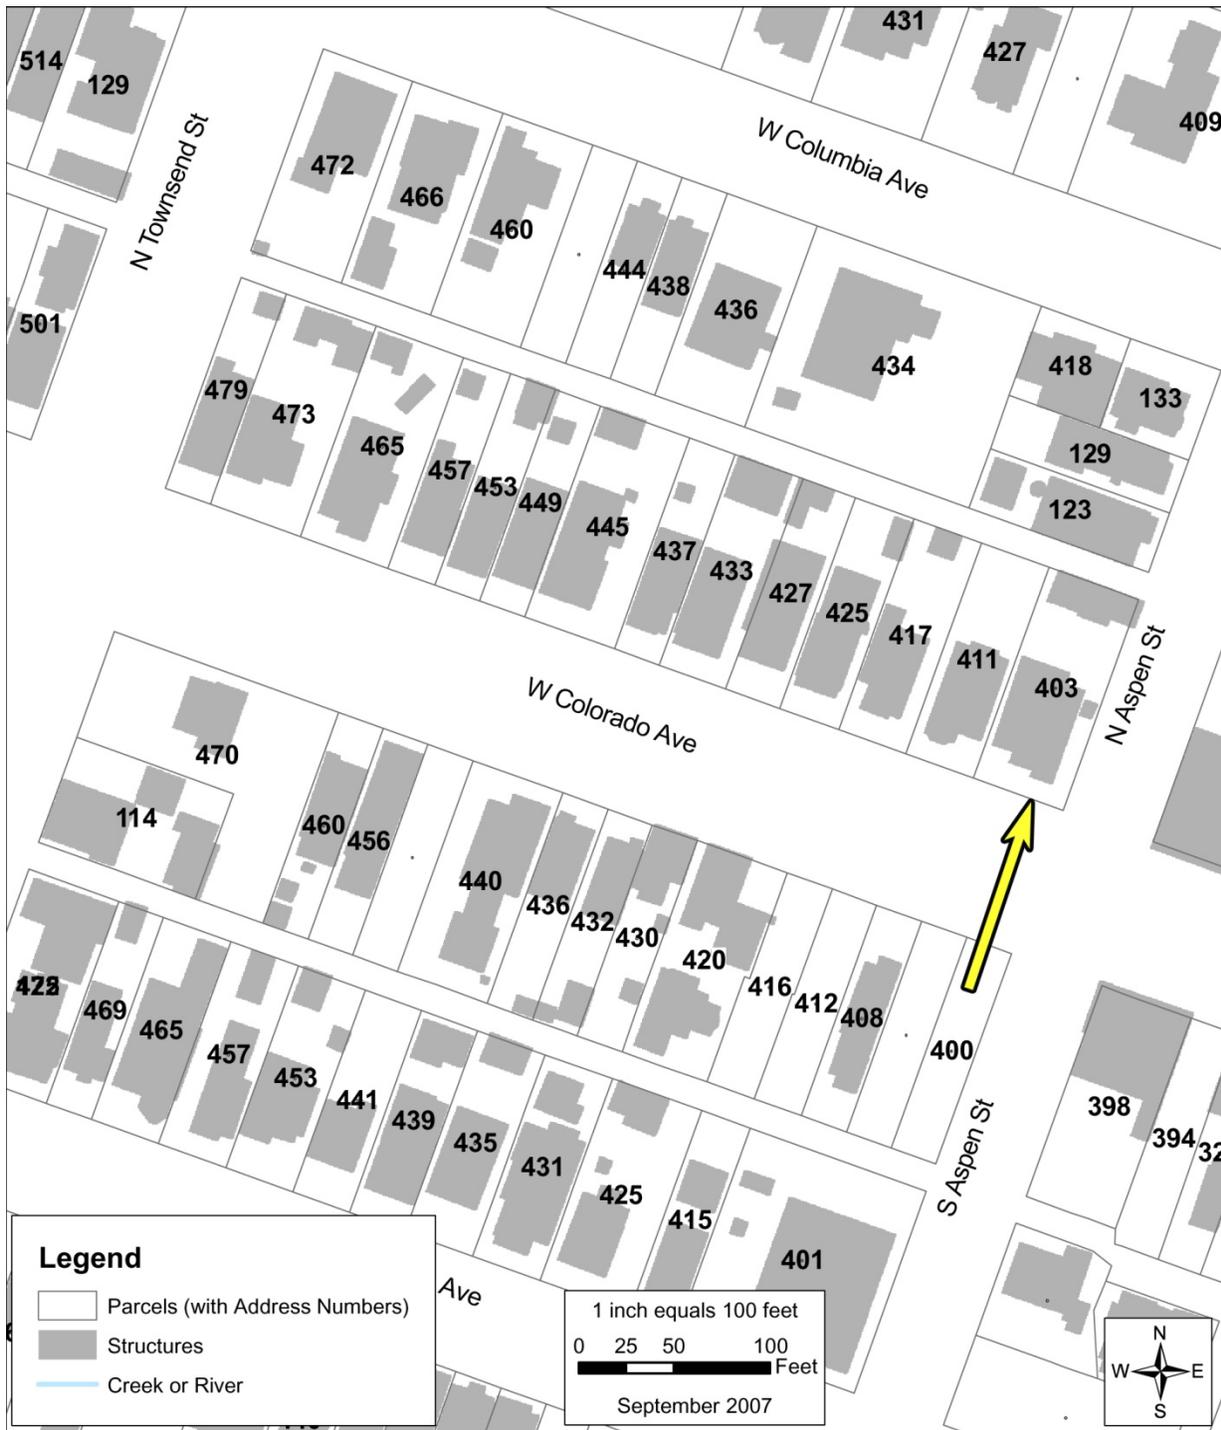
## Sketch Map

22. Architectural style: **No Defined Style**  
 Building type:
23. Landscape or special setting features:  
**This property is located on the west side of N. Aspen Street, in the block north of Colorado Avenue. The house at 403 W. Colorado Avenue (5SM.1602) is adjacent to the south. The alley between Colorado and Columbia Avenues is to the north.**
