COLORADO CULTURAL RESOURCE SURVEY

**Architectural Inventory Form**

- 1. Resource number: **5SM.1644/THAS.174**
- 2. Temporary resource number: **N/A**
- 3. County: **San Miguel**
- 4. City: **Telluride**
- 5. Historic Building Name: **Unknown**
- 6. Current Building Name: **Alpine Chapel**
- 7. Building Address: **122 S. Aspen Street**
- 8. Owner Name and Address: **Village A CO Non Profit Corp.  
P. O. Box 3536  
Telluride, CO 81435**

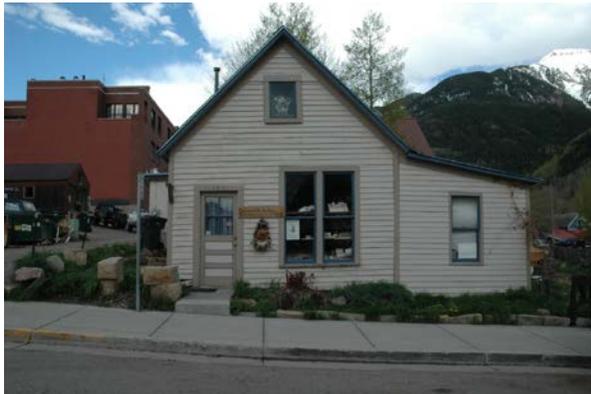
Dwelling at 122 S. Aspen Street before it was incorporated into the Alpine Chapel building. Photo August 2007.

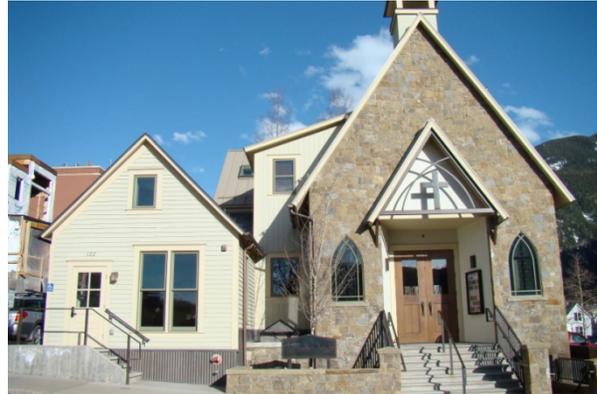
Dwelling at 122 S. Aspen Street after it was incorporated into the Alpine Chapel building. Photo March 2012.

**Note:** The dwelling at 122 S. Aspen Street was intensively surveyed in August 2007 during phase one of the Telluride Re-Survey of Historic Structures project. The dwelling was renovated and incorporated into the Alpine Chapel, a new building erected subsequent to the time of survey. This form’s architectural description (fields 14-21 below) relate to the dwelling’s appearance as it existed in August 2007. The form’s eligibility evaluation (fields 37-46 below) relates to the dwelling as it exists in April 2012, after it was incorporated into the newly-built Alpine Chapel.
