COLORADO CULTURAL RESOURCE SURVEY

Architectural Inventory Form

- 1. Resource number: **5SM.1706**
- 2. Temporary resource number: **N/A**
- 3. County: **San Miguel**
- 4. City: **Telluride**
- 5. Historic Building Name: **Hogg House**
- 6. Current Building Name: **Montgomery House**
- 7. Building Address: **123 N. Aspen Street**
- 8. Owner Name and Address: **Don D. Montgomery
2701 State Street
Dallas, TX 752042634**

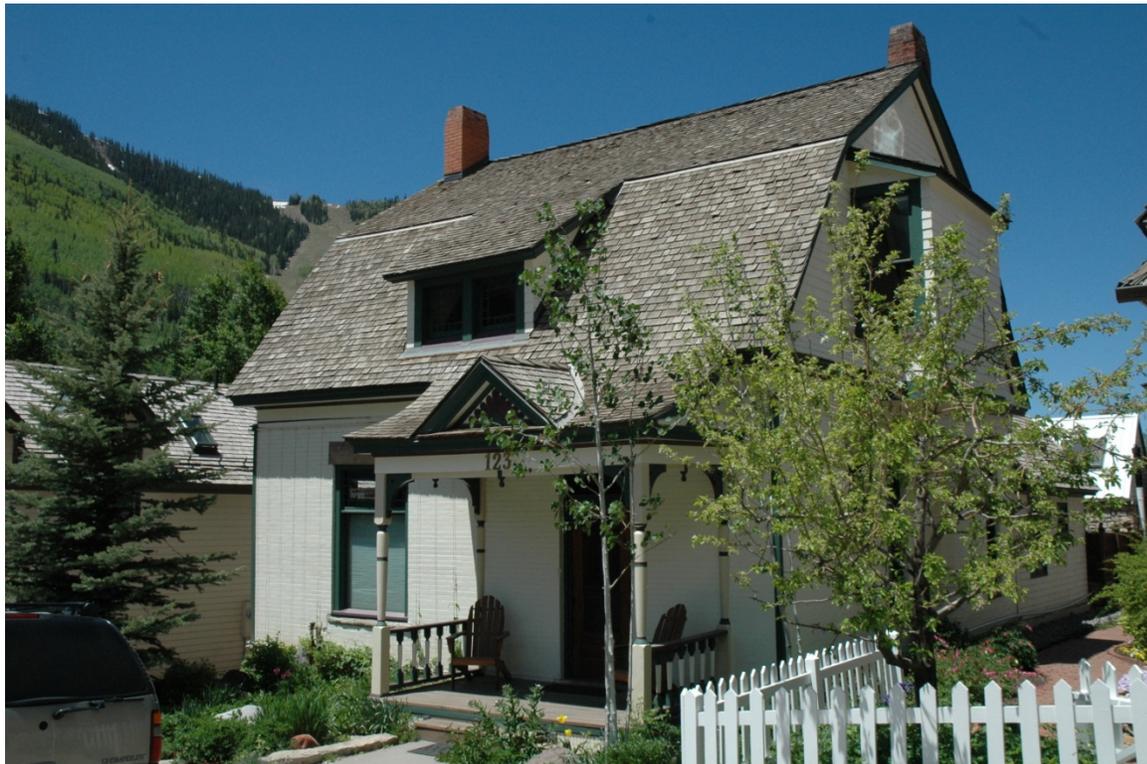
21. General architectural description:
This 1½-story residence rests on a coursed sandstone foundation which extends from at grade on the north elevation to nearly six feet above grade on the south elevation. The house's first story walls are made of painted cream white brick laid in running bond, while its roof is a steeply-pitched side-gambrel with wood shingles. Painted cream white square-cut wood shingles appear in the upper gambrel ends on the north and south elevations. Shed-roofed dormers are on the east and west facing roof slopes, and there are two red brick chimneys, one at the south end of the ridge, and the other just below the ridge near the north end of the west facing roof slope. The house's asymmetrical facade faces Aspen Street on the east elevation. A painted green wood-paneled front door, with a transom light and covered by a wood screen door, enters the north end of the facade beneath a heavy sandstone lintel. This door enters the house from an open front porch which features a wood plank floor, and open wood railing with turned balusters, turned columns with brackets, and a swept side gabled roof with an intersecting gable. A painted cream white wood-paneled door, beneath a segmental arch, enters the basement level from the alley on the south elevation. A single-hung sash window with Queen Anne lights penetrates the facade wall south of the front porch. Windows on the south elevation include two single-hung sash first story windows with Queen Anne lights, sandstone lugsills and lintels, and two 1/1 double-hung windows in the upper gambrel end. Windows on the north elevation include two 1/1 double-hung first story windows with sandstone lugsills and lintels, and a smaller window with Queen Anne lights also with a sandstone lugsill and lintel. The building's west (rear) elevation comprises an older (pre-1986) wood frame addition. The addition's walls are clad with painted cream white square-cut wood shingles with painted green 1" by 4" corner boards. The addition's roof is a clipped gable with wood shingles and painted white and green boxed eaves. An

intersecting gable over a rounded arch window overlooks the alley on the south elevation. A stone fireplace chimney is on the addition's west elevation. A wood-paneled door, with leaded glass lights, enters the south end of the west elevation from a stone and concrete porch/patio which extends to a detached garage / secondary residence.

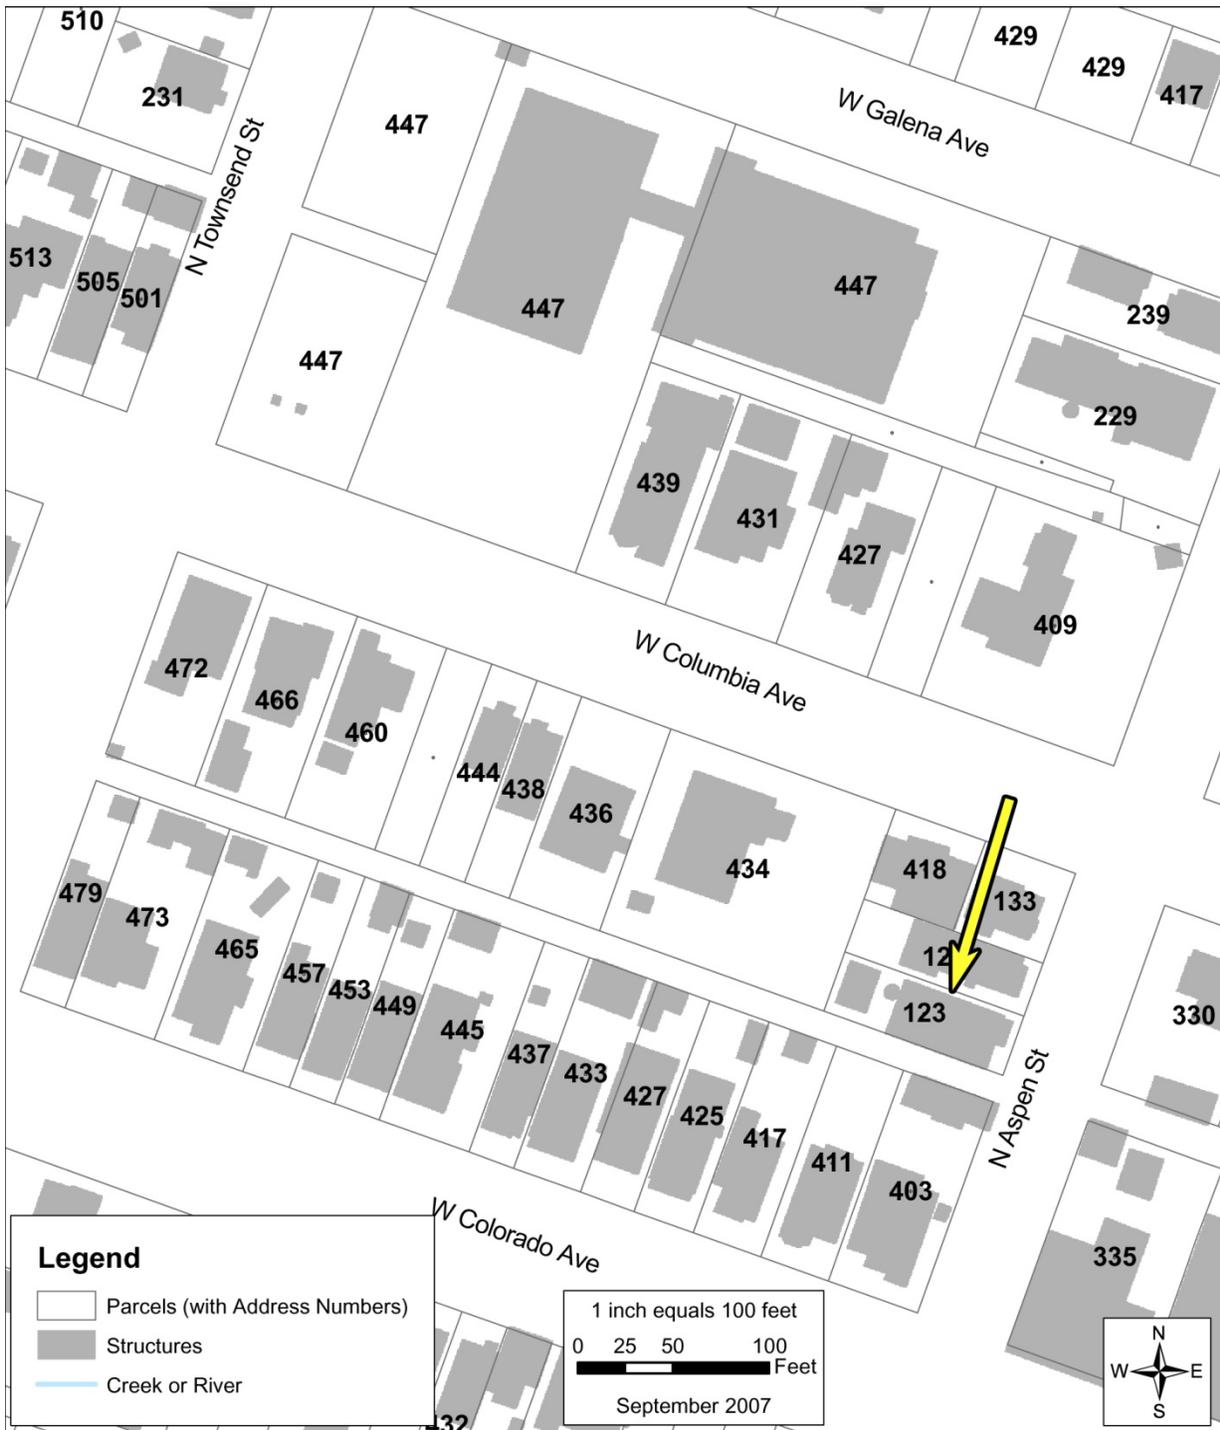
Sketch Map

This well-maintained property is located on the west side of Aspen Street in the block between Colorado and Columbia Avenues. The front yard is landscaped with an abundance of wildflowers and a small spruce tree. A low stone retaining wall parallels the front sidewalk. The alley between Colorado and Columbia parallels the south property line.
