COLORADO CULTURAL RESOURCE SURVEY

Architectural Inventory Form

- 1. Resource number: **5SM.1541** Parcel number(s): **477901119003**
- 2. Temporary resource number: **N/A**
- 3. County: **San Miguel**
- 4. City: **Telluride**
- 5. Historic Buildings Names: **Van Atta Dry Goods and Clothing/ Bank of Telluride**
- 6. Current Building Name: **Floradora Saloon**
- 7. Building Address: **103 W. Colorado Avenue**
- 8. Owner Name and Address: **Kane Corporation
266 Hillside Lane
Telluride, CO 81435**

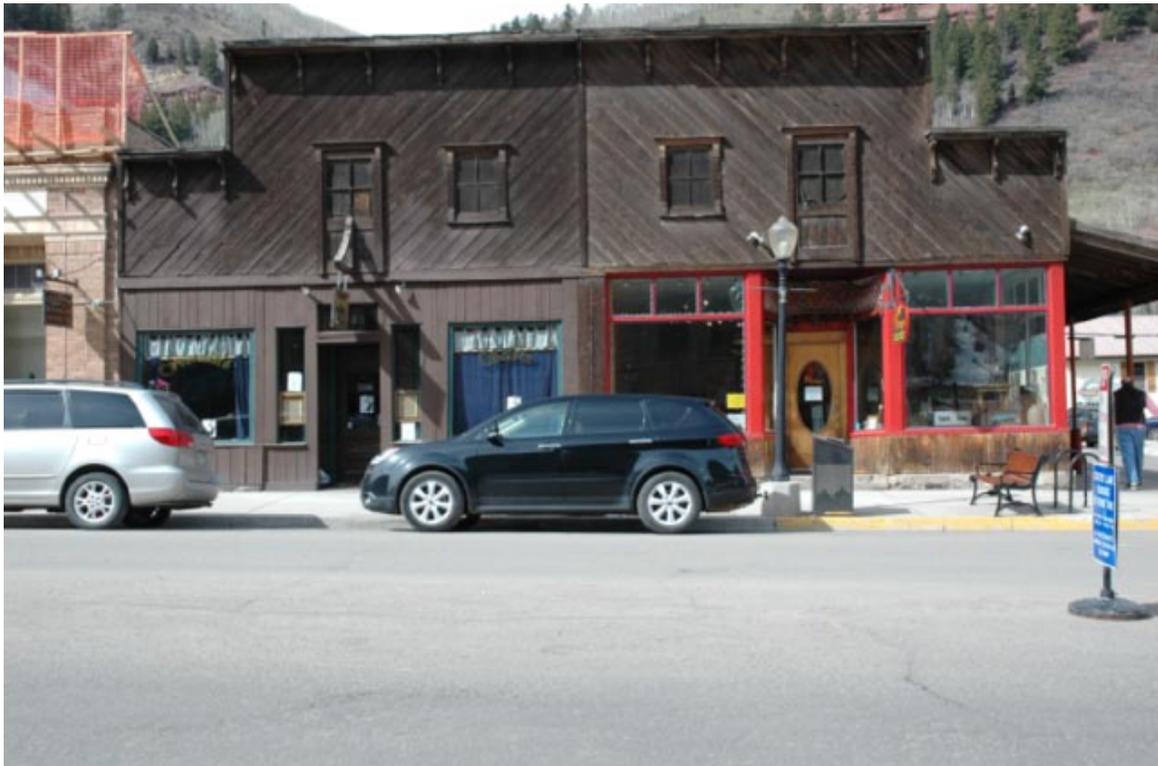
21. General architectural description:
This large wood-frame false front building is located at the northwest corner of Colorado Avenue and Pine Street in downtown Telluride. The façade, fronting onto Colorado Avenue on the south elevation, is divided into east and west halves. The west half contains a single storefront, presently occupied by the "Floradora Saloon," a restaurant and bar. A stained dark brown wood-paneled door, with one upper sash light and with flanking sidelights, is located within a recessed entryway located near the center of the west half of the façade. This entryway is flanked on either side by a large square single-light fixed-pane display window. The east half of the façade also features a centered recessed entryway which contains a stained natural brown solid wood door, with an oval-shaped light and flanking sidelights. This entryway is flanked on either side by large storefront display windows, with painted red wood frames and with transom lights. The upper false front façade wall is mad of stained dark brown vertical and diagonal wood planks. Four false windows in the upper façade wall help give the illusion that the building contains a second story. The top of the façade wall is finished with a simple bracketed wood cornice. Behind the false front, the building is covered by a low-pitched saltbox roof, with corrugated metal roofing material laid over 1x wood decking and 2x wood rafters. A crumbling brick chimney is located near the north end of the west-facing roof slope. The building's east elevation fronts onto a concrete sidewalk which parallels Pine Street. The roof eave extends beyond the east elevation wall to cover the sidewalk, and is supported by a series of steel poles set in concrete bases. The east elevation wall is clad with unpainted board and batten, which has been applied over earlier faux brick rolled asphalt siding. A large 2-light fixed-pane display

window, topped by four transom lights, is located at the south end of the east elevation. A stained brown wood-paneled door enters the building near the north end of the east elevation.

The building has been extended to the rear (north elevation) by what appears to be three small additions. The first of these extensions (closest to the main building) has a corrugated metal exterior wall on its north elevation, a metal-paneled wall on its west elevation, and a board and batten wall on its east elevation, beneath the roof overhang over the sidewalk. This extension also features a shed roof with corrugated metal roofing material laid over 1x wood decking and 2x wood rafters. The second extension has painted white horizontal wood siding exterior wall cladding on its exposed north and west elevations. The second extension is covered by a nearly flat shed roof. The third extension is a lower shed-roofed structure with unpainted concrete walls. Two square window openings face the alley on the north elevation.

This property displays a below average standard of physical integrity, relative to the seven aspects of integrity as defined by the National Park Service and the Colorado Historical Society, Office of Archaeology and Historic Preservation - setting, location, design, materials, workmanship, feeling and association. Virtually no tangible evidence of the historic Van Atta Dry Goods building, or the original Bank of Telluride building now remains.
