COLORADO CULTURAL RESOURCE SURVEY

Architectural Inventory Form

- 1. Resource number: **5SM.1552**
- 2. Temporary resource number: **N/A**
- 3. County: **San Miguel**
- 4. City: **Telluride**
- 5. Historic Building Name: **Saloon**
- 6. Current Building Name: **Down to Earth**
- 7. Building Address: **124 E. Colorado Avenue**
- 8. Owner Name and Address: **Robert C- and Bruce E. Millar
901 Calle De Julio
Green Valley, AZ 85614**

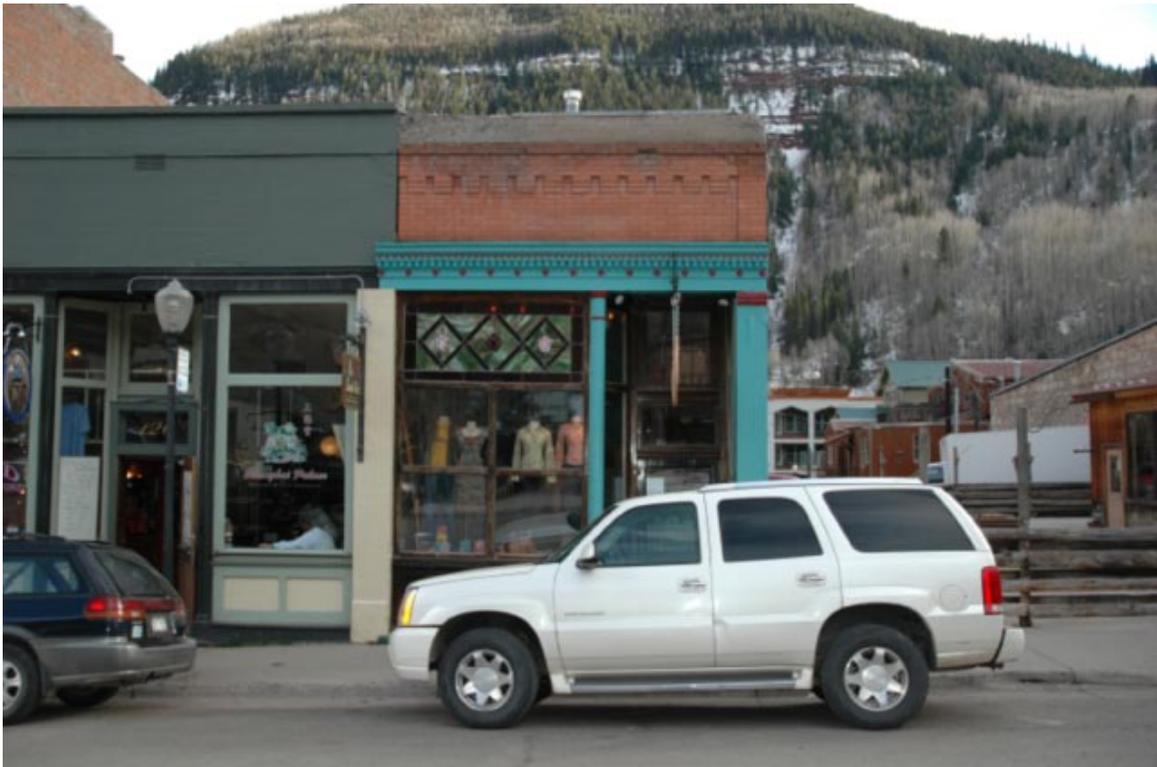
21. General architectural description:
This single-story brick commercial building measures 100' N-S (deep) by just 15' E-W (across). Containing a single storefront, the building's façade fronts directly onto the concrete sidewalk which parallels Colorado Avenue on the north elevation. A painted black wood-paneled door, with one upper sash light, and with sidelights and a transom light, enters the building from within a recessed entryway at the west end of the façade. Two additional windows are located above the transom light. The entryway is flanked on its east side by a round, painted turquoise, cast iron column, and on its west side by a square, fluted, painted turquoise cast iron column. A plate at the base of the square column is stamped "TELLURIDE IRON WORKS." A large 4-light fixed-pane display window, with a leaded and stained glass transom light, penetrates the façade wall to the east of the entry. The wood-paneled kickplate below the window is penetrated by a painted black metal coal chute cover. A painted turquoise cornice, with painted buff red accents, and with a dentil course, extends along the top of the entryway and window. Above this cornice, the upper façade wall is made of red brick laid in running bond, with corbelling near the top. Exposed concrete appears along the top of the façade wall, where a cornice which apparently once existed has been removed. The building's long west (side) elevation is fully exposed, and is made of red brick laid in running bond. The west (side) elevation is not exposed. A tall, 2-story, wood-frame, shed-roofed addition to the south (rear) elevation measures approximately 38' N-S by 15' E-W. It is supported by a high painted white concrete block foundation, and its exterior walls are made of unpainted board and batten. A set of paired 1/1 double-hung sash windows penetrate the addition's west elevation, and another 1/1 double-hung window penetrates its east elevation. Service doors enter the addition's first and second stories. A wooden staircase ascends to the second story door .
