COLORADO CULTURAL RESOURCE SURVEY

Architectural Inventory Form

- 1. Resource number: **5SM.1544**
- 2. Temporary resource number: **N/A**
- 3. County: **San Miguel**
- 4. City: **Telluride**
- 5. Historic Building Name: **Roma Bar**
- 6. Current Building Name: **Honga's Lotus Petal Restaurant**
- 7. Building Address: **133-137 E. Colorado Avenue**
- 8. Owner Name and Address: **RRP Inc
529 East South Temple
Salt Lake City, UT 84102**

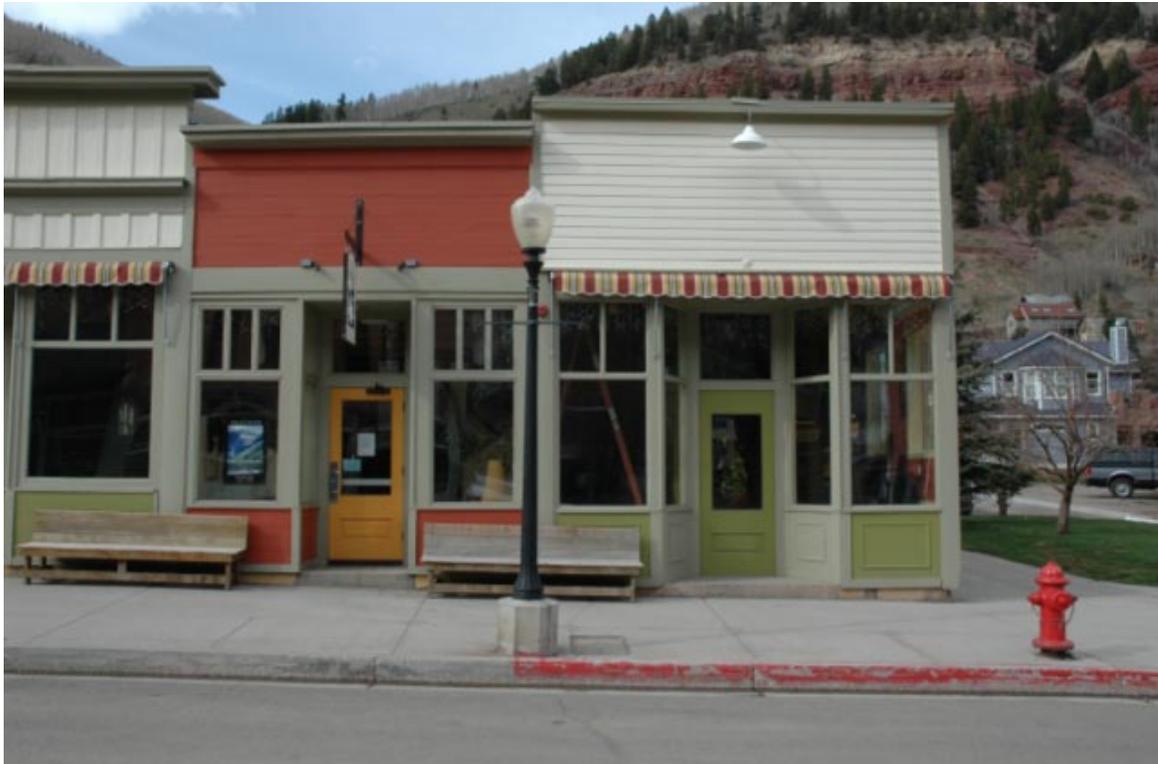
21. General architectural description:
The building at 133/137 E. Colorado Avenue is made up of what historically was two adjacent, but separate, single-story, wood frame false-front commercial buildings. The interior of these two buildings, along with that of a similar building next door the west (131 E. Colorado Avenue) now comprise a single retail space occupied by Honga's Lotus Petal Restaurant. The façade of this building at 133/137 E. Colorado Avenue, thus, is composed of two storefronts.

- The storefront to the east (137 E. Colorado Avenue) is symmetrical. Here, a painted green wood-paneled door, with a long upper sash light, enters the building from within a centered recessed entryway. The door is flanked by sidelights and topped by a transom light (a relatively modern Marvin brand awning style replacement window). Fixed-pane display windows, with transom lights, flank the recessed entryway. Painted green wood-paneled kickplates are located beneath the windows. The single storefront is separated from the upper false-front facade wall by a short canvas awning. The upper false-front portion of the façade wall is clad with painted cream yellow horizontal weatherboard siding, with a modest wood cornice along the top of the wall.**

- The storefront to the west (133 E. Colorado Avenue) is also symmetrical, and also features a centered recessed entryway. A painted yellow wood-paneled door, with a long upper sash light, has flanking sidelights and is topped by a transom light (a relatively modern Marvin brand awning style replacement window). Storefront display windows, with transom lights, flank the recessed entryway, and feature painted red horizontal wood plank**

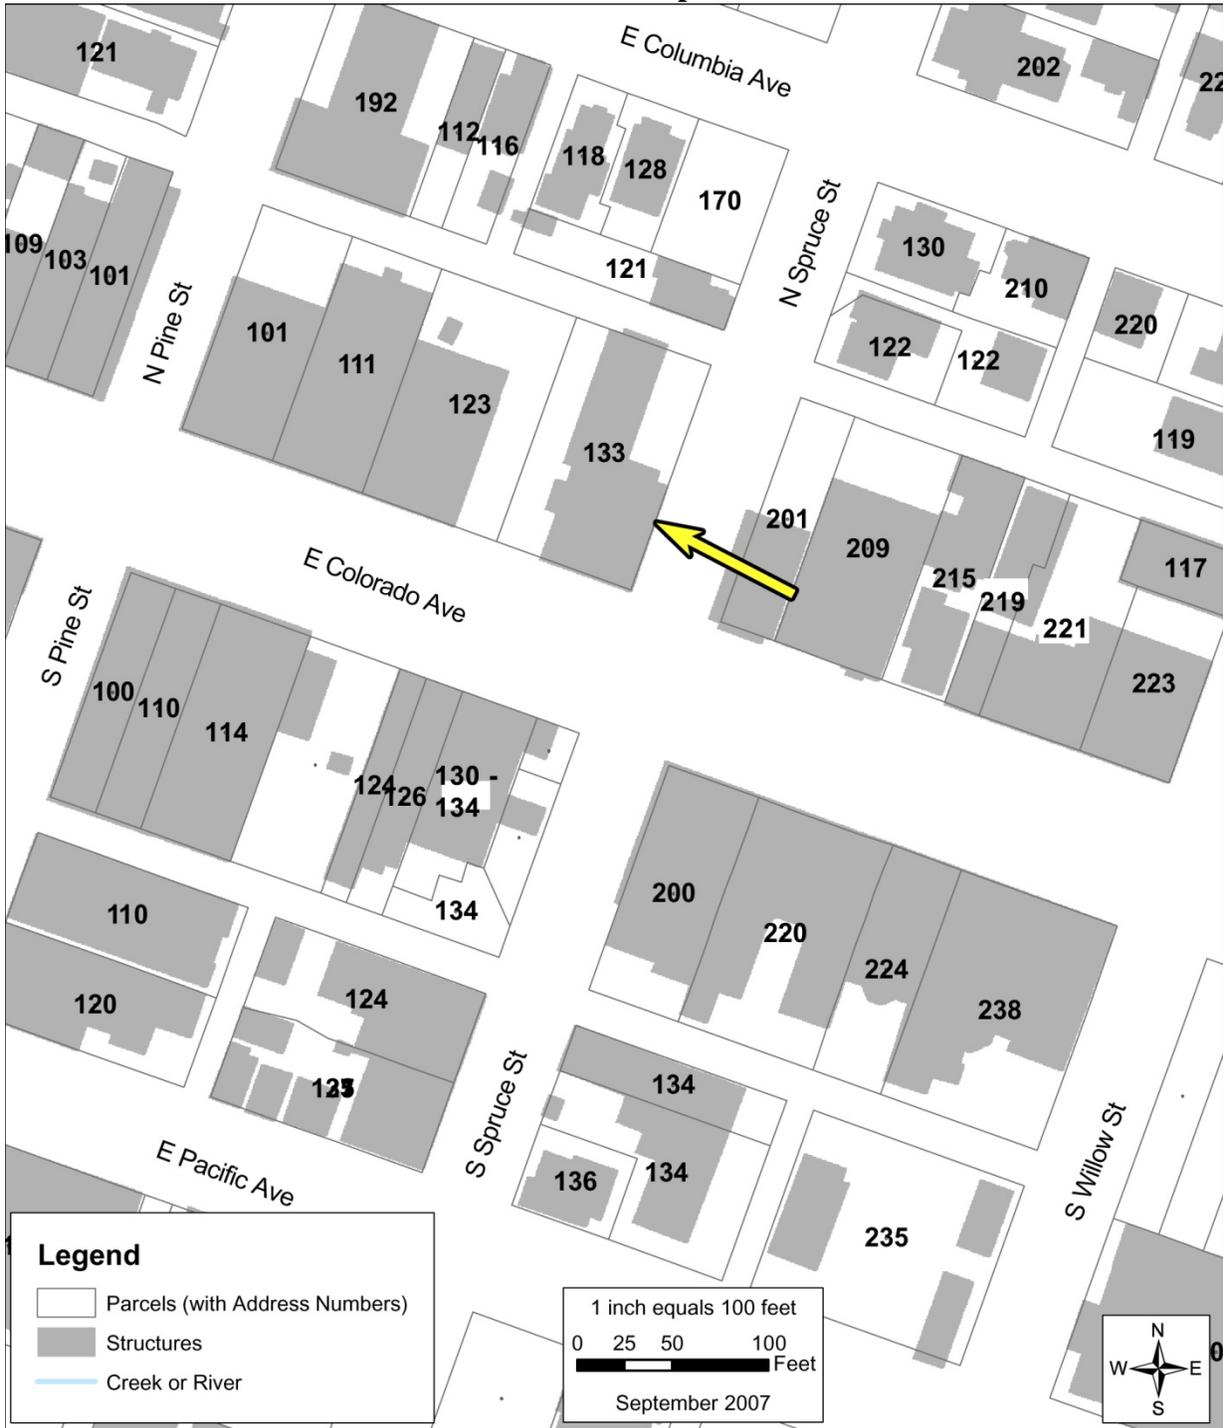
Sketch Map

23. Landscape or special setting features:
This property is located at the northwest corner of Colorado Avenue and Spruce Street in downtown Telluride. Spruce Street in this area has been vacated to create a small park and pedestrian area.
