COLORADO CULTURAL RESOURCE SURVEY

Architectural Inventory Form

- 1. Resource number: **5SM1828**
- 2. Temporary resource number: **N/A**
- 3. County: **San Miguel**
- 4. City: **Telluride**
- 5. Historic Building Name: **Warehouse**
- 6. Current Building Name: **New Sheridan Hotel Colorado Suites Building**
- 7. Building Address: **133 E. Colorado Avenue (rear)**
- 8. Owner Name and Address: **Roma Building LLC  
P. O. Box 1285  
Telluride, CO 81435**

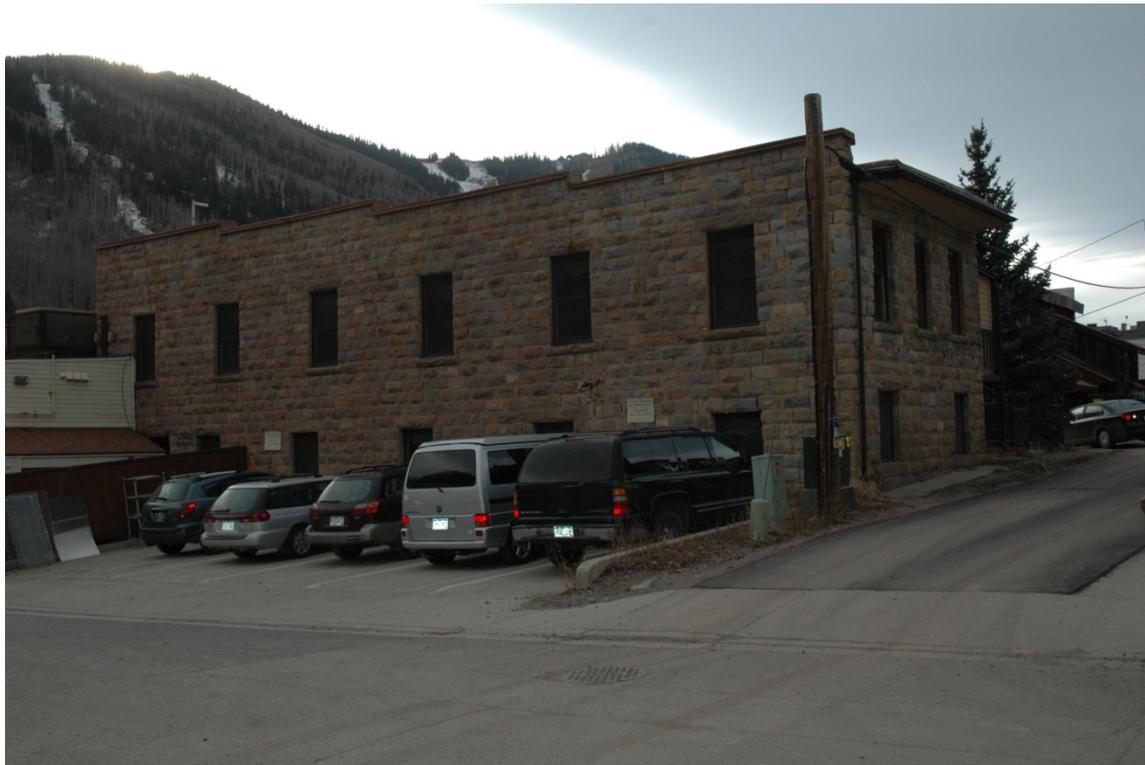
**This two-story stone building abuts the north (rear) elevations of two joined buildings which front onto East Colorado Avenue to the south (5SM.1543 and 5SM-1544). Measuring approximately 70' N-S by 25' E-W, this rectangular-shaped building features coursed sandstone exterior walls and a flat, or nearly flat, roof with stepped parapets on the east and west elevations. The west elevation, which faces toward Spruce Street, is penetrated by six 1/1 double-hung sash first story windows and six 1/1 double-hung sash second story windows. The north elevation, facing the alley, is penetrated by two 1/1 double-hung sash first story windows and three 1/1 double-hung sash second story windows. The windows predominantly feature sandstone lugsills and lintels. The west elevation (façade) features first story entry doors at just below grade and second story entry doors leading into a narrow wood frame addition, from an elevated second story porch accessed by an exterior metal stairway.**
