COLORADO CULTURAL RESOURCE SURVEY

Architectural Inventory Form

- 1. Resource number: **5SM.1545** Parcel number(s): **477901117005**
- 2. Temporary resource number: **N/A**
- 3. County: **San Miguel**
- 4. City: **Telluride**
- 5. Historic Building Name: **Hudson's and Peters' Saloon; Sheridan Saloon,
Sheridan Pool Hall**
- 6. Current Building Name: **Telluride Music Company Building**
- 7. Building Address: **201 E. Colorado Avenue**
- 8. Owner Name: **Proprietors West LLC**
- Owner Address: **P. O. Box 1473
Telluride, CO 81435**

| 48. Report title: | Town of Telluride Re-Survey of Historic Structures | | Planning and Building Dept. |

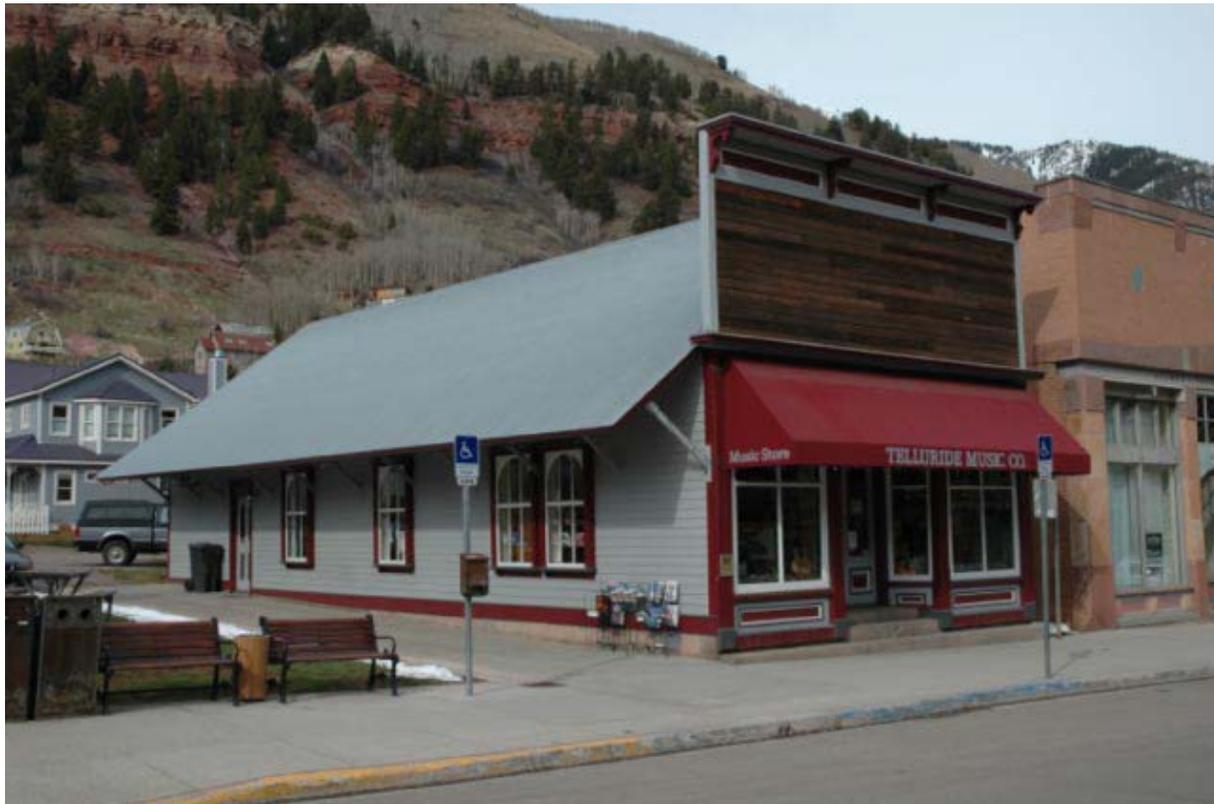
21. General architectural description:
This late nineteenth century, wood-frame false front, building is located at the northeast corner of Colorado Avenue and Spruce Street. Supported by a low, non-historic, unpainted concrete foundation, the building features a basic rectangular plan which measures 60' N-S (deep) by 24' E-W (across). Comprising a single storefront, the symmetrical façade fronts directly onto the concrete sidewalk which parallels Colorado Avenue on the south elevation. A set of paired, painted grey with red, black and white trim, glass-in-wood-frame doors enter the center of the façade from within a centered recessed entryway. The entryway is approached by three concrete steps, and features a concrete floor, while the doors are flanked by single light sidelights, and are topped by transom lights, all with painted white wood frames. The recessed entryway is flanked on either side by large 4-light storefront display windows, set over wood-paneled kick plates with painted red, grey and white wood trim. Painted burgundy color wood columns flank the entryway and appear at either end of the façade. A canvas awning, with the words "TELLURIDE MUSIC CO." along its front edge extends along all of the façade covering the entry and display windows. A secondary cornice is located directly above the canvas awning, visually separating the upper and lower portions of the façade. The upper false front portion of the façade wall is clad with stained natural brown horizontal wood siding, with three recessed wood panels near the top of the wall surface. A bracketed cornice forms the top of the false front façade wall. A Telluride Historical Museum plaque is affixed to the façade wall. Hidden behind the false front, the building is covered by a moderately-pitched front gable roof, with metal roofing material laid over plywood decking and 2x wood rafters. The roof eave along the east (side) elevation is closed, while the eave along the west (side) elevation features an extended overhang with knee brace supports. The building's secondary elevations (east, west and north) are clad with painted grey horizontal wood

siding, with painted burgundy 1" by 4" corner boards. Stained brown vertical wood siding appears in the rear upper gable end, however. A painted burgundy 1" by 10" or 1" by 12" board separates the horizontal wood siding from the concrete foundation on the west elevation. The west elevation is penetrated by one set of paired 3/3 (ribbon style) double-hung sash windows, and two single 3/3 (ribbon style) double hung sash windows, with painted white wood frames and painted burgundy wood surrounds. A painted grey wood-paneled door, with two vertically-oriented upper sash lights with rounded tops, enters the building near the north end of the west elevation.

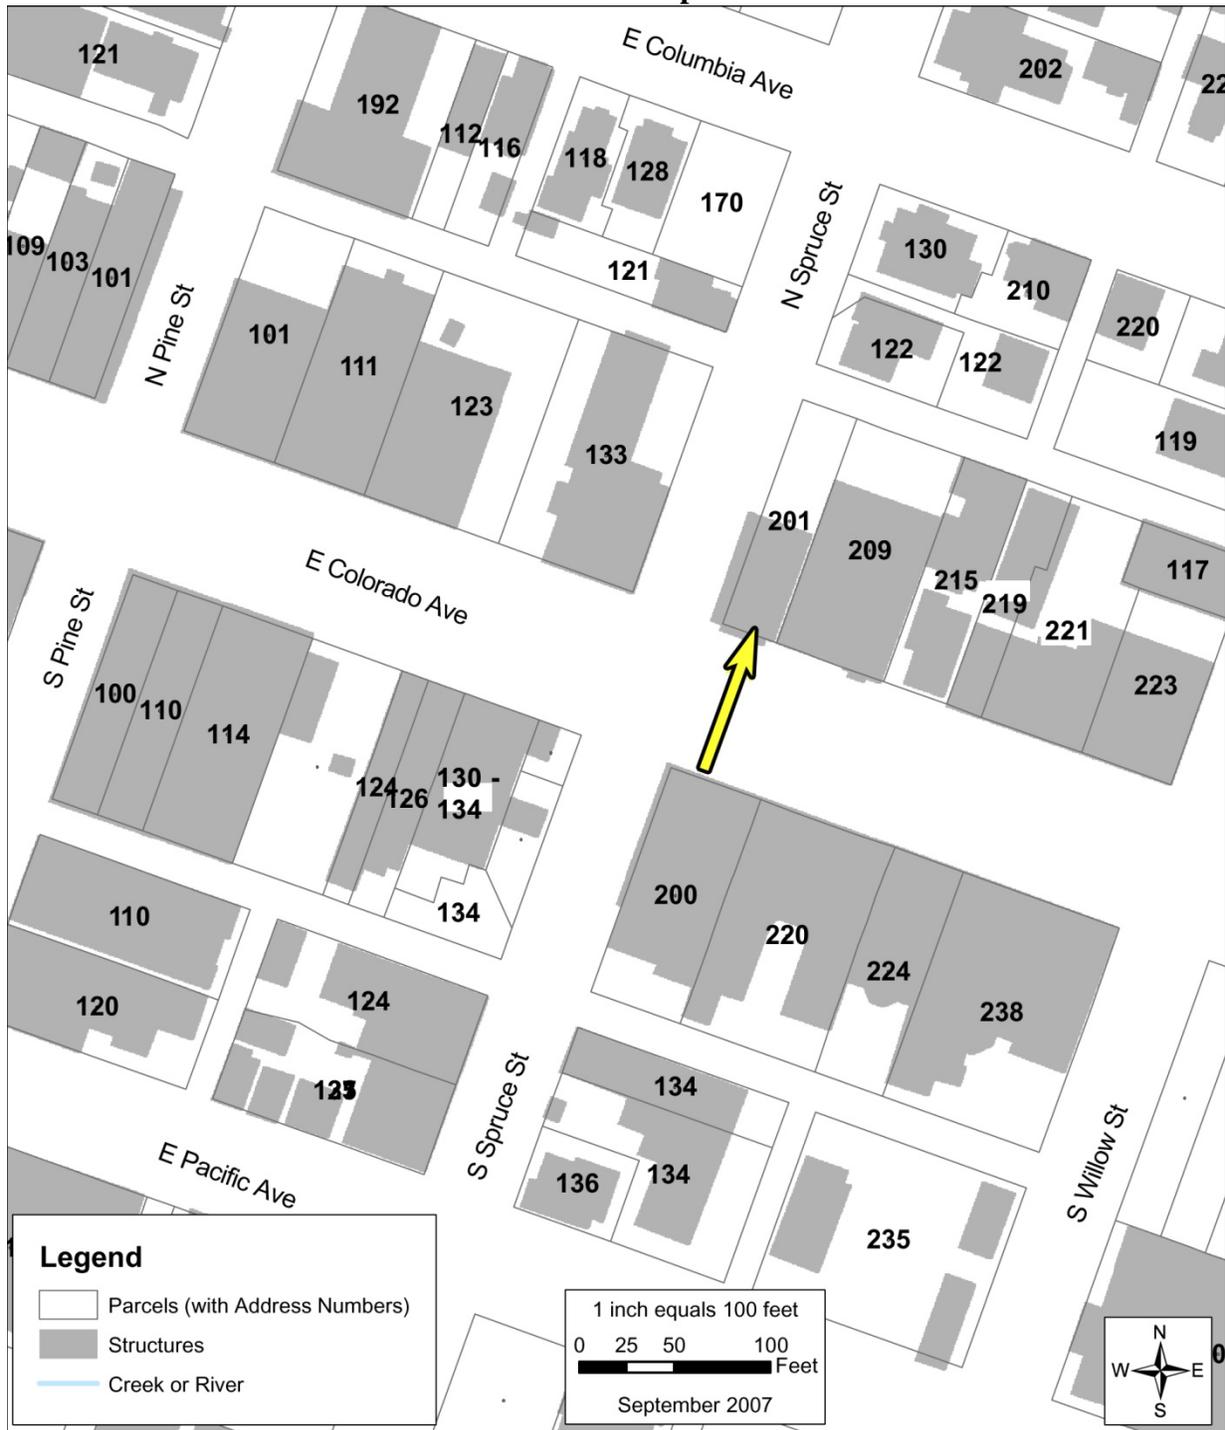
Sketch Map

22. Architectural style: **Late Victorian/False Front Commercial**
 Building type: **N/A**
23. Landscape or special setting features: **This building is located at the northeast corner of Colorado Avenue and Spruce Street, near the eastern end of Telluride's historic commercial district along Colorado Avenue. A small park, where Spruce Street historically ran through, now flanks the building's west elevation.**
24. Associated buildings, features or objects: **Not Applicable**
