COLORADO CULTURAL RESOURCE SURVEY

Architectural Inventory Form

- 1. Resource number: 5SM1546 Parcel number(s): See Below
2. Temporary resource number: N/A
3. County: San Miguel
4. City: Telluride
5. Historic Building Name: Dwelling
6. Current Building Name: Andrews Real Estate/ Hell Bent Leather and Silver Bldg.
7. Building Address: 215 E. Colorado Avenue

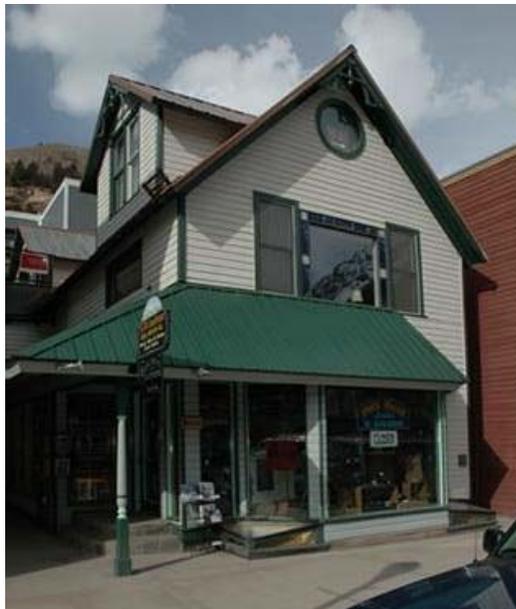
THLD RATING: Noncontributing Without Qualifications
Fino Building – Non-designated.

21. General architectural description:
Historically a dwelling, this building at 215 E. Colorado Avenue presently houses the E.W. Andrews Real Estate Company and Hell Bent Leather and Silver. Featuring a front gabled plan, with an enclosed wrap-around former front porch, this is a tall angular 2.5-story building. Supported by a non-historic concrete block foundation, the building has painted cream white horizontal weatherboard exterior walls, with painted dark green fluted 1" by 4" corner boards. The steeply-pitched front gable roof is covered with non-historic brown metal roofing material, while painted green sculptured rafter ends are exposed beneath the eaves. Two gabled dormers are located on the west-facing roof slope, and one gabled dormer is located on the east-facing roof slope. The gabled dormer toward the south (front) end of the west elevation is penetrated by a set of paired 1/1 double-hung windows. The gabled dormer toward the north (rear) end of the same elevation is penetrated by a door which opens onto a small balcony above a Mansard-roofed extension to the north end of the west elevation. A canted bay window, with three single-light fixed-pane display windows, is located on the façade (south elevation). A painted green glass-in-wood-frame door enters the building from a 2-step porch at the south end of the west elevation. Another wood-paneled entry door, and three large single-light fixed-pane display windows, are located toward the south end of the west elevation. An oculus window penetrates the façade's upper gable end, directly below a gable ornament. A (probably non-historic) single-light fixed-pane window, with flanking 1/1 double-hung windows, penetrates the façade's second story. Additional gable ornaments are located in the upper gable ends of the dormers on the east and west facing roof slopes. Windows elsewhere are primarily 1/1 double-hung sash with painted wood surrounds; however, there are also some non-historic fixed-pane windows.
