COLORADO CULTURAL RESOURCE SURVEY

Architectural Inventory Form

- 1. Resource number: **5SM.1556**
- 2. Temporary resource number: **N/A**
- 3. County: **San Miguel**
- 4. City: **Telluride**
- 5. Historic Building Name: **Pekkarine Building**
- 6. Current Building Name: **Pekkarine Building**
- 7. Building Address: **220-224 W Colorado Ave**
- 8. Owners Names and Addresses: **Numerous Owners**

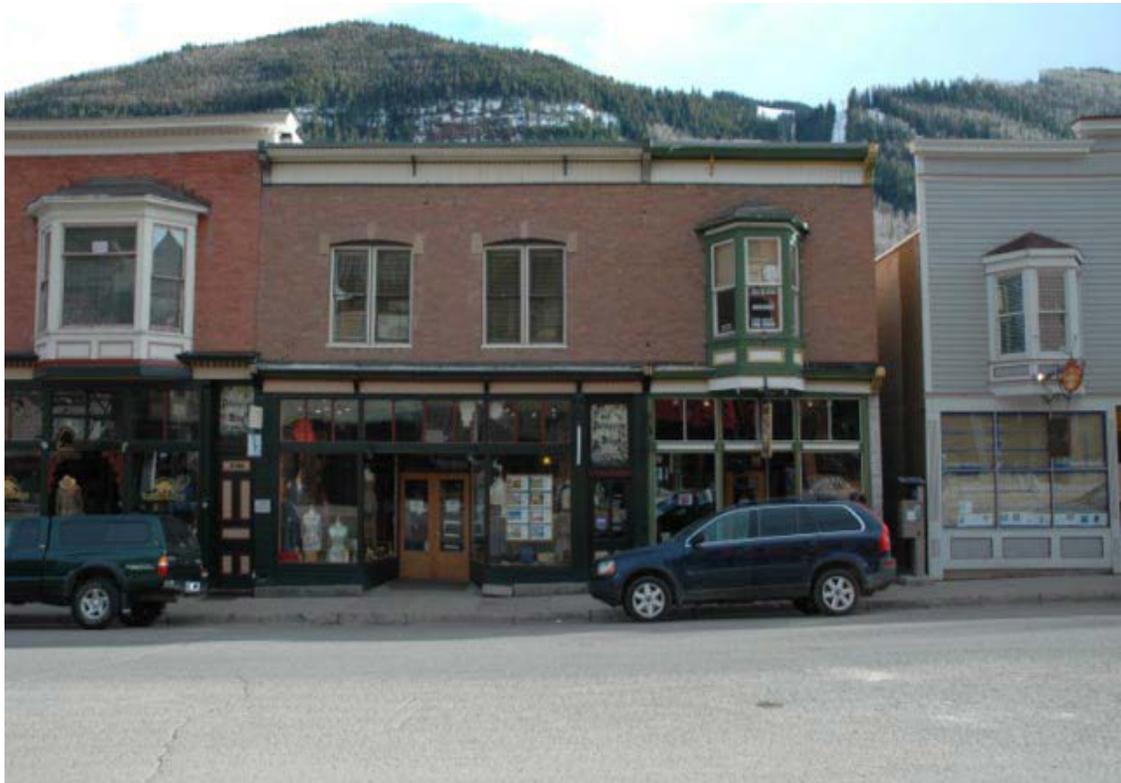
21. General architectural description:
The Pekkarine Building is a two-story brick commercial block located on the south side of Colorado Avenue, in downtown Telluride. The façade, which fronts toward Colorado Avenue on the north elevation, contains two storefronts. "Bear Mountain Trading Company" presently occupies the retail space in the building's east half (at 220 E. Colorado Avenue), while "Between the Covers Book & Espresso Bar" presently occupies the retail space in the west half (at 224 E. Colorado Avenue). A set of paired, stained natural brown, glass-in-wood-frame doors, with transom lights, enter the east half of the facade from within a recessed entryway which is flanked by large single-light fixed-pane storefront display windows. A stained natural brown glass-in-wood-frame door, with a transom light, enters the west half of the façade from within another recessed entryway which is also flanked by single-light fixed-pane storefront display windows. Painted green or black wood-paneled kickplates appear beneath the windows. Another door, which accesses an interior stairwell, is located between the two recessed entries. This is a painted black wood-paneled door, with red and beige trim, and with two vertically-oriented upper sash lights, with rounded tops. This door is topped by a distinctive leaded glass and stained glass transom light, with the words "Pekkarine Bldg" etched in the glass. Brick columns flank either side of this door, and are also located at either end of the façade's first story. The façade's first story doors and windows are topped by a band of fixed-pane clerestory lights located beneath a secondary cornice with a dentil course. The upper façade wall is of red brick construction, and is penetrated by two sets of paired 1/1 double-hung sash windows with segmental brick arches and sandstone keystones and springers. A historic projecting hip-roofed oriel window, with three 1/1 double-hung windows, penetrates the second story near the west end of the façade. The top of the

façade wall is finished with a bracketed cornice. The building's west (side) elevation is made of red brick, laid in running bond. Three 1/1 double-hung sash windows, with wood sills and segmental brick arches, penetrate the west elevation's second story. The building's east elevation is not exposed. The building's south (rear) elevation is covered by a two-story wood-frame addition, with a walk-out (below grade) basement level. Multiple entry doors on the addition's south elevation are accessed by a series of exterior wooden staircases, porches and balconies.
